## HOME INSPECTION REPORT

1234 Main St. Minneapolis MN 55407

Buyer Name 09/24/2020 9:00AM

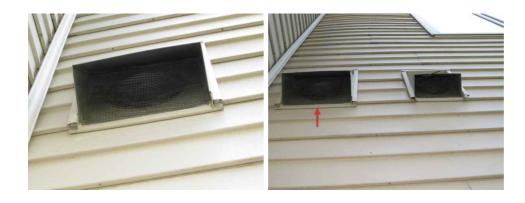
3.15.1 Combustion Air Intake

The combustion air intake should be checked regularly and cleared if necessary to ensure sufficient combustion air is brought into the house for fuel-burning appliances. The intake was clean at the time of inspection. For more information on this topic, click here: Combustion Air Ducts, Part II: Problems and Solutions

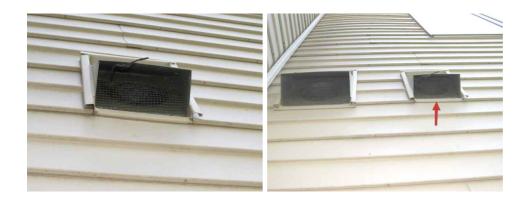
3.16.1 Air Exchanger Intake/Exhaust

### **DIRTY INTAKE**

The intake vent for the air exchanger was dirty and should be cleaned. This will allow proper airflow and operation of the air exchanger.

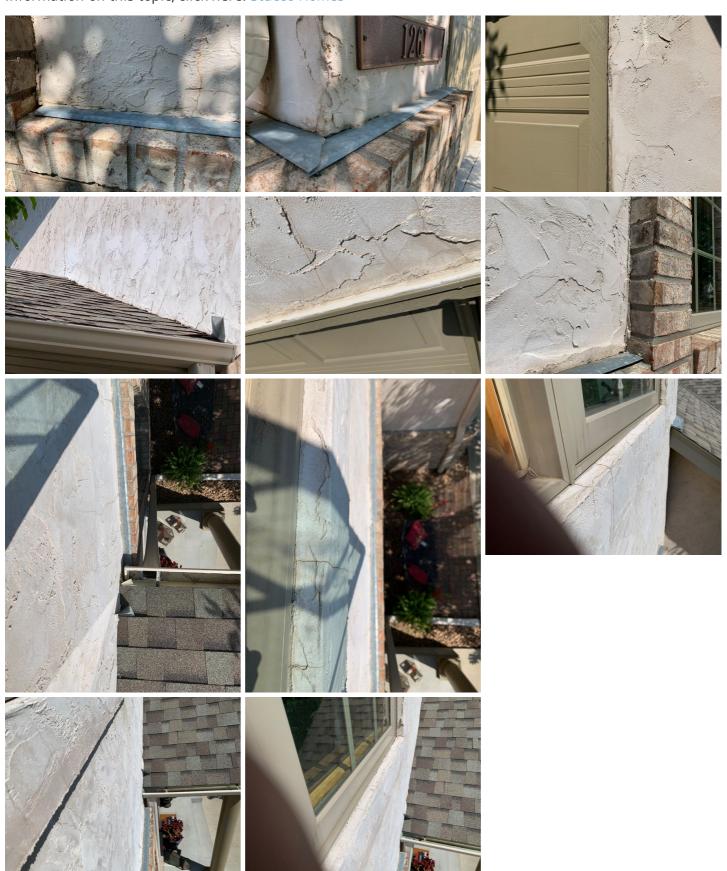
4.4.1 Stucco

### **INTRUSIVE MOISTURE TESTING**

Stucco siding on a house of this age is prone to water intrusion and water damage inside the walls. The stucco lacked proper gaps at the flashing and roof to allow moisture to drain. The stucco was also cracked in areas. Have intrusive moisture testing performed by a company that specializes in this. For more information on this topic, click here: Stucco Homes

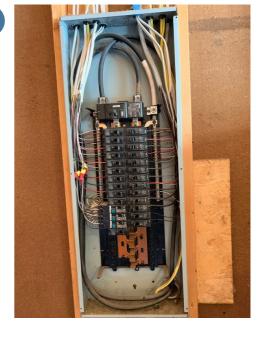
7.1.1 Main Panel

# MAIN ELECTRICAL PANEL ACCEPTABLE

The main electrical panel and its interior components were in acceptable condition.
