STRUCTURE TECH HOME INSPECTIONS

HOME INSPECTION REPORT

1234 Main st.
undefined, undefined undefined

07/07/2022 9:00AM

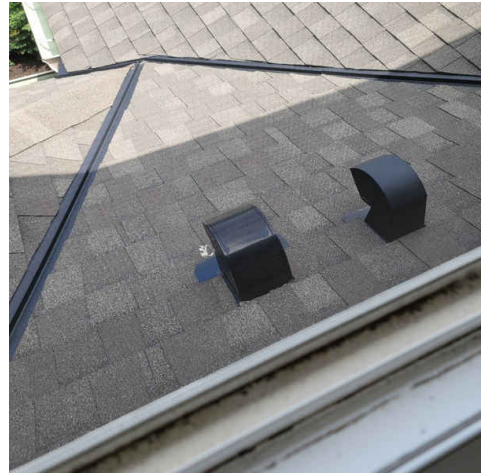
DRYER VENT TERMINATES AT ROOF

The vent terminal for the dryer exhaust was located at the roof. The terminal will need to be cleaned regularly to help prevent accumulated lint from blocking the vent. The vent may also contribute to ice dams in the winter. Consider having the dryer exhaust relocated to a more accessible location, such as an exterior sidewall. For more information on this topic, click here: [Clothes Dryer Maintenance](#)

back of house - outside laundry room window

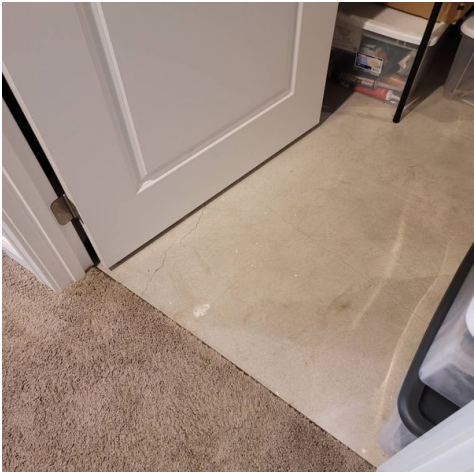
SHRINKAGE CRACKS

There were cracks visible on the floor in the basement. These cracks are typically due to shrinkage and are not a concern.

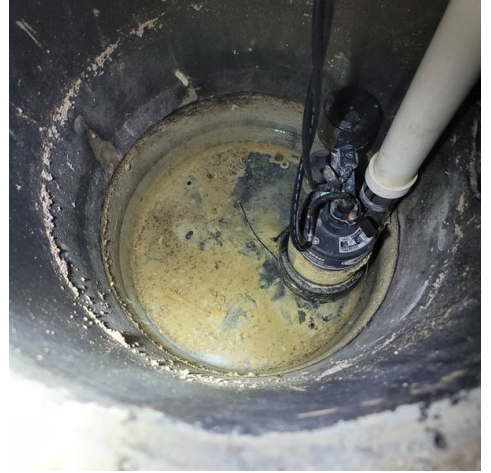
**BACKUP SUMP PUMP
RECOMMENDED**

water in basket at time of inspection
and pump was active

Consider having a backup sump pump installed to help guard against basement flooding if the primary pump fails, or there is a power outage. For more information on this topic, click here: [Backup Sump Pumps](#)

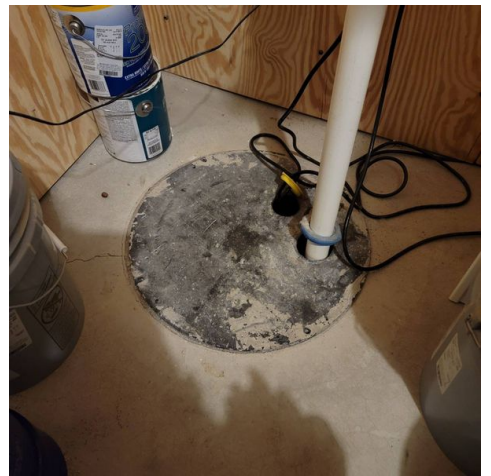
COVER - NOT SECURED & NOT AIRTIGHT

The sump cover was not screwed shut, which is a safety issue. The sump basket cover was also not airtight. This can allow air with relatively high levels of moisture to enter the home and can contribute to radon gas entry. Have the sump basket cover made airtight and secure the cover with screws to help prevent its removal by children. For more information on this topic, click here: [Five Common Sump System Defects](#)

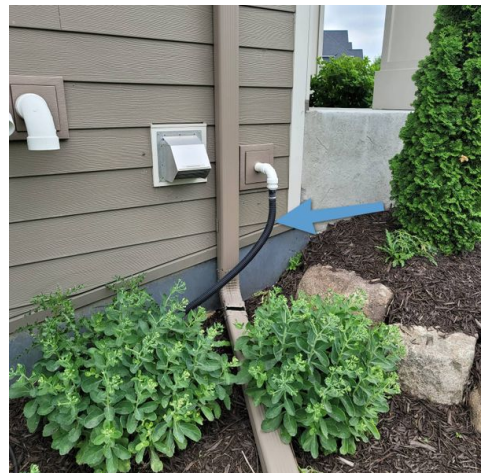
**DISCHARGE PIPE -
CORRUGATED AT EXTERIOR**

The sump pump discharge tube was connected to a corrugated tube that runs across the lawn. This tube has the potential to fill with ice and prevent the pump from functioning properly during the winter. Remember to disconnect the corrugated extension tube in the fall. For more information on this topic, click here: [Potential for Freezing at the Exterior](#)

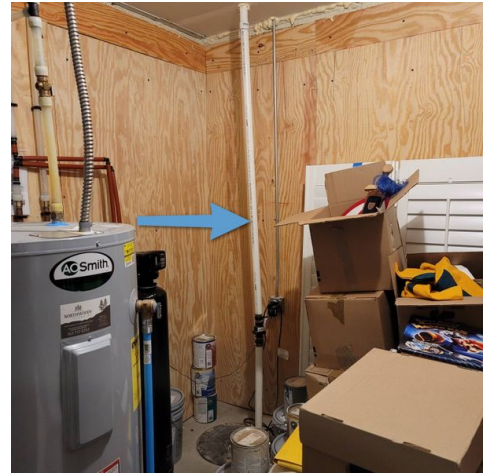
DISCHARGE PIPE - LOOSE

The sump pump discharge pipe was loose and should be secured to help reduce the potential for damage.

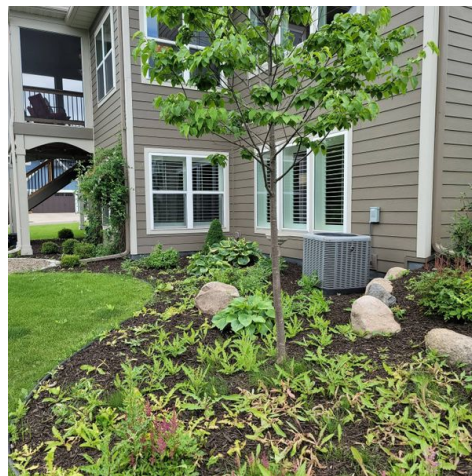
GRADING - FLAT

The ground was flat in areas next to the building, which could allow water to enter the basement or cause excessive soil pressures against the foundation walls. The soil or hard surfaces should slope away from the house for at least ten feet to help prevent basement water intrusion and foundation problems.

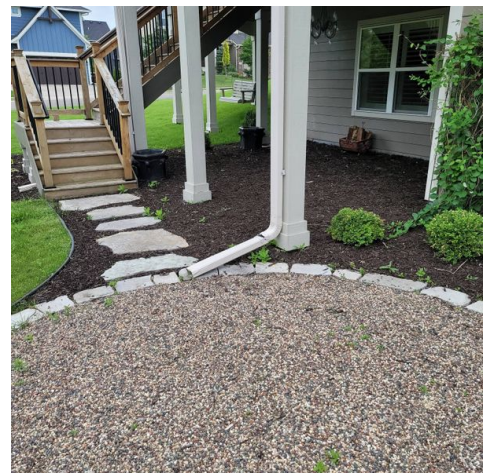
DOWNSPOUTS - CLOSE TO DECK FOOTINGS

The downspouts lacked proper extensions to carry the water away from the deck footings. Downspouts dumping water near the footings will concentrate water against them and greatly increase the potential for problems with settled footings or frost heave. Add solid aluminum downspout extensions to carry the water at least 6 feet away from the footings.

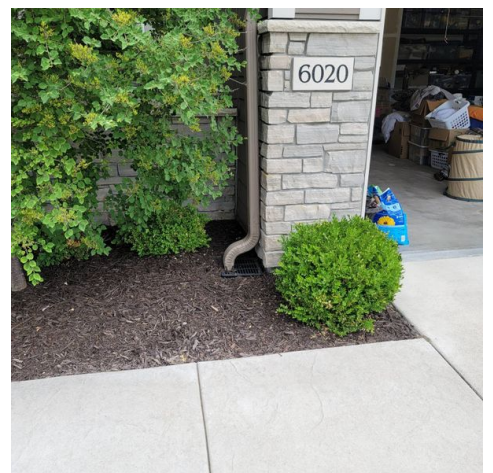
DOWNSPOUTS - DRAINS TO UNDERGROUND SYSTEM

Some downspouts drain to an underground system, which cannot be seen. Check with the seller for the history of this installation and the exit locations to keep clear.

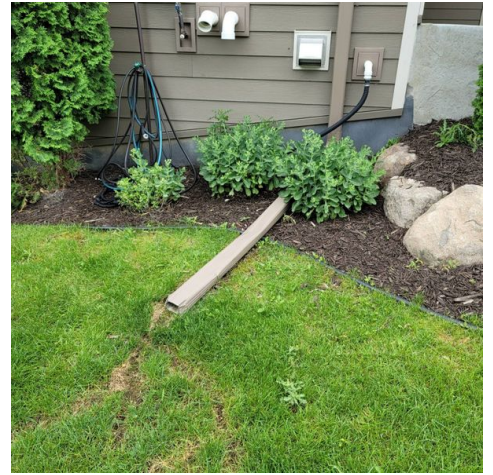
EXTENSIONS - DAMAGED

One or more downspout extensions were damaged and should be replaced.

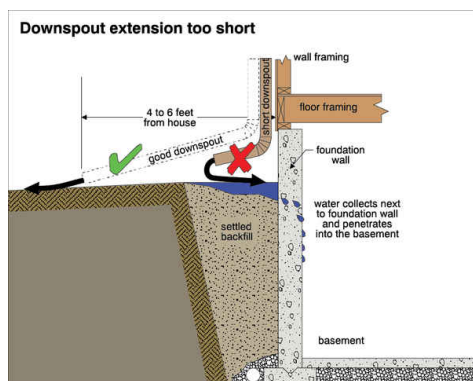
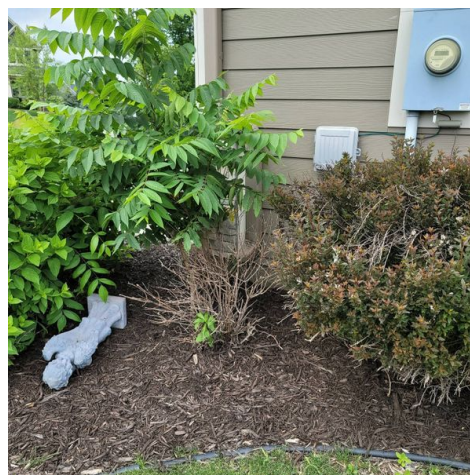
EXTENSIONS - IMPROPER

One or more downspouts lacked proper extensions to carry the water away from the foundation. Downspouts dumping water against the building will concentrate water and greatly increase the potential for basement water problems and foundation problems. Additionally, plastic/corrugated downspouts are prone to clogging and deterioration. Add solid aluminum downspout extensions to carry the water at least 6 feet away from the house and beyond any landscape edging.

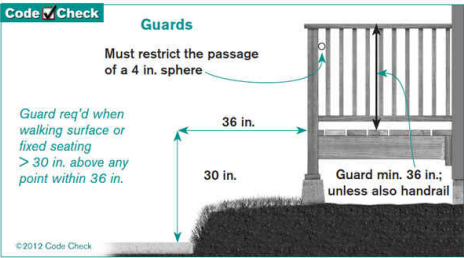
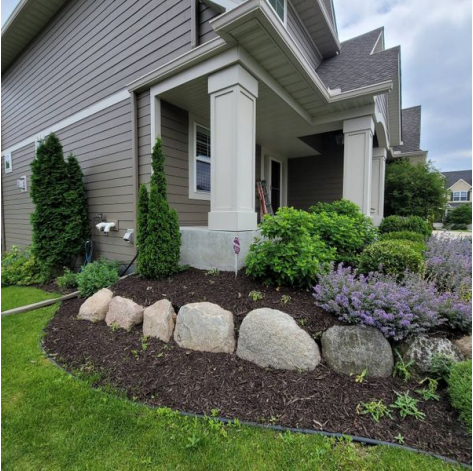
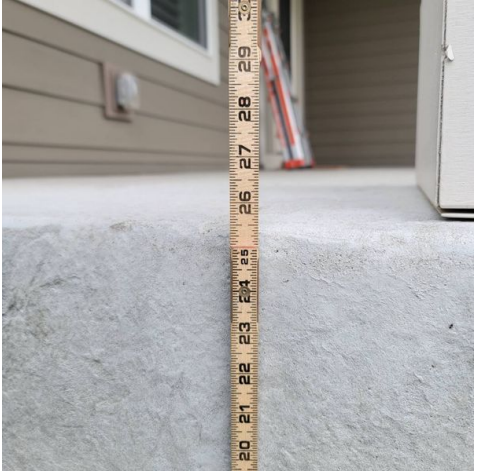
GUARDRAIL - MISSING AT FRONT PORCH

The minimum Minnesota requirement requires a guardrail at a dropoff greater than 30", measured straight down. While the finished grade makes the drop-off less than 30", the diagram below should be used as a guideline to help determine whether to install guardrails for safety.

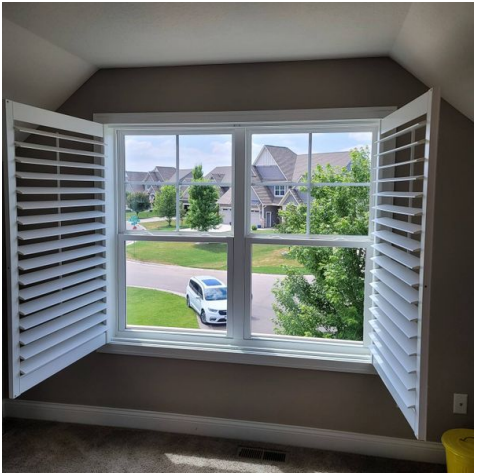
2nd floor bedroom

MISSING SCREENS

One or more window screens were missing. Have the screens installed for the pre-closing walk-through to verify that all screens are present, fit properly, and in acceptable condition.

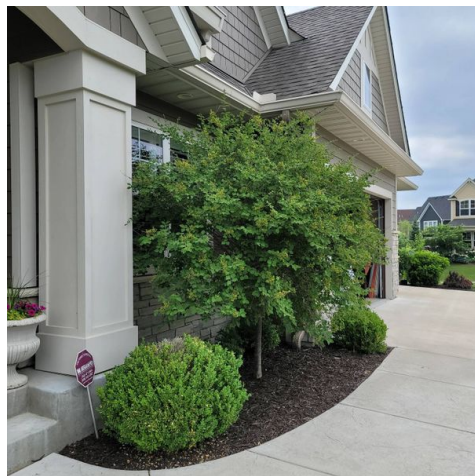
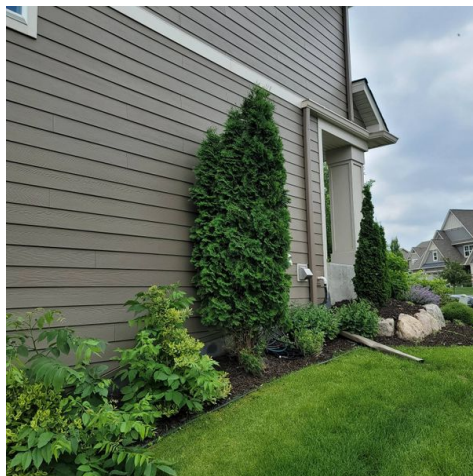
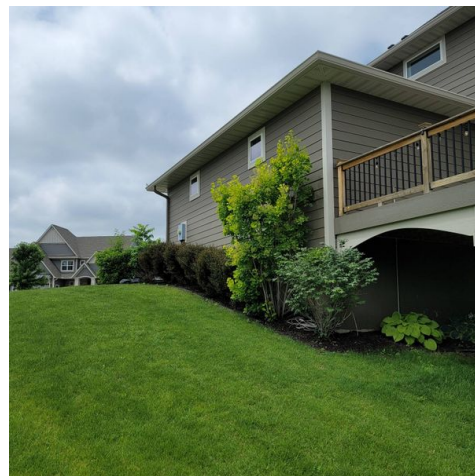
BUSHES CLOSE TO HOUSE

Bushes were growing close to the house, but should be kept a minimum of 12" away to help prevent damage to the siding. Trim the bushes.

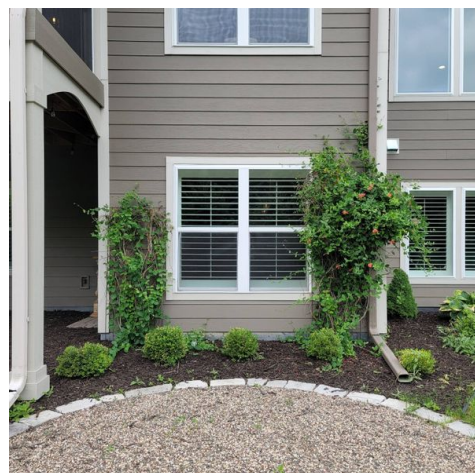
VINES AT WALLS

There were vines present at the exterior walls. Vines prevent the exterior walls from drying out and can grow through small crevices, eventually damaging the siding. Have the vines removed.

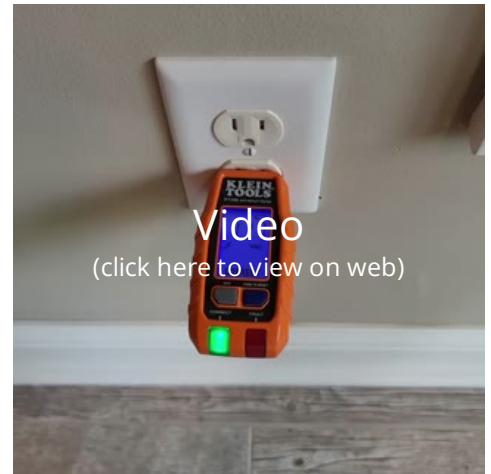
OUTLETS - LOOSE

One or more outlets were loose and should be secured. This is typically as easy as removing the cover plate and tightening the screws that hold the outlet in place.

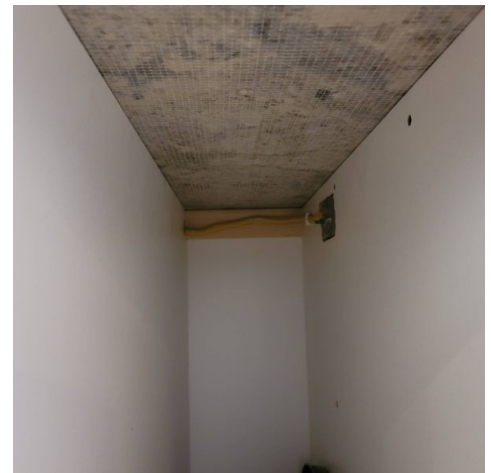
kitchen island

WIRING - UNPROTECTED IN CABINET

There was unprotected non-metallic cable (Romex) inside one or more cabinets. This can allow damage to the wire from items being moved in the cabinet. This has potential to be a fire/shock hazard which should be corrected.

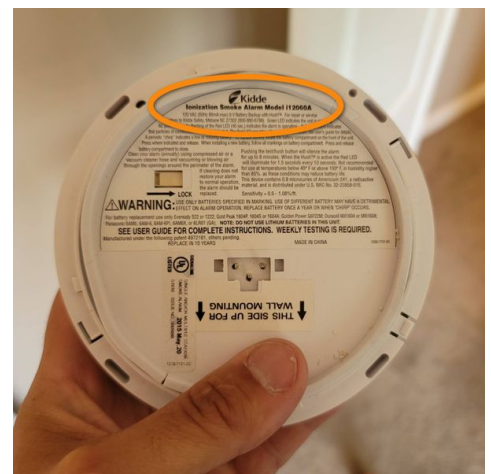
SMOKE ALARMS - REPLACE

There were one or more smoke alarms present that use an ionization type sensor to detect smoke. This type of sensor has a history of not signaling an alarm soon enough in the event of a smoldering fire, which may not give occupants proper warning to safely escape. For increased safety, replace all ionization smoke alarms with photoelectric, 10-year sealed-battery smoke alarms. For more information on this topic, click here: [Photoelectric smoke alarms are all you need](#)

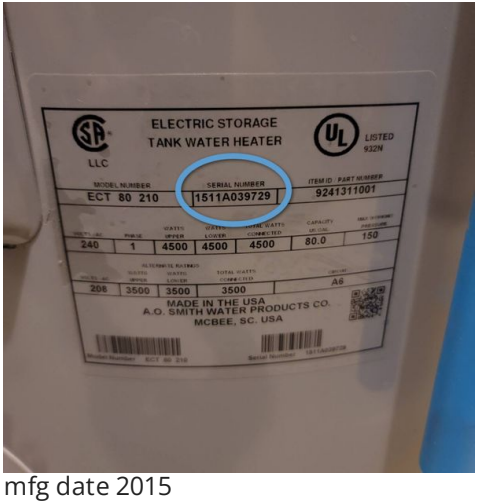
AGE - END OF LIFE (CLOSE)

The water heater was near the end of its service life expectancy. Plan for replacement.

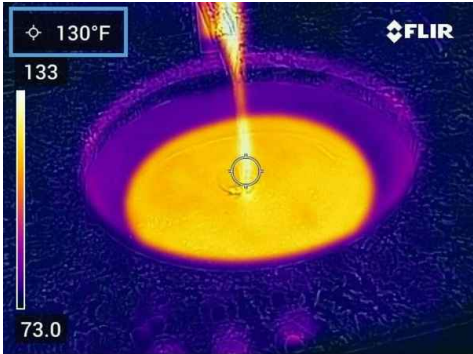
WATER TEMPERATURE TOO HIGH

The hot water temperature was too high, which can cause scalding very quickly. The water temperature should not be higher than 120° at any faucet. To reduce the risk of scalding, reduce the temperature at the water heater. Be aware, however, that this can increase the potential for Legionellae Bacteria growth. To minimize the risk of scalding and bacteria growth, consider installing a tempering valve. For more information on this topic, click here: [There's No Perfect Temperature For Your Water Heater](#)

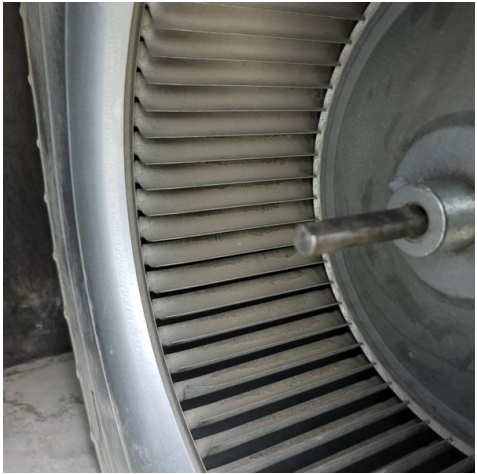
DIRTY BLOWER FAN

The blower fan blades were dirty. Have the furnace and the air conditioner evaporator coil professionally cleaned.

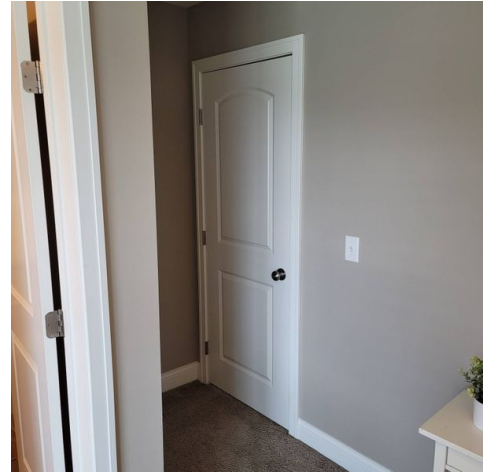
2nd floor bedroom

DOORS NOT LATCHING

One or more doors did not latch properly. For instructions on how to correct this, click here: [Door repair: how to fix a door that doesn't latch](#)

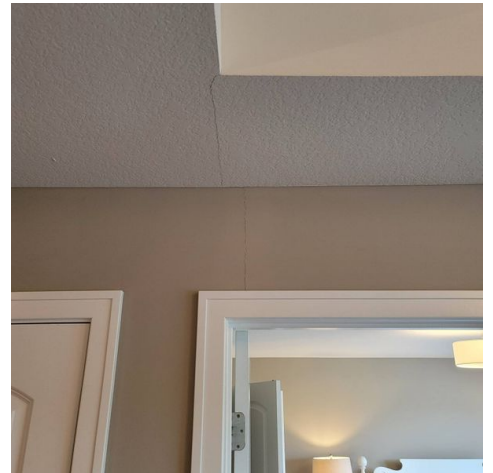
CRACKS AT WALLS

There were some common cracks present in the walls, which are typically cosmetic and not structural.

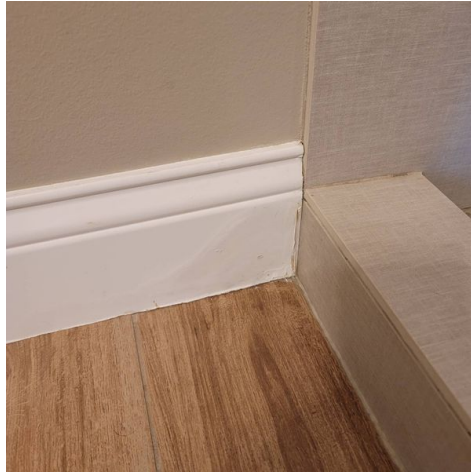
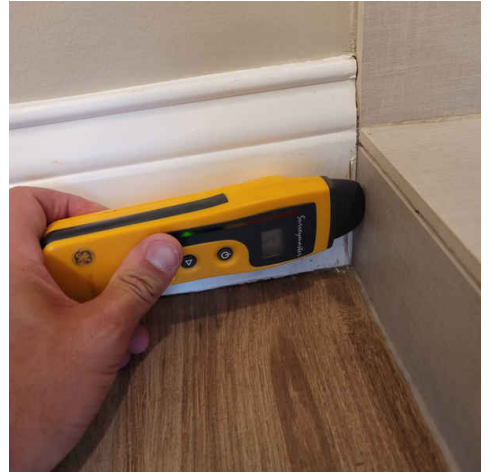
2nd floor bathroom

DRYWALL BY SHOWER DAMAGED

There was water damage at the drywall at the base of the shower wall. Consider adding splash guards to help prevent future water damage.

no/low moisture level (acceptable)

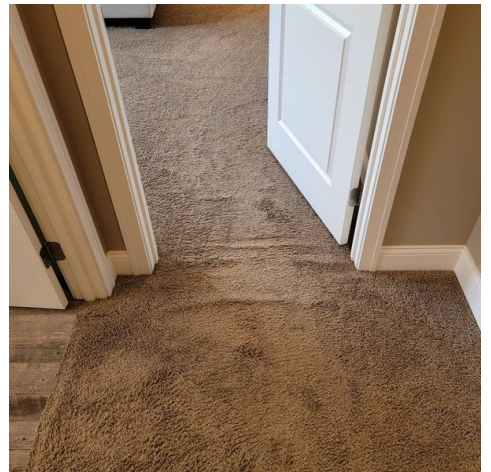
CARPET LOOSE

The carpeting was loose in areas. Have the carpet re-stretched or replaced.

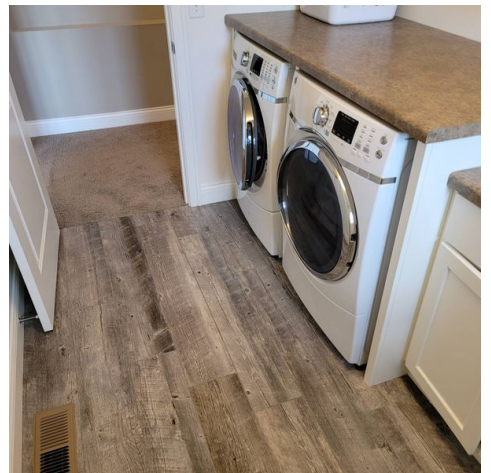
NO EMERGENCY DRAIN PAN

There was no emergency drain pan installed at the washing machine. Without a drain pan, the washing machine could cause damage if it leaked or if a hose burst. Consider installing an emergency shut-off device such as [Flood Stop](#) on the water supply lines. These are DIY devices that can help prevent major damage for approximately \$200.

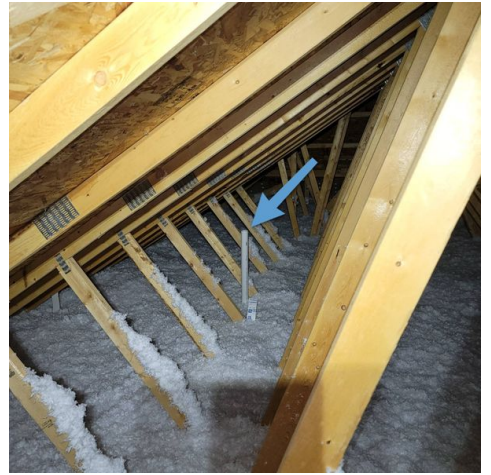
The 'tech tube' that leads to the basement was open in the attic. This can allow conditioned air from the house into the attic, possibly causing moisture issues. Have this tube sealed in the attic. For more information on this topic, click here: [A New Attic Problem with New Construction Homes](#)

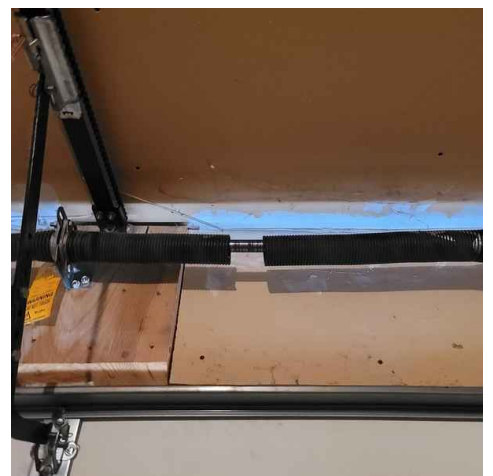
TORSION SPRING BROKEN

The torsion spring was broken at the overhead door. This will cause excess strain on the opener and could allow the door to fall if disconnected from the opener. Have the spring replaced to avoid possible injury.
