Inspection Report

Sample Report

Property Address:
1234 Anyplace Terrace
Yourtown MN

Structure Tech Home Inspections

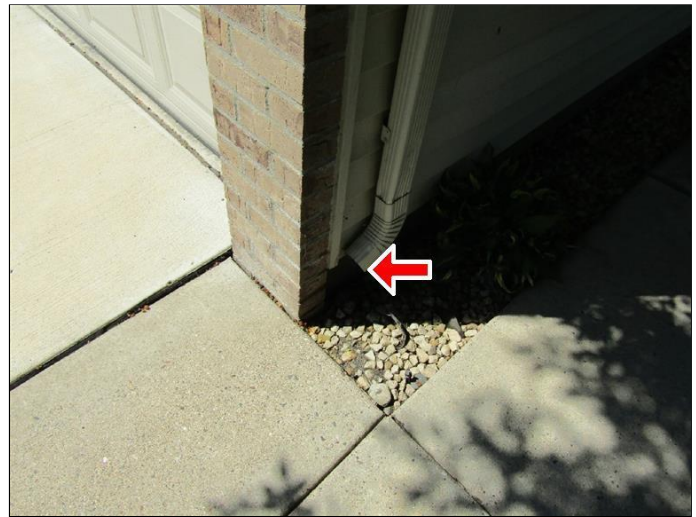
(1) A majority of the garage downspouts lacked proper extensions to carry the water away from the foundation. Downspouts dumping water against the building will concentrate water and greatly increase the potential for water problems and foundation problems. Add solid aluminum downspout extensions to carry the water at least 6 feet away from the house and beyond any landscape edging. Unit 4340 had an extension directed back toward the front entry.

One example. A majority of the downspouts lack proper extensions

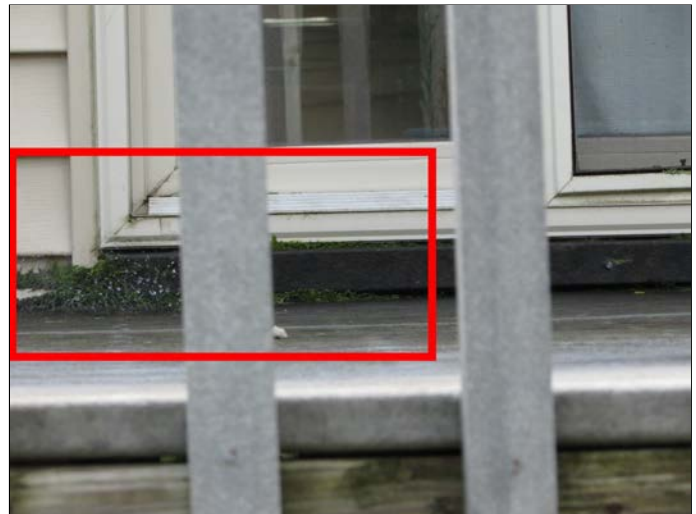
Heavy moss growth, unit 4373

Typical type of deterioration where water splashes off decks without gutter protection

- (3) Gutters were only partially installed at various areas throughout the community. A complete gutter system is recommended for moisture control at the foundation and to help prevent damage to the house at areas such as decks where splashing water can accelerate deterioration and contribute to water intrusion. Consider having a full system of gutters and downspouts installed.

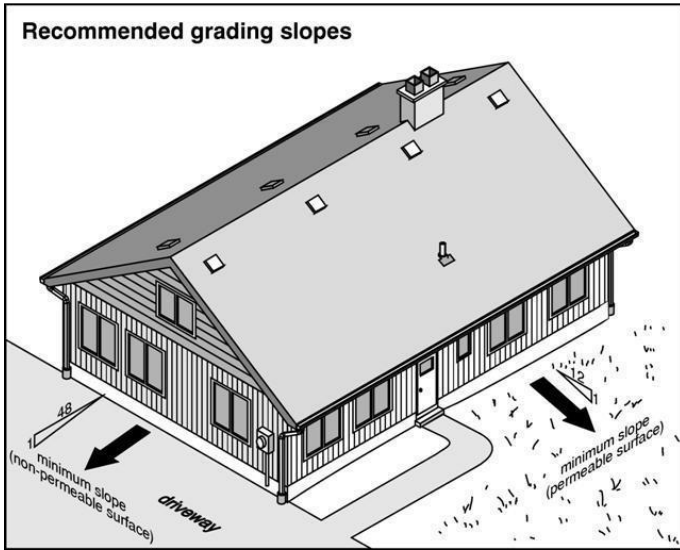
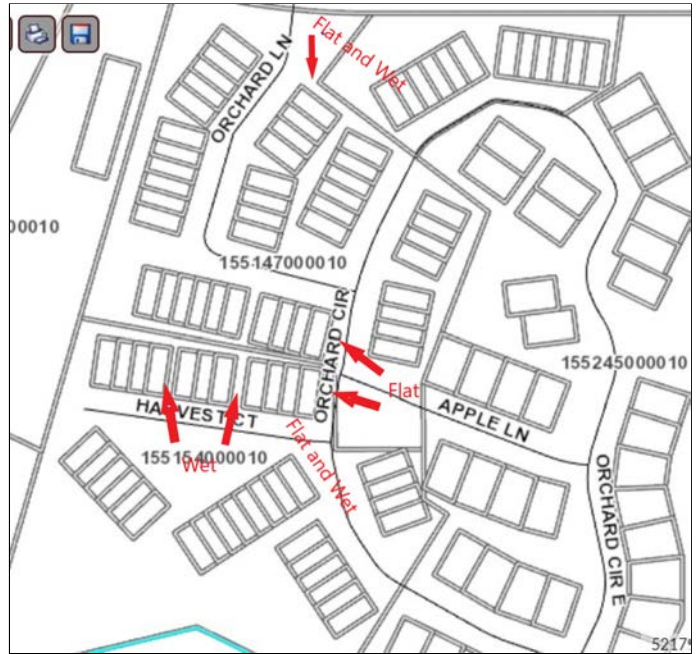
Unit 9161 - flat grading

(5) The ground sloped toward the buildings or was flat in areas next to the buildings, which could lead to water entering the basements and/or cause excessive soil pressures against the foundations. The soil or the hard surfaces should slope away from the buildings for at least ten feet if possible, to help prevent basement water intrusion and foundation problems. Re-grade where possible to provide positive slope away from the buildings.

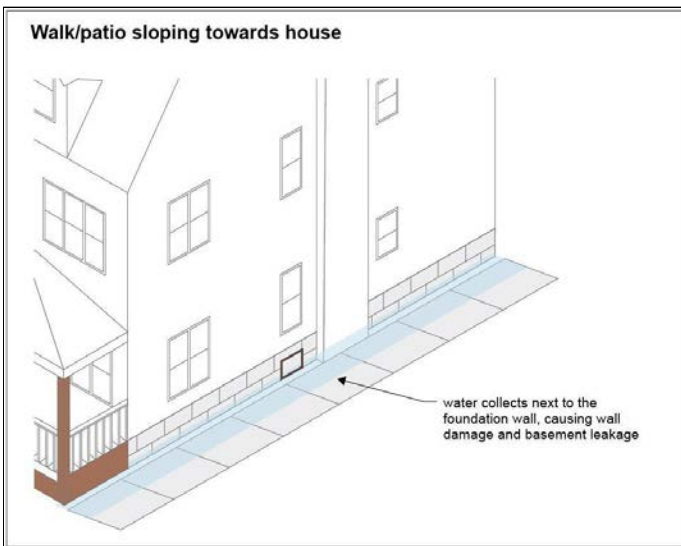
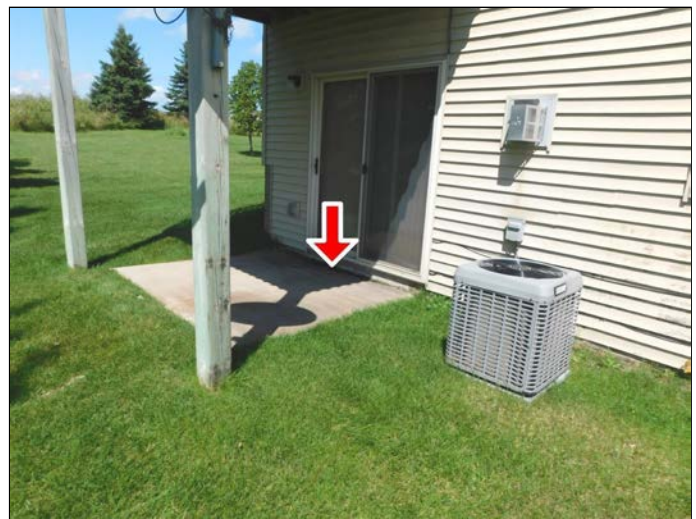
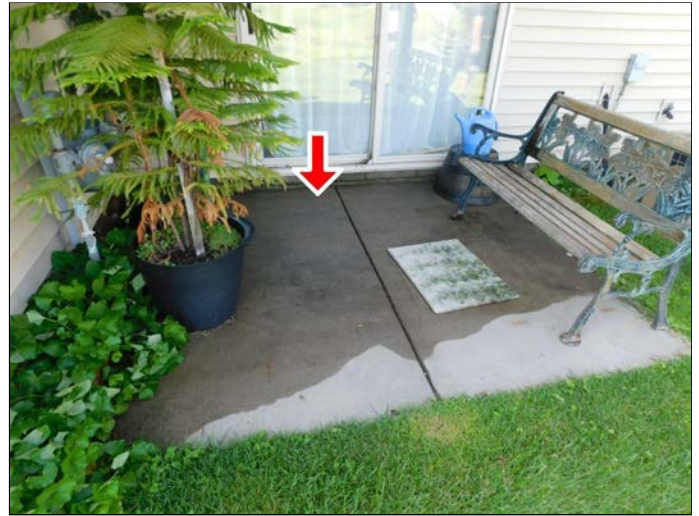
Example

(1) The patios at numerous units sloped toward the structure, which can lead to water intrusion and damage to the foundation wall. Have the slope corrected at the patios. Two common methods of leveling concrete are sandjacking and mudjacking. Units noted: 9166, 9162, 4318, 4320, 4322, 4328, 4330, 4332, 4340, 4344, 4348, 4352, 9162, 9156, 9152, 9184, 9188, 9192, 9221, 9223, 9225, 9227, 9201, 9195, and 9193.

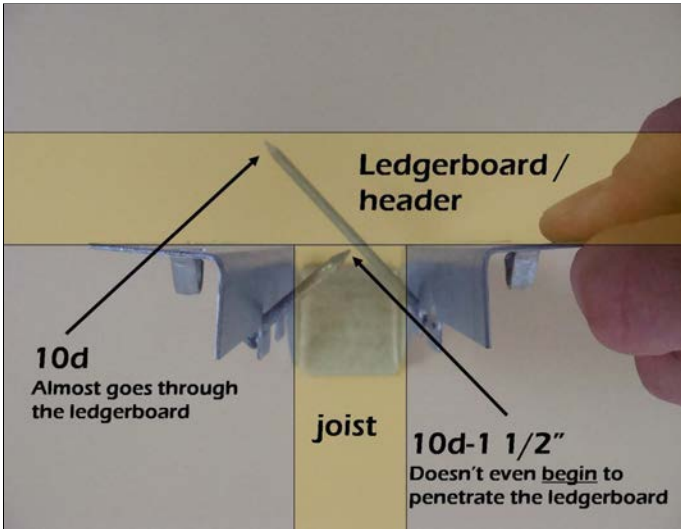
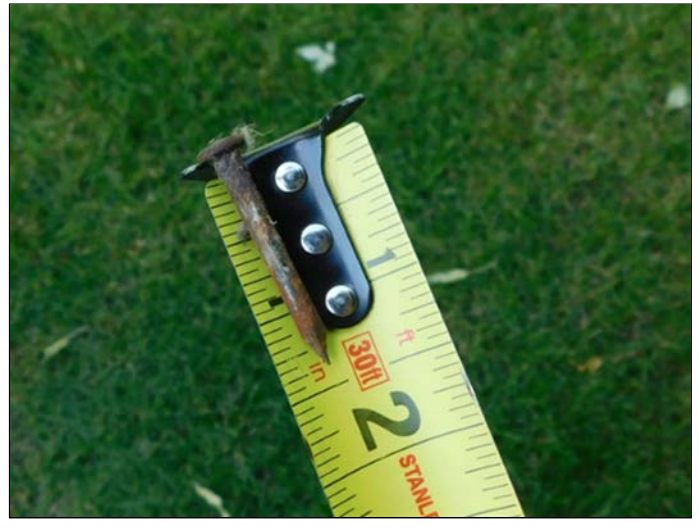
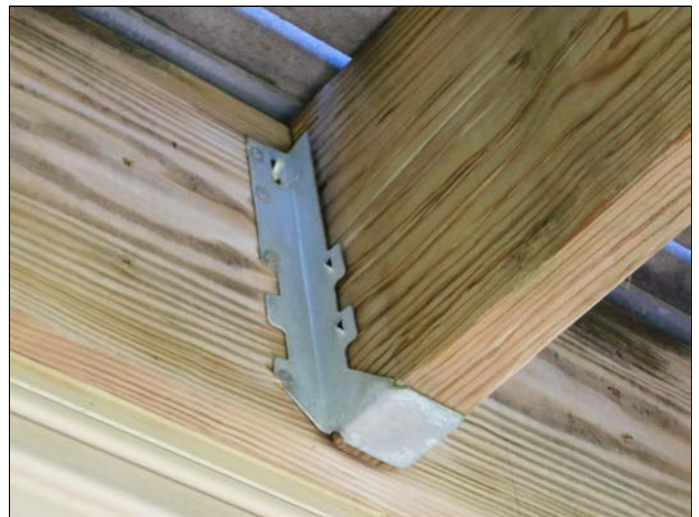
(2) Improper nails were used at the joist hangers at all the buildings. The joist hangers support the deck and now have the potential to fail. There were also missing nails at many of the hangers. Additionally, some joists were noted to be pulling away from the ledger board at numerous units. Have this corrected. For information on this correction, click here: [How to Correct Improper Joist Hanger Nails](#)

missing nails

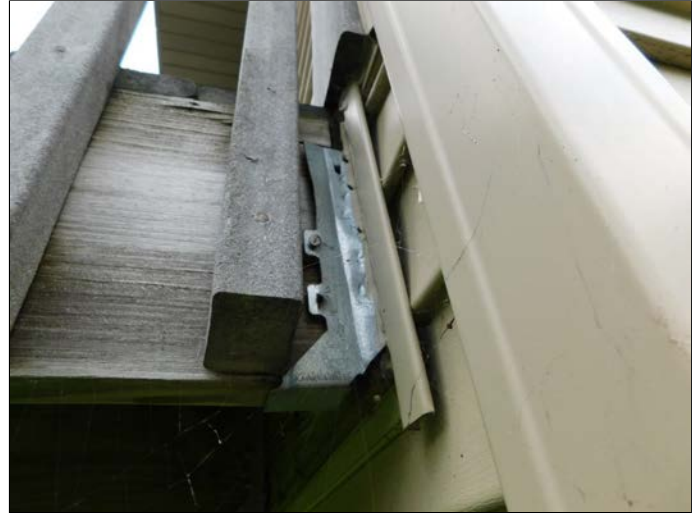
(3) There were improper joist hangers used at the ends of the ledger boards. These end joists have hangers specifically designed for these locations. Have this corrected.

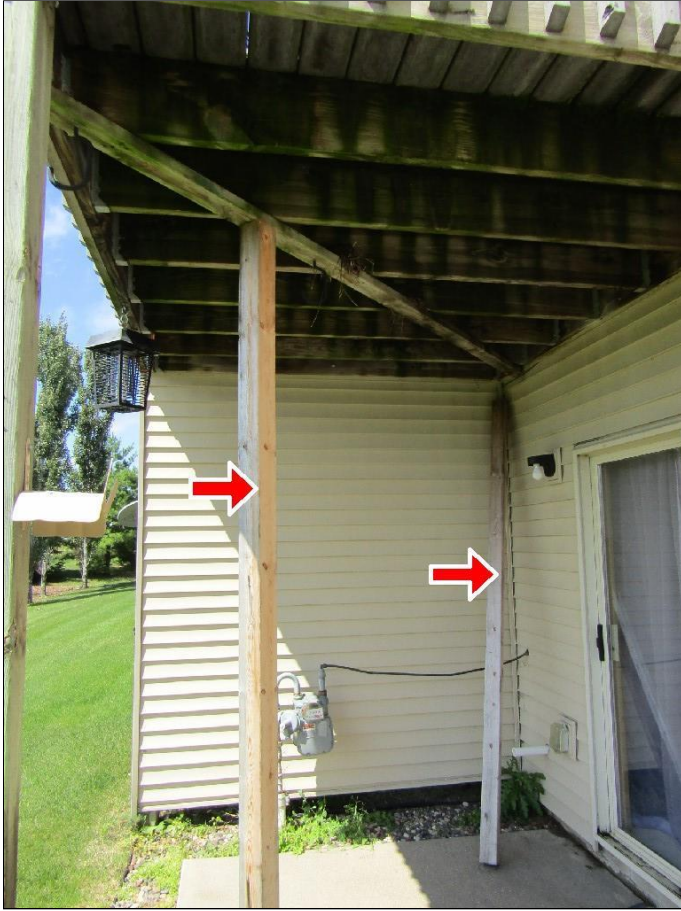
- (6) There was temporary bracing installed at unit 4330 beneath the diagonal bracing beneath the deck. This shouldn't be necessary after the defects noted at the joist hangers are corrected.

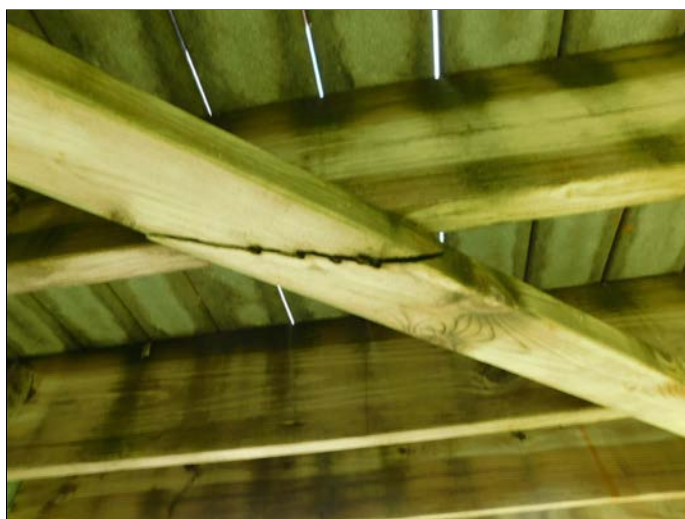
Example

(9) There was cracked diagonal bracing at multiple decks throughout the complex.

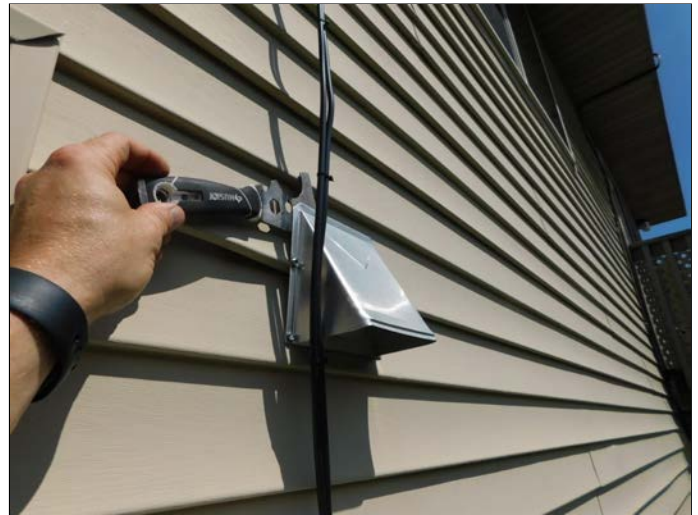
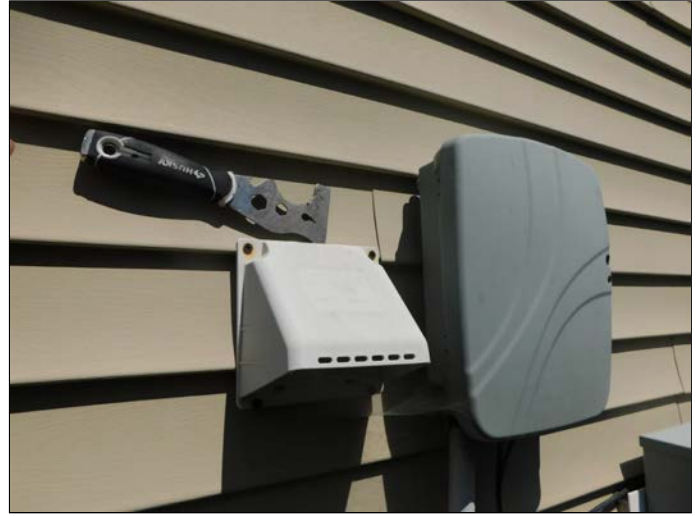
- (4) There was excessive lint accumulation around numerous dryer vent exhaust covers. This is a potential fire hazard and could allow air leakage and pest intrusion. Have the dryer ducts and terminals cleaned. For more information, click here: [Dryer Ducts](#)
- (5) Multiple vent covers throughout the community were not properly installed, were loose, and not caulked or flashed. Have this corrected to help prevent water intrusion.

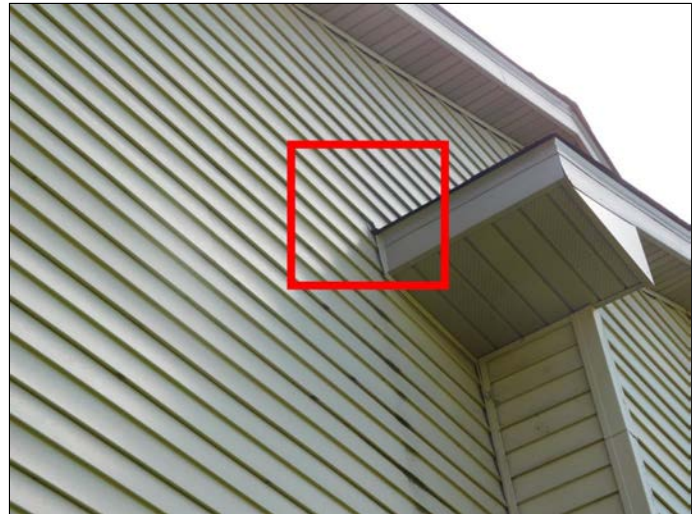
Example

Kickout flashing was not installed at most of the roof/wall intersections, which is recommended to help prevent moisture intrusion at roof/wall intersections. Consider having kickout flashing installed at these locations to help prevent water intrusion. For more information on this topic, click here: [Kickout Flashing](#)

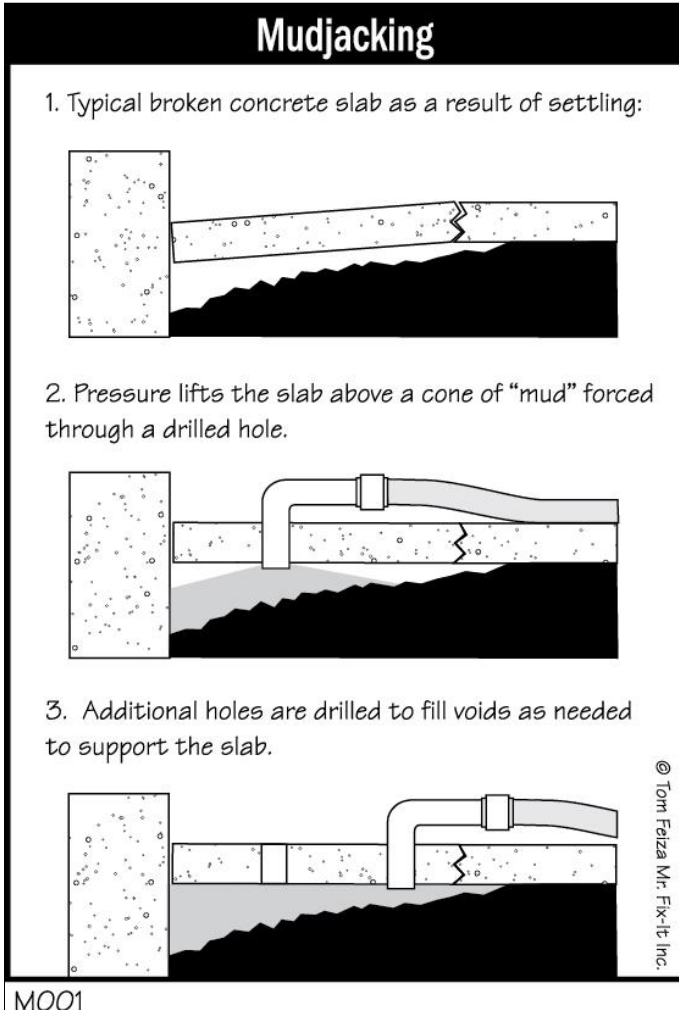
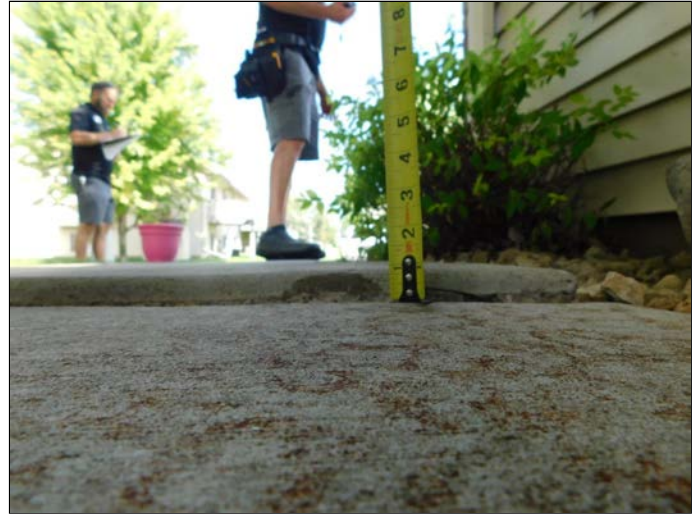
Unit 9167

👉 (1) Several walkways have settled, cracked and/or are uneven. This can be a trip hazard and prevent proper drainage of water away from the buildings. Have this corrected. Consider mudjacking or sandjacking for correction.

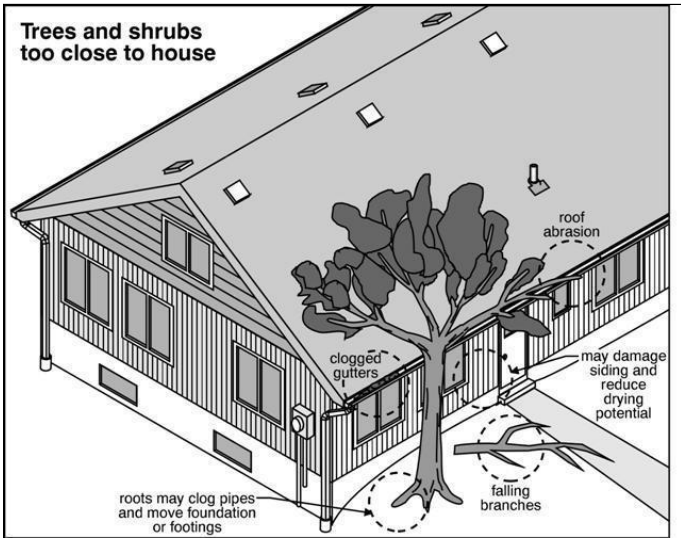
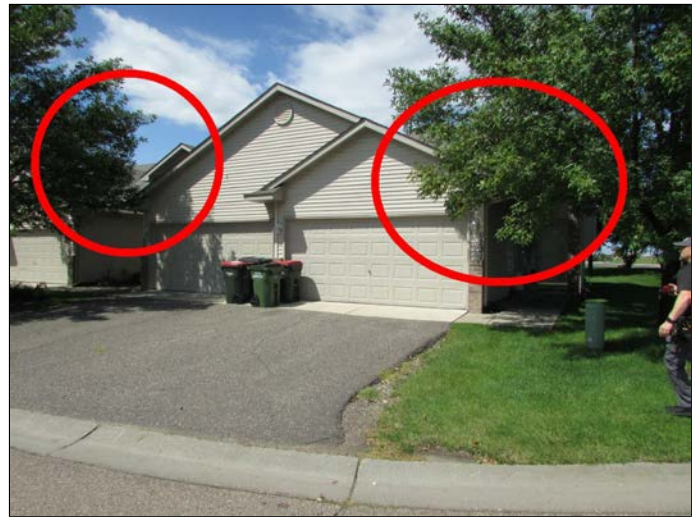
(1) There were tree branches in contact with the roof at building 1. Trees should be kept trimmed at least 6' away from the siding and roof to prevent damage to the building, and to help keep pests like squirrels and raccoons off the roof. Trim the tree branches back.

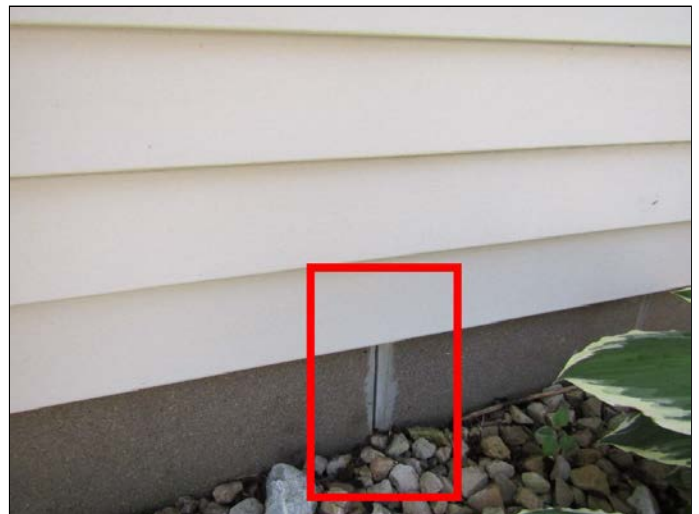
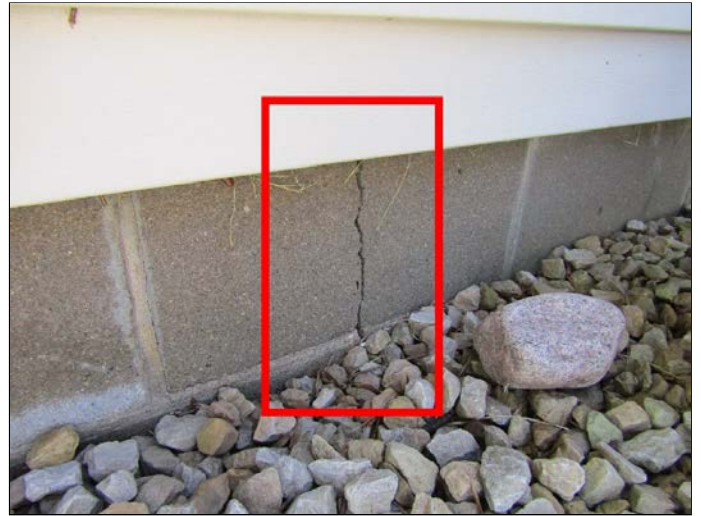
(4) There were some small cracks and gaps at a few foundation walls. Seal the cracks with mortar and monitor for any future movement.

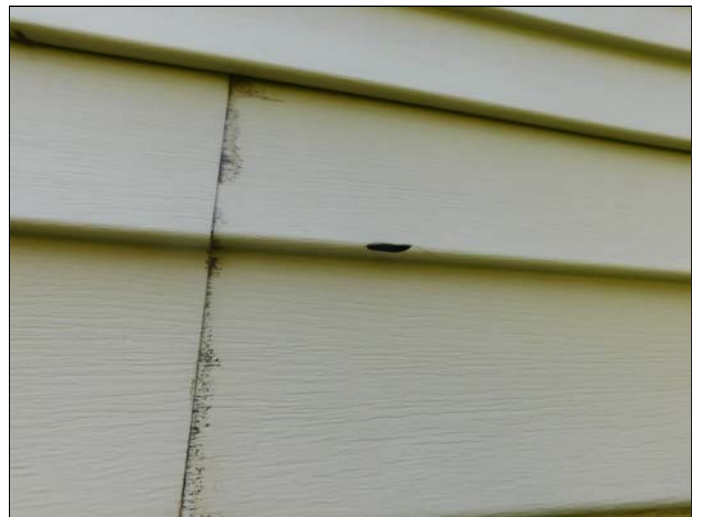
(5) There were loose, damaged or missing pieces of vinyl siding at the building. Have the loose pieces of siding secured to lower the potential for water intrusion or wind damage.

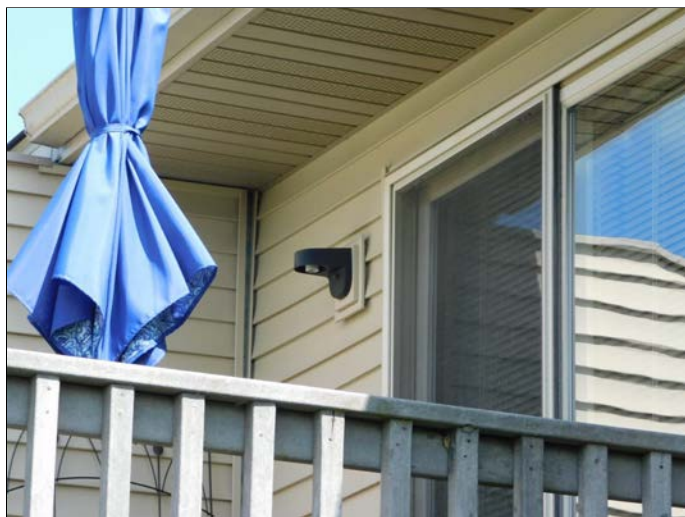
(2) There were missing globes at the back of the units at building 2. Have the globes replaced.

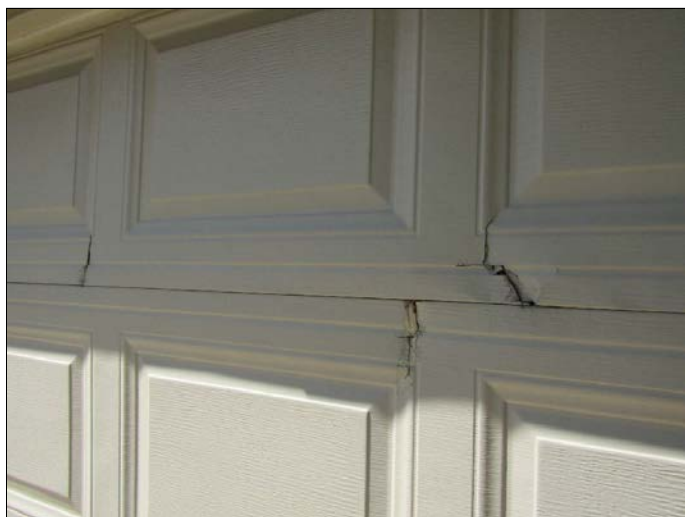
(2) There was a severely damaged garage door at 9201 Orchard Lane. Have the door repaired or replaced.

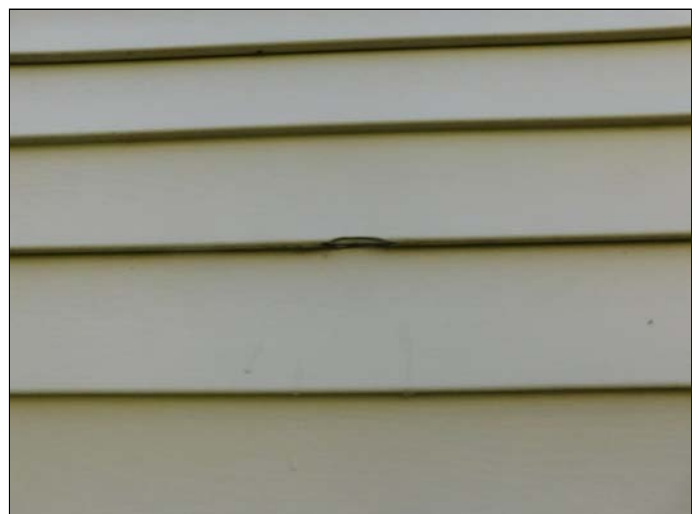
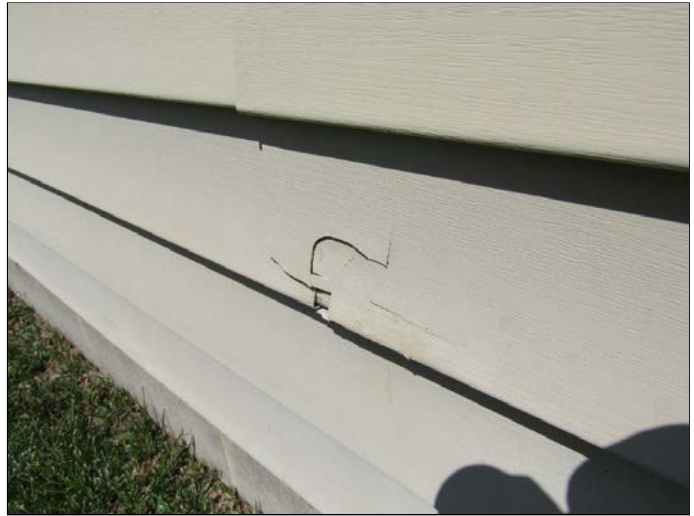
- (6) There were loose, damaged or missing pieces of vinyl siding at the building. Have the loose pieces of siding secured to lower the potential for water intrusion or wind damage.

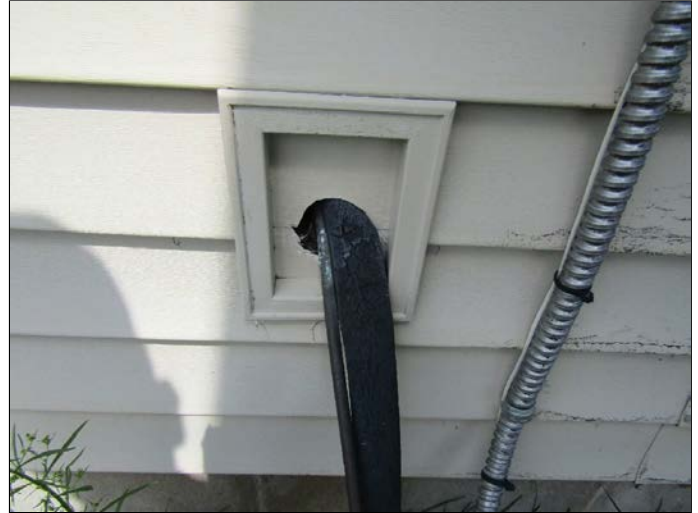
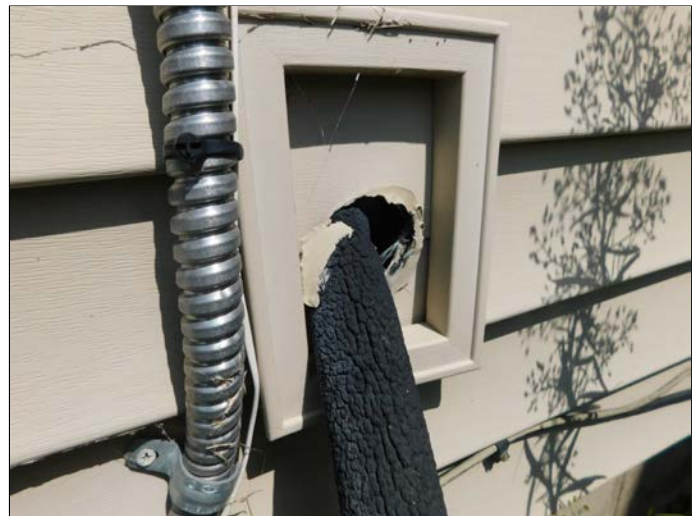
- (1) Caulk around the AC refrigerant lines where they enter the building. This will help prevent water intrusion, pest intrusion, and air leakage.

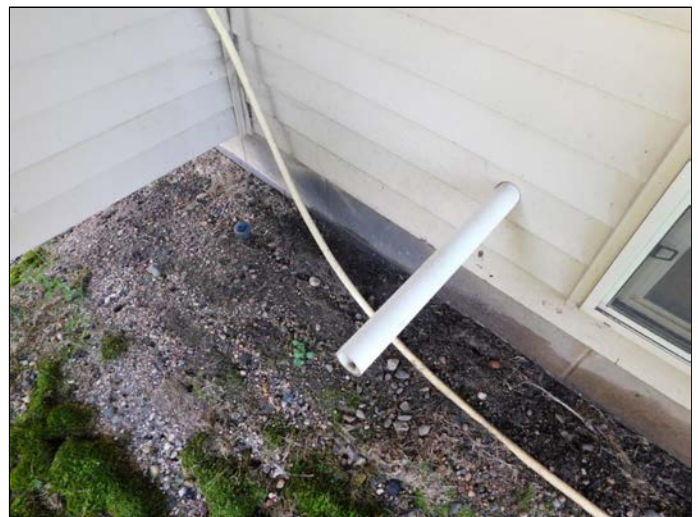
- (2) Caulk around the sump pump pipes where they enter the building. This will help prevent water intrusion, pest intrusion, and air leakage.

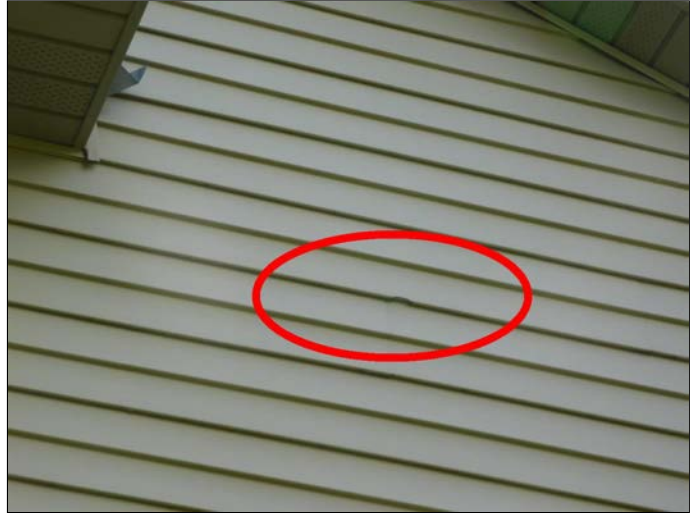
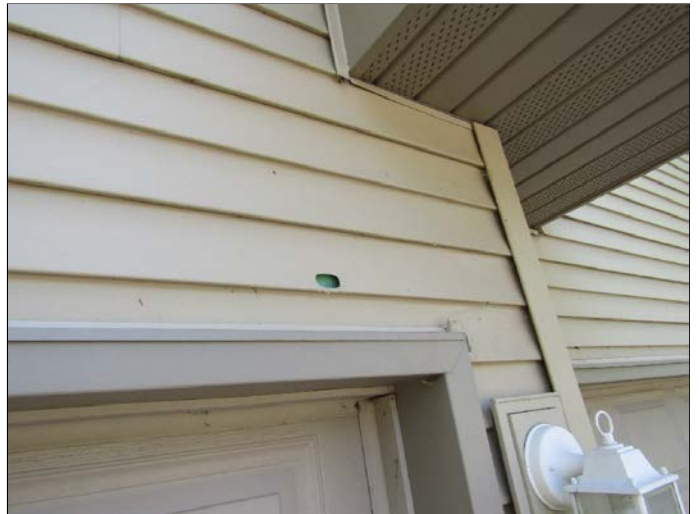
📍 (2) There were loose, damaged or missing pieces of vinyl siding at the building. Have the loose pieces of siding secured to lower the potential for water intrusion or wind damage.

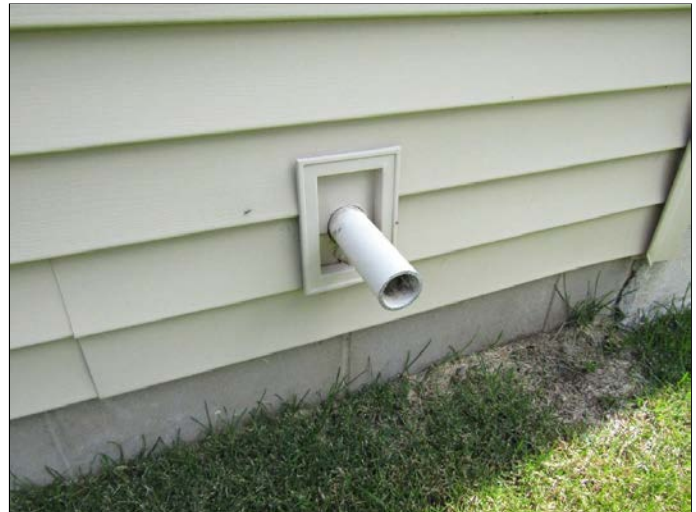
- (2) Caulk around the sump pump pipes where they enter the building. This will help prevent water intrusion, pest intrusion, and air leakage.

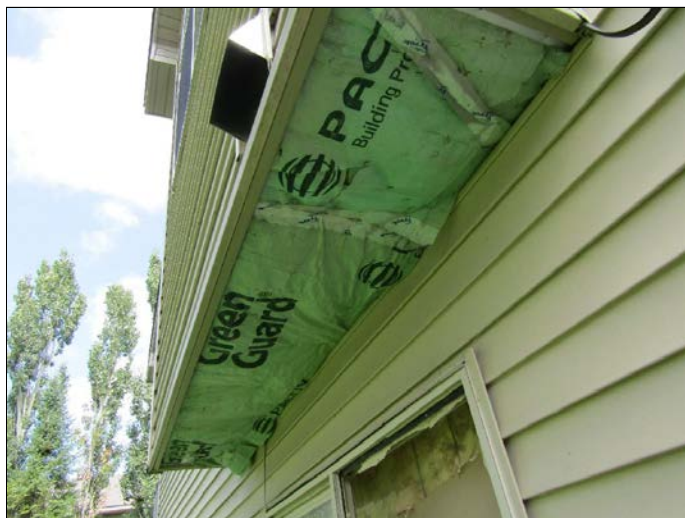
Soffit material was missing at unit 4341. Have this corrected to prevent water, pest, and rodent intrusion.

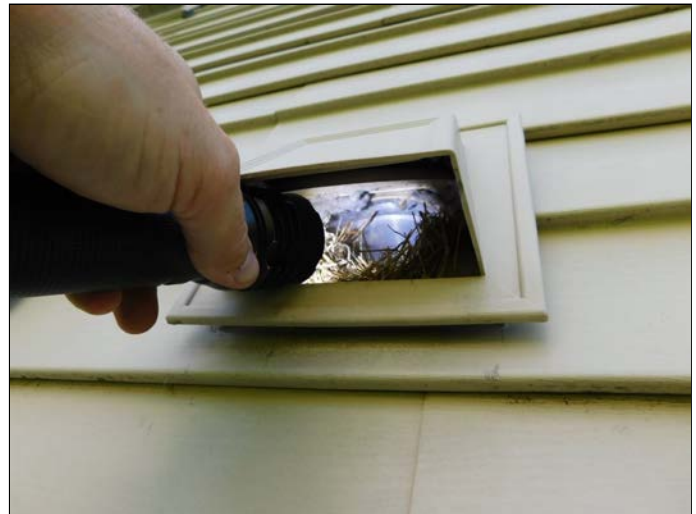
(4) There was bird nesting materials in multiple dryer vents at building 7. Have the materials cleared out for proper operation of the dryer, to reduce the potential for fire, and reduce the potential for carbon monoxide buildup in the homes.

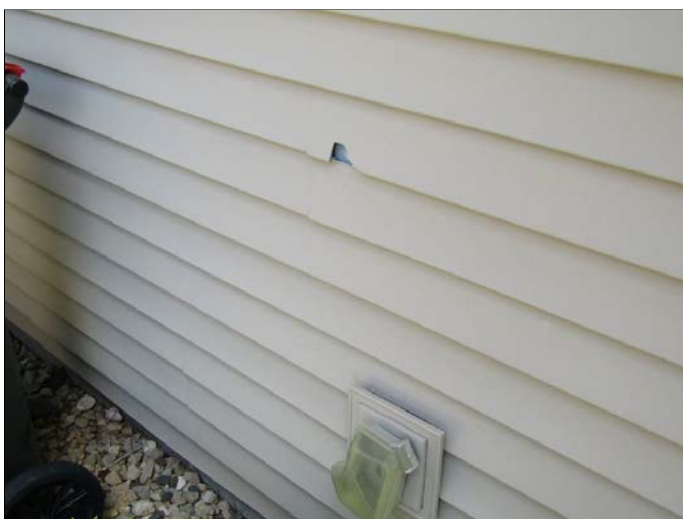
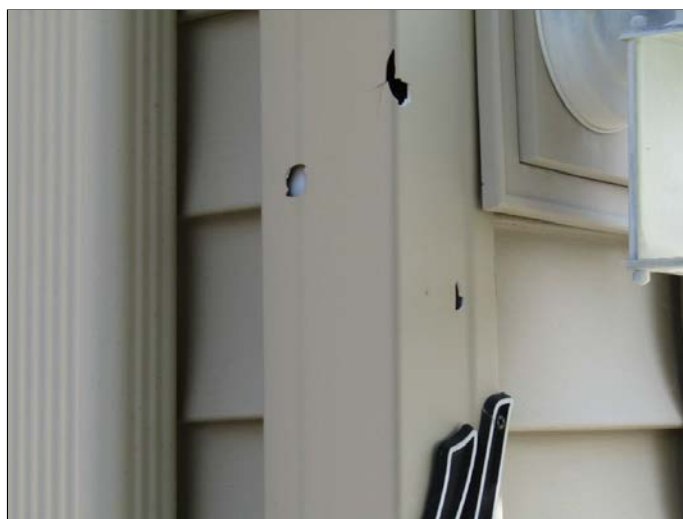
- (6) There were loose, damaged or missing pieces of vinyl siding at the building. Have the loose pieces of siding secured to lower the potential for water intrusion or wind damage.

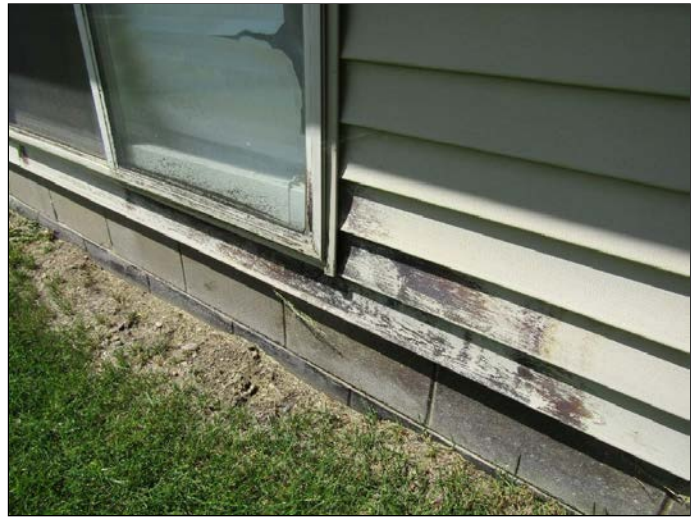
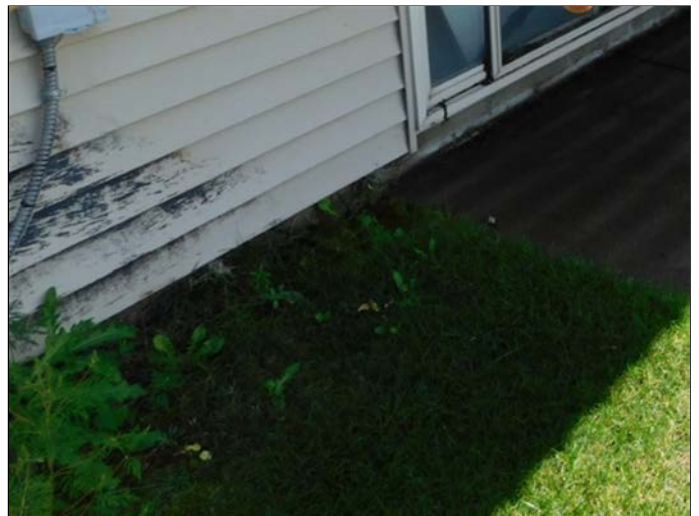
(2) Staining was noted at several walls. This is a cosmetic concern.

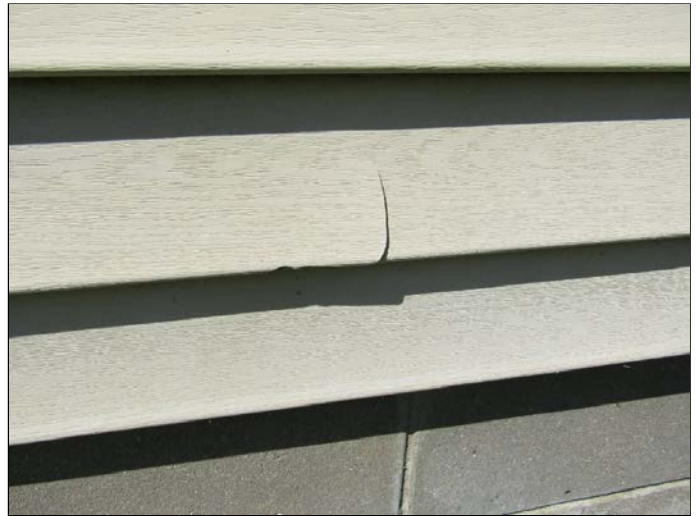
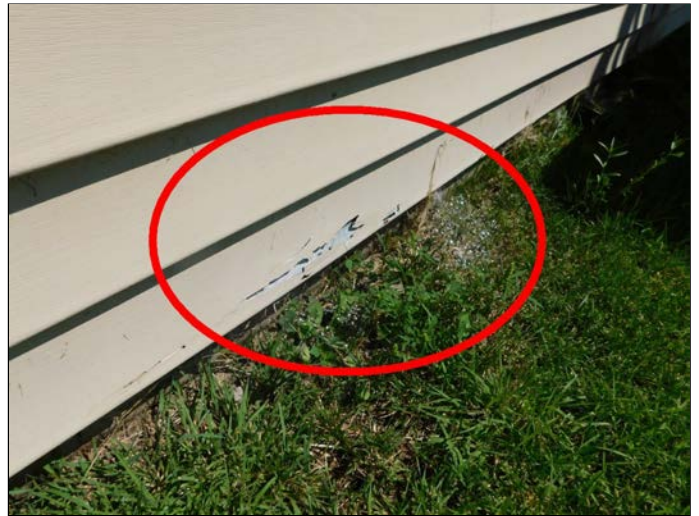
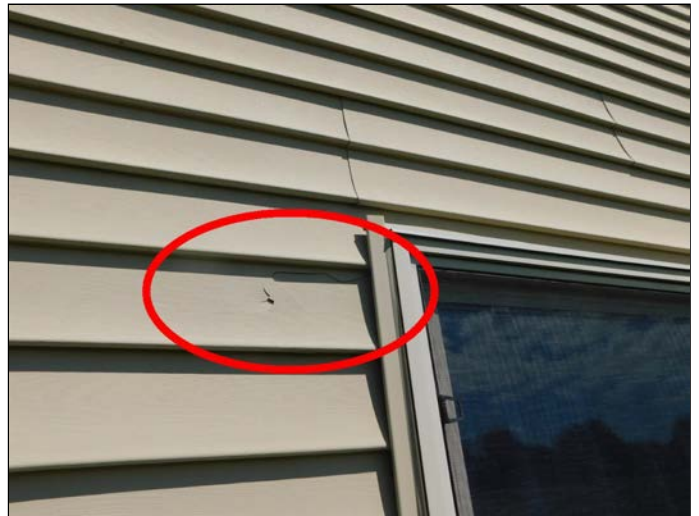
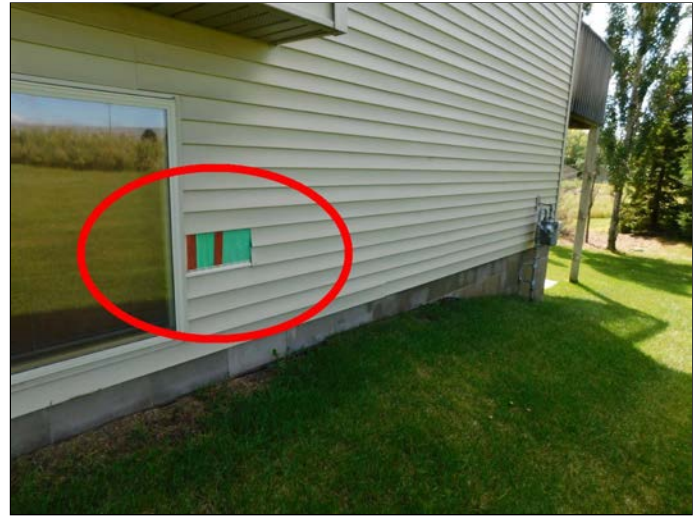
- (4) There were loose, damaged or missing pieces of vinyl siding at the building. Have the loose pieces of siding secured to lower the potential for water intrusion or wind damage.

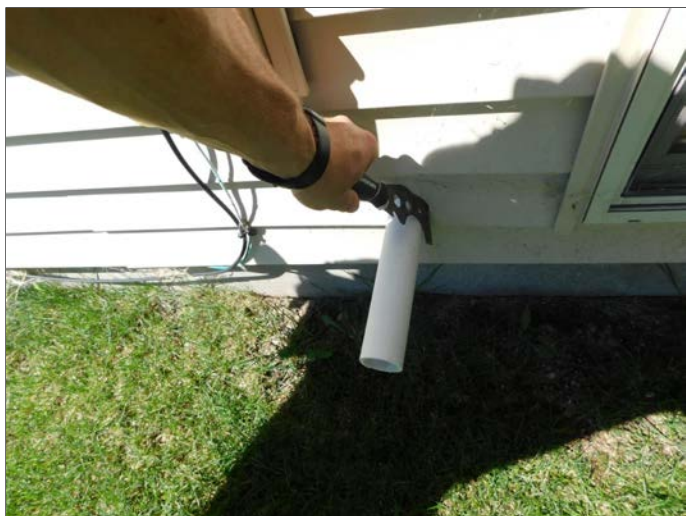
(2) Caulk around the sump pump pipes where they enter the building. This will help prevent water intrusion, pest intrusion, and air leakage.

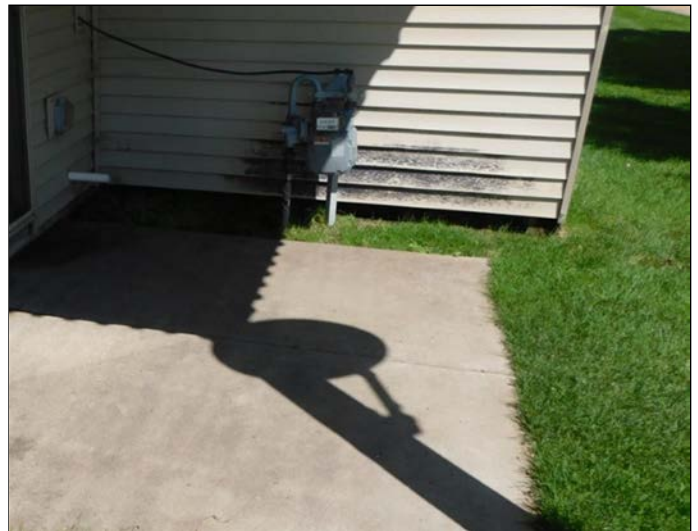
- (3) Staining was noted at a couple walls. This is a cosmetic concern.

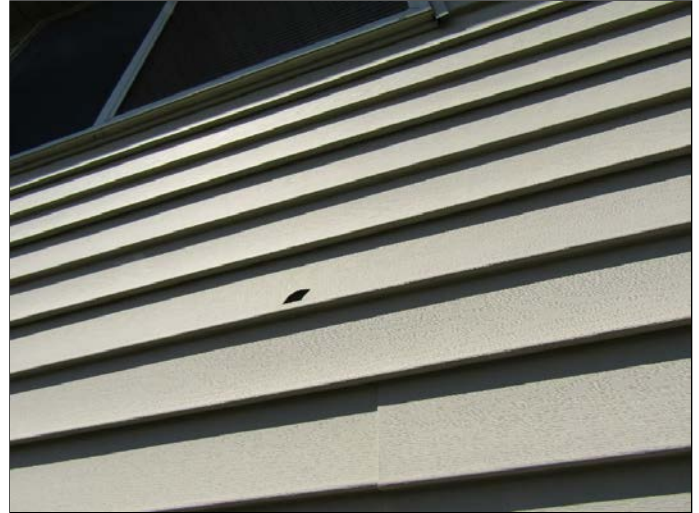
- (4) There were loose, damaged or missing pieces of vinyl siding at the building. Have the loose pieces of siding secured to lower the potential for water intrusion or wind damage.

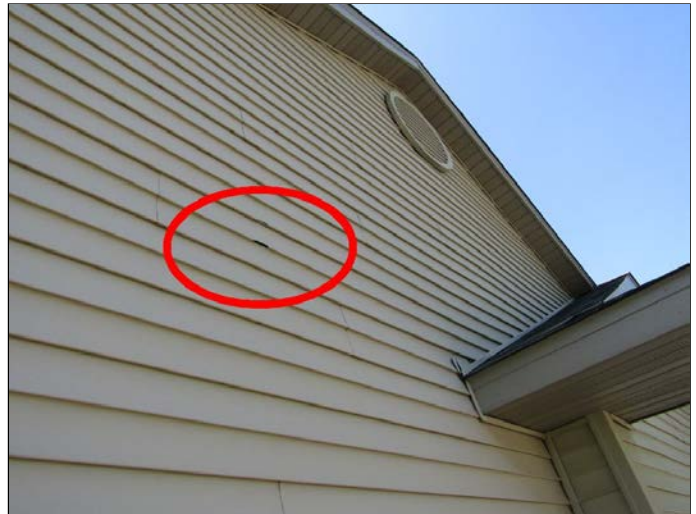
- (7) There were loose, damaged or missing pieces of vinyl siding at the building. Have the loose pieces of siding secured to lower the potential for water intrusion or wind damage.

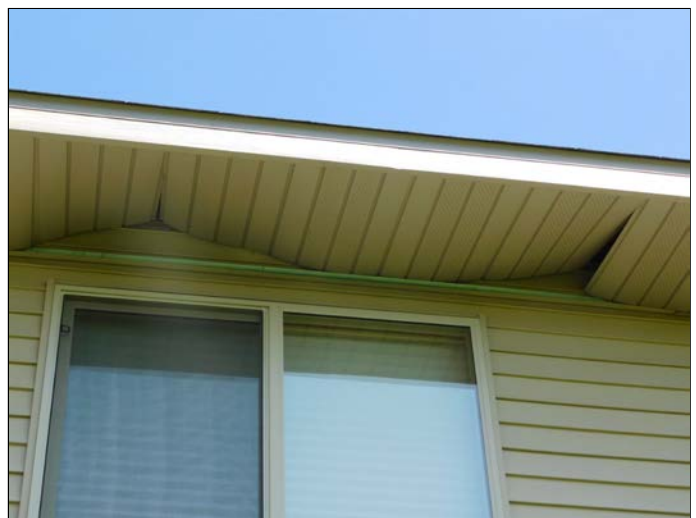
Near 9083

- There was some loose and damaged sections of soffit at building 10. This could allow for pest intrusion and should be serviced.

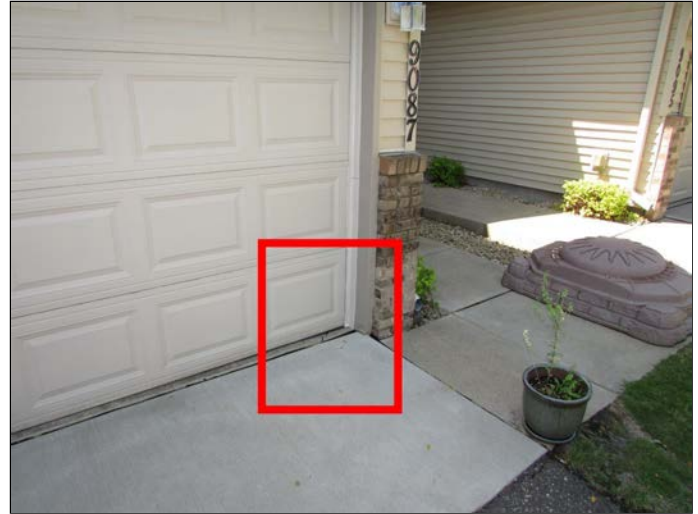
🔍 There was a crack noted at the garage floor or unit 9087. Repair the damage.

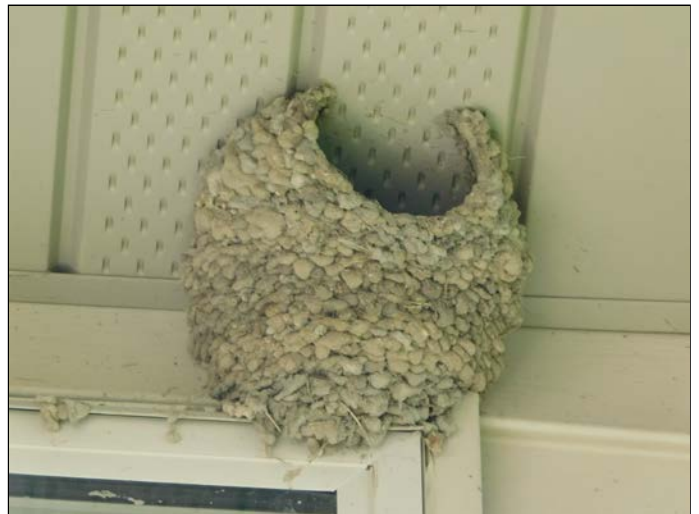
- (3) There was bird nesting material located at unit 9114. Have the nests removed to help eliminate bird activity.

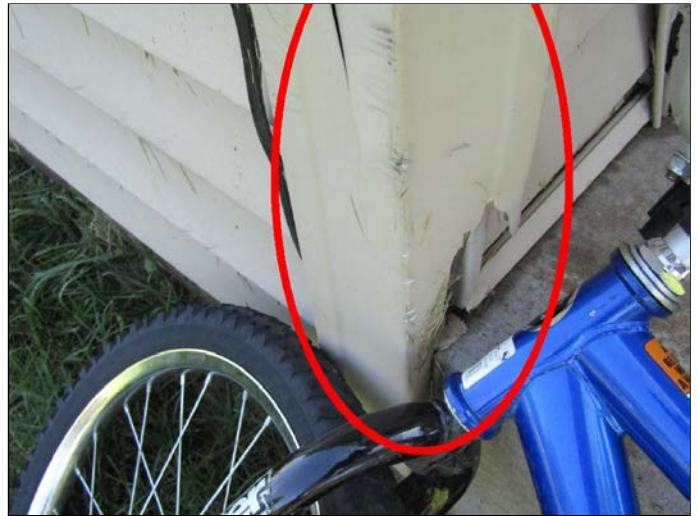
- (4) There were loose, damaged or missing pieces of vinyl siding at the building. Have the loose pieces of siding secured to lower the potential for water intrusion or wind damage.

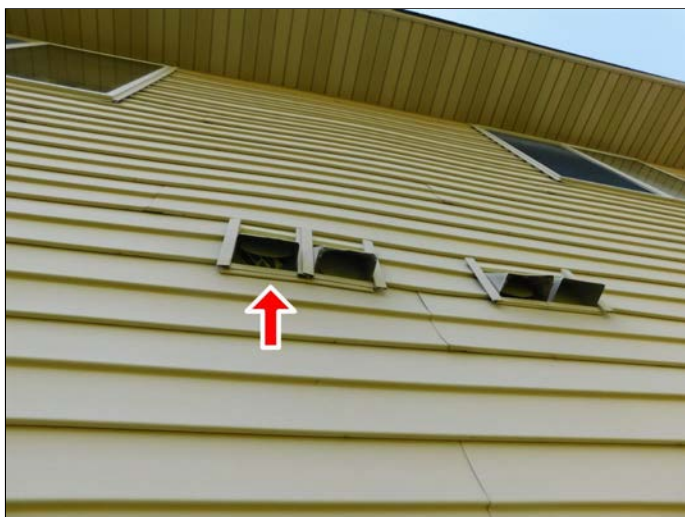
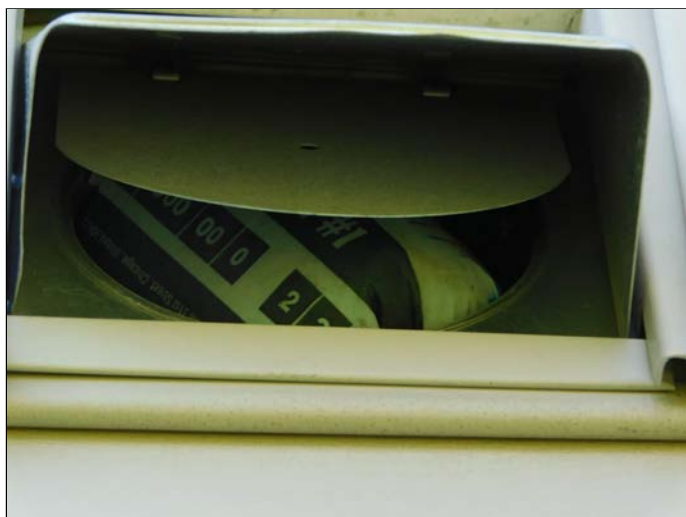
- 🔍 (1) There was a blocked vent at building 12. Have this corrected for proper ventilation.

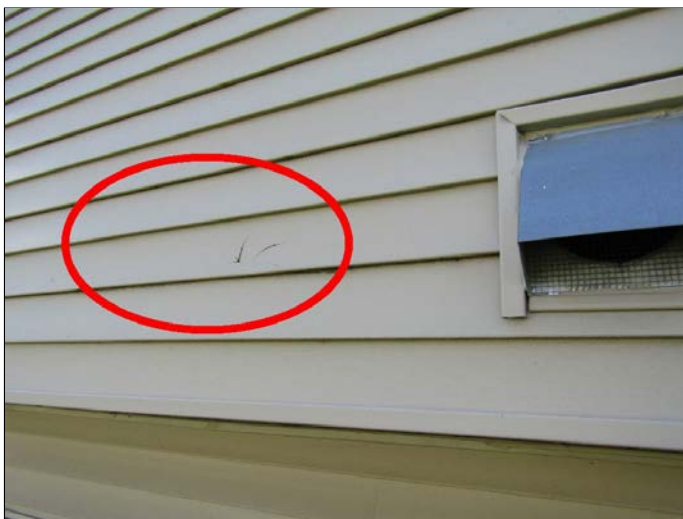
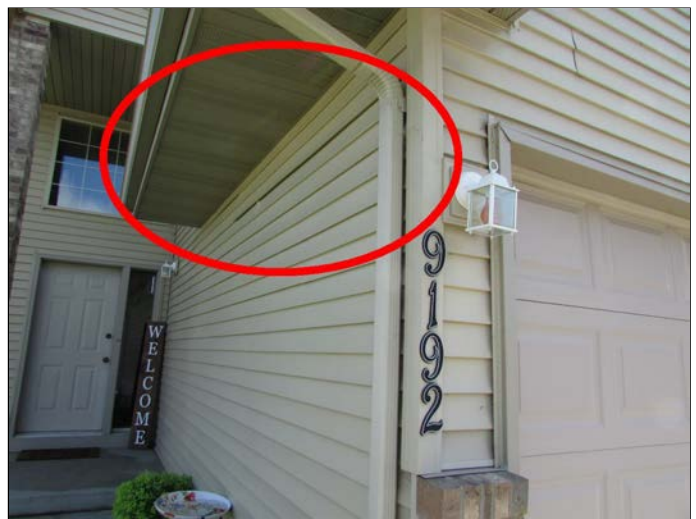
- (2) There were loose, damaged or missing pieces of vinyl siding at the building. Have the loose pieces of siding secured to lower the potential for water intrusion or wind damage.

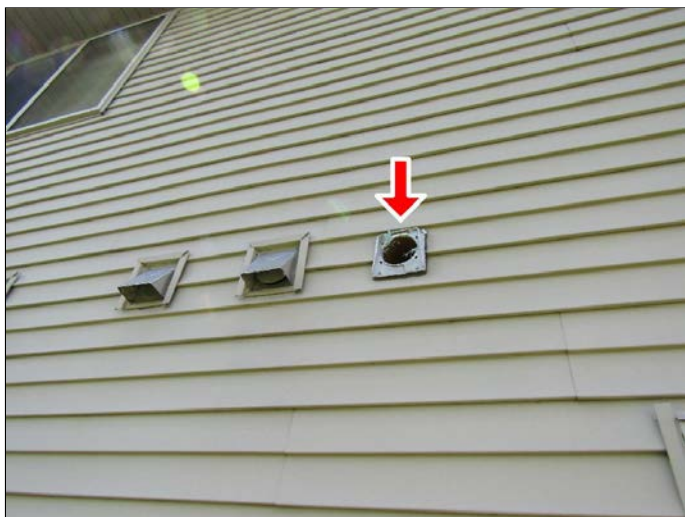
Unit 9192

- (3) There was a missing vent terminal at the back of building 13.
