Inspection Report

Sample Report

Property Address:
1234 Anyplace Terrace
Yourtown MN

Structure Tech Home Inspections

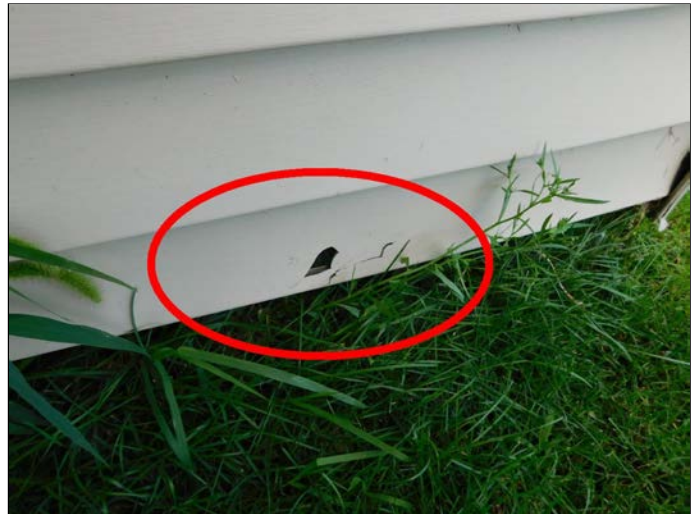
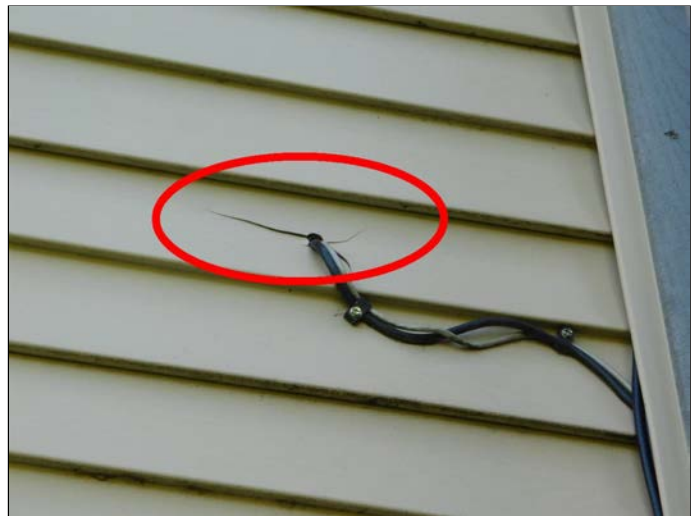
(3) There were loose, damaged or missing pieces of vinyl siding at the building. Have the loose pieces of siding secured to lower the potential for water intrusion or wind damage.

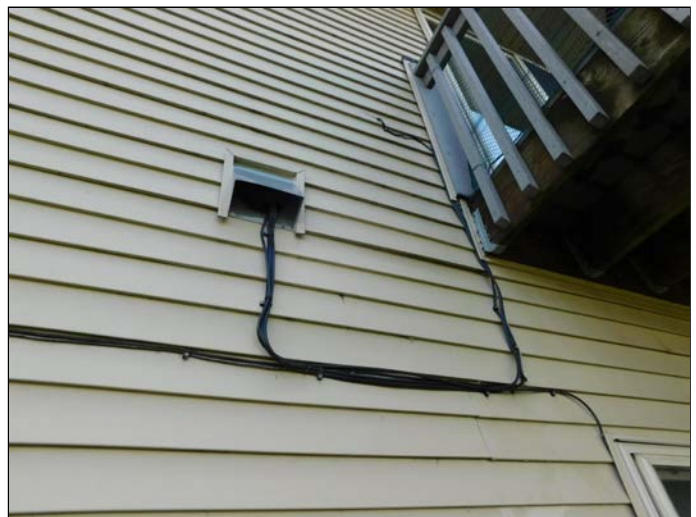
(4) There was a damaged combustion air intake from the communication wire installation. Have this corrected to help prevent pest intrusion.

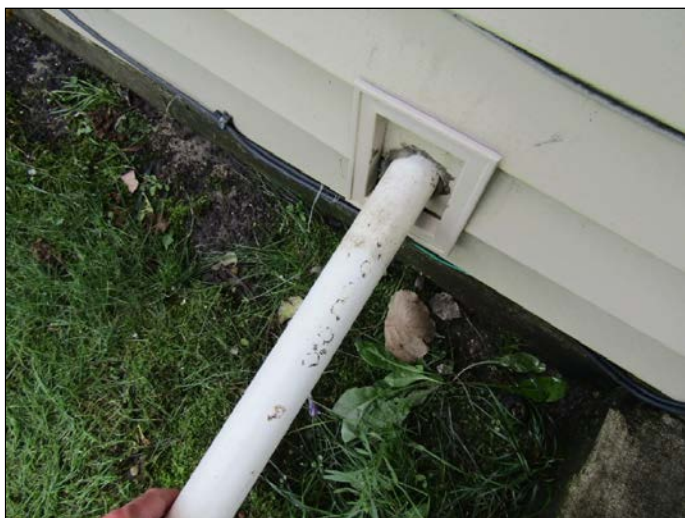
Caulk around the sump pump pipes where they enter the building. This will help prevent water intrusion, pest intrusion, and air leakage.

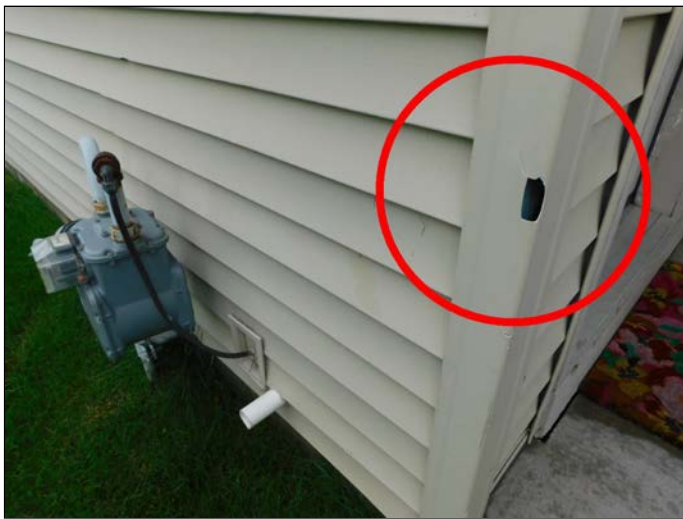
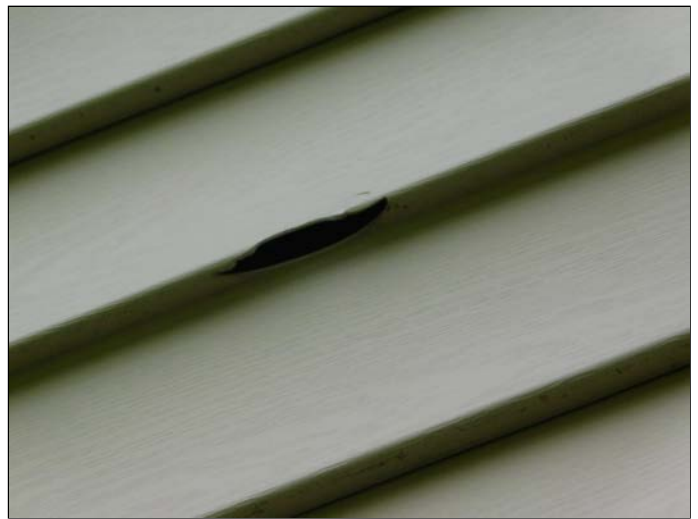
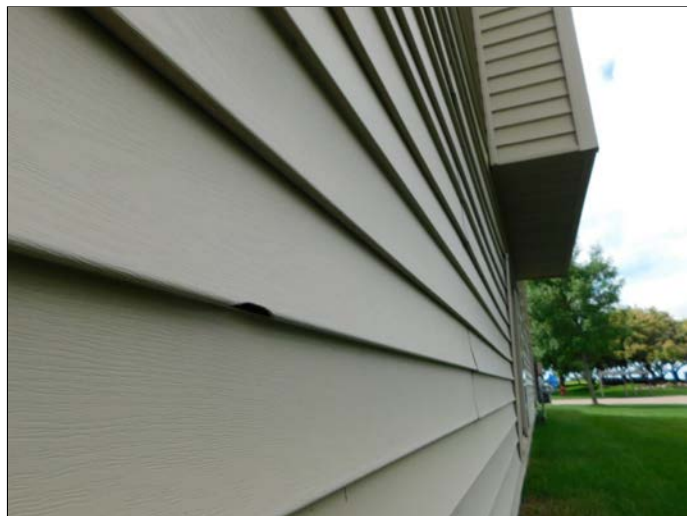
(1) There were loose, damaged or missing pieces of vinyl siding at the building. Have the loose pieces of siding secured to lower the potential for water intrusion or wind damage.

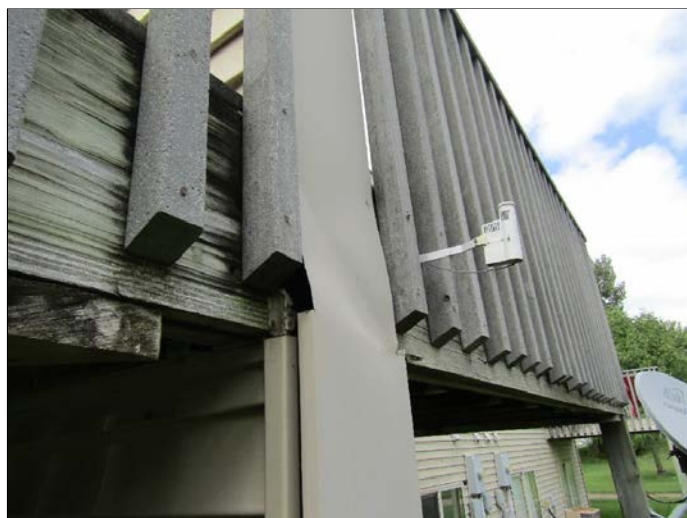
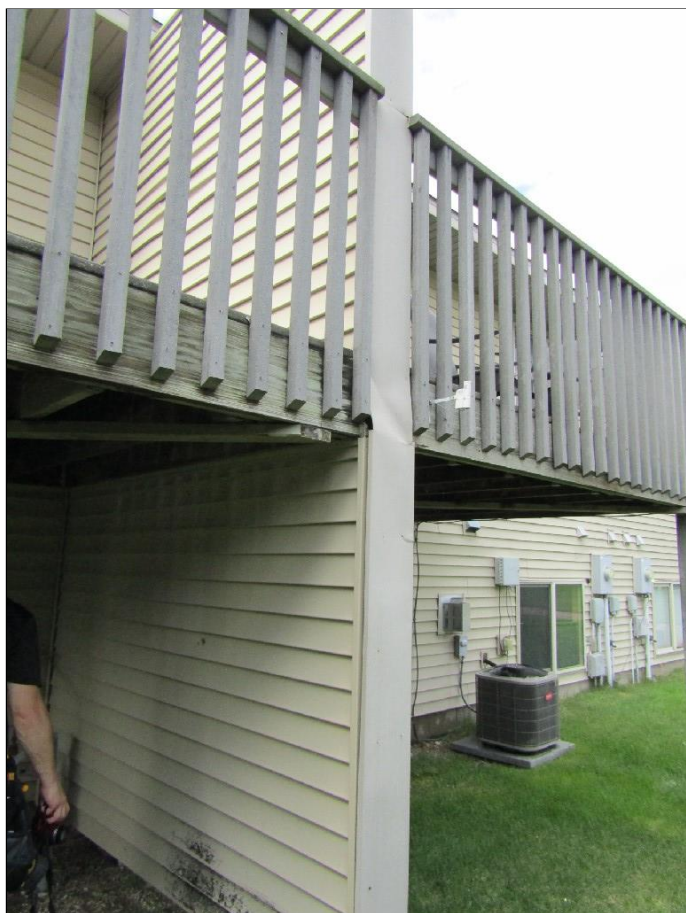
(2) There was a loose piece of metal wrap at the privacy wall at building 17. Have the covering secured to help prevent damage to the material or passerby.

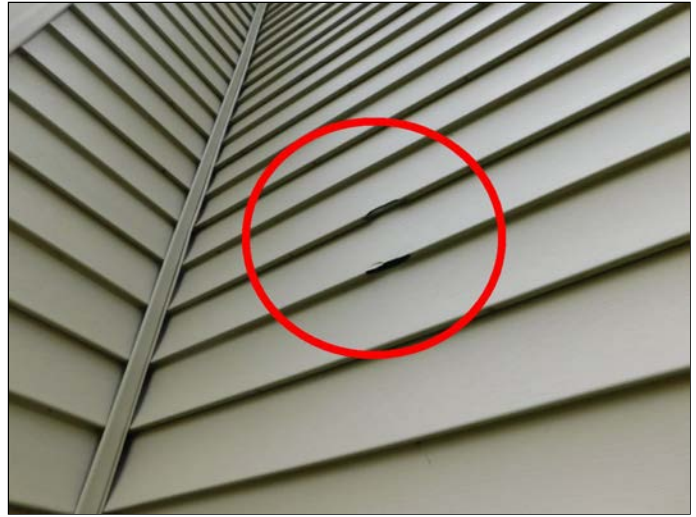
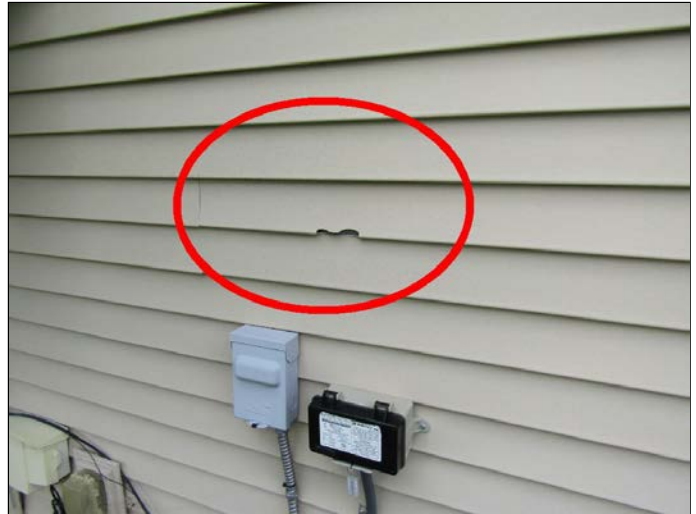
(2) There were loose, damaged or missing pieces of vinyl siding at the building. Have the loose pieces of siding secured to lower the potential for water intrusion or wind damage.
