## HAIL DAMAGE TO ASPHALT ROOF SHINGLES

Timothy P. Marshall\*, Richard F. Herzog, and Scott J. Morrison  
Haag Engineering Co.  
Dallas, Texas

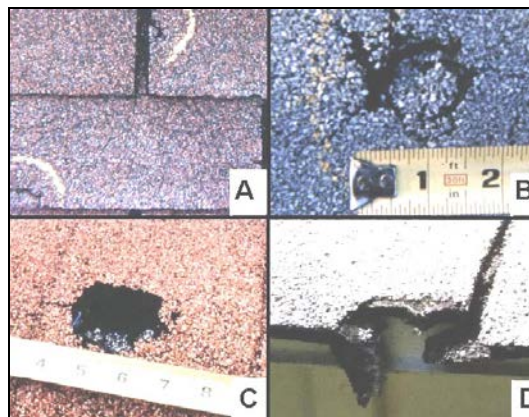
Figure 1: Hail damage to asphalt shingles: a) broken edges, b) bruise, c) puncture, d) torn edge.

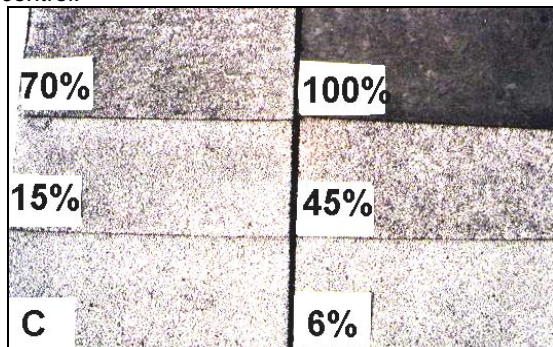
**Figure 3.** Same view as Figure 2 only at the conclusion of the ten-year study.

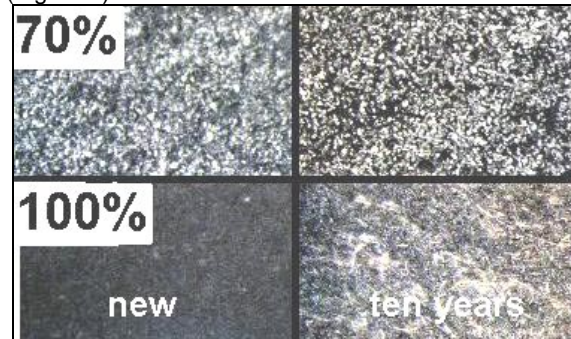
**Figure 4.** Close up views of new shingle and ten-year weathering with both 70 percent of the granules removed and no granules, respectively.

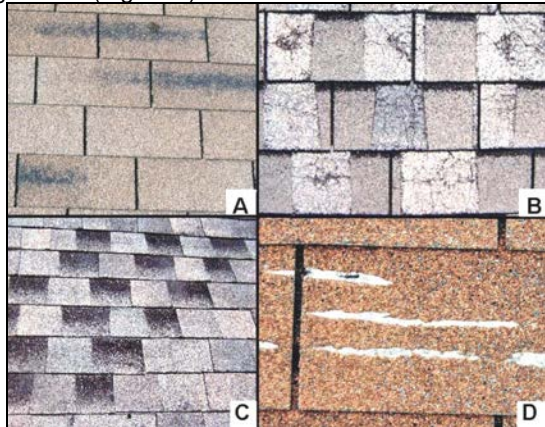
**Figure 5.** Various shingle manufacturing defects: a) lack of granule adhesion on a three-tab, b) blotchy appliques, c) asphalt exposed in lower laminate, and d) lines of missing asphalt and granules.

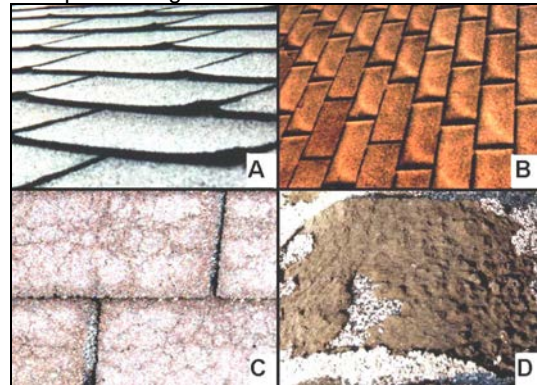
**Figure 7.** Various shingle anomalies not caused by hail: a) cupping, b) clawing, c) crazing, and d) flaking.

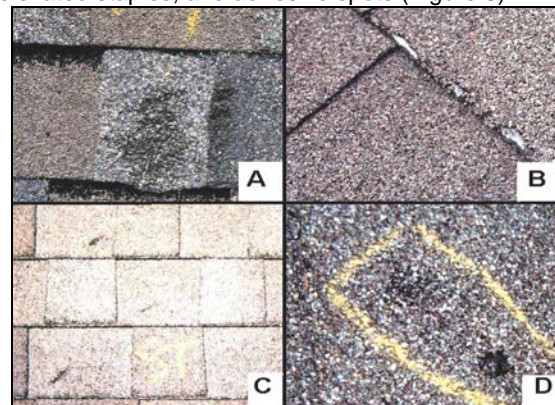
**Figure 8.** Shingle installation deficiencies: a) marring, b) edge scuffing, c) elevated fasteners, and d) adhesive spots.

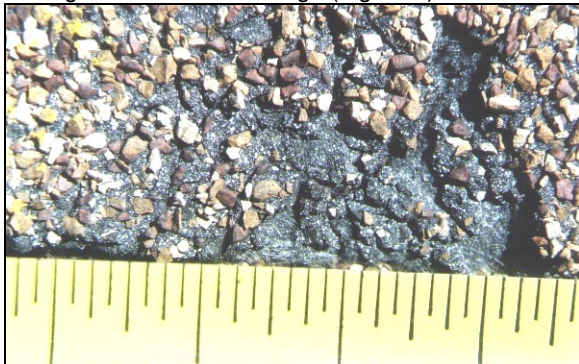
**Figure 9.** An example of 9-year-old hail damage to a glass-fiber mat asphalt shingle.

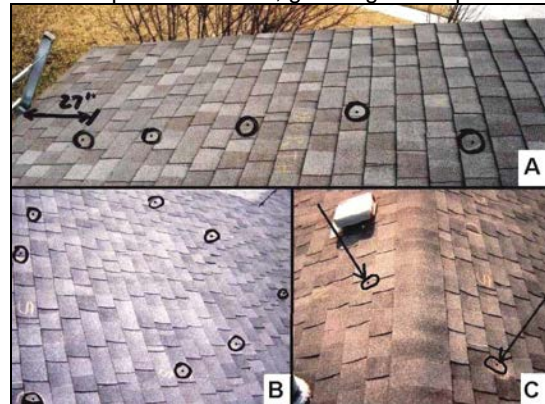
**Figure 10.** Intentional roof damage examples: a) line of impact marks, b) circular arrangement of impact marks, and c) impact marks perpendicular to each affected slope with no marks on the ridge.

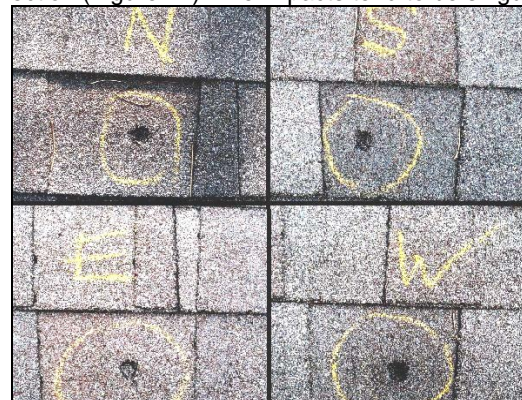
**Figure 11.** Attempts to simulate hail damage with a ball peen hammer.

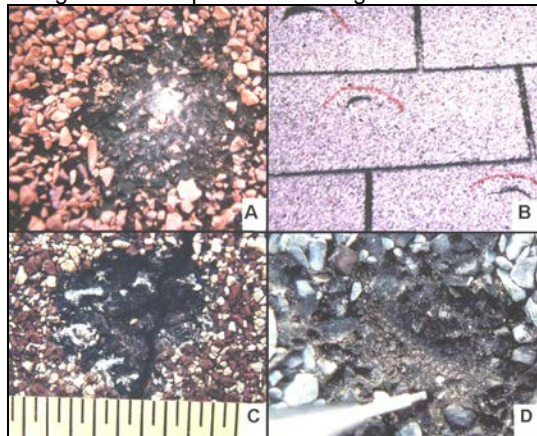
**Figure 12.** Close-up views of mechanically caused impacts to shingles using: a) a ball-peen hammer, b) claw hammer, c) screwdriver, and d) quarter coin.
