STRUCTURE TECH HOME INSPECTIONS

HOME INSPECTION REPORT

1234 Main st.
undefined, undefined undefined

07/07/2022 9:00AM

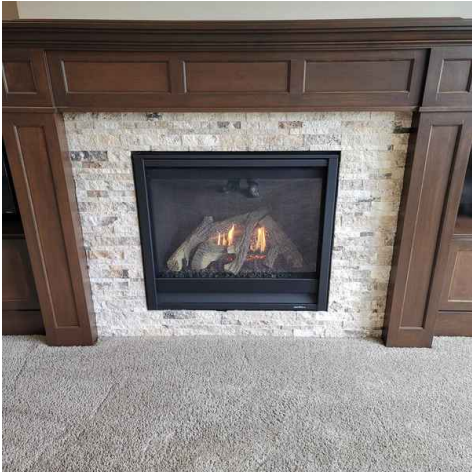
1st floor

The gas fireplace/fireplaces were in acceptable condition.

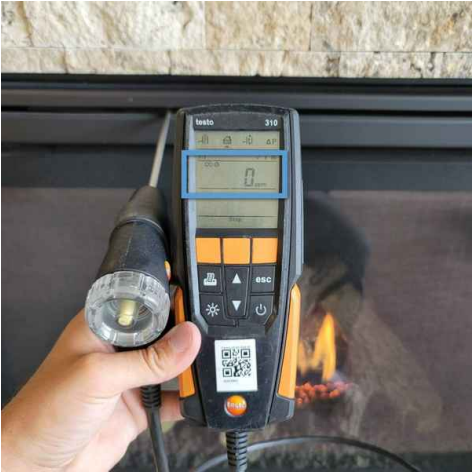
no signs of CO backdrafting into the home

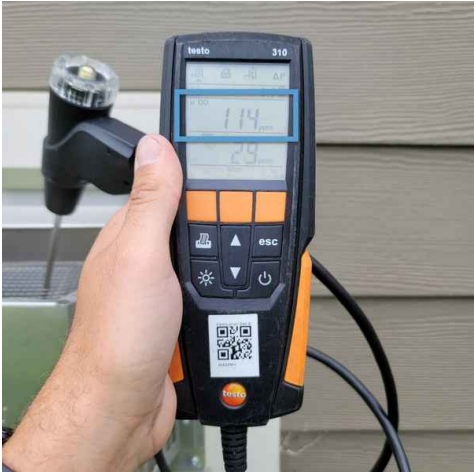
acceptable flue gas CO level

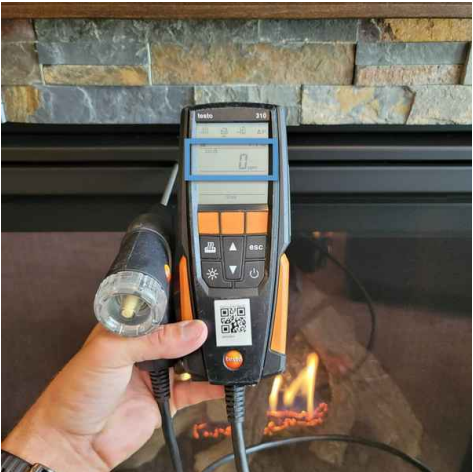
no signs of CO backdrafting into the home

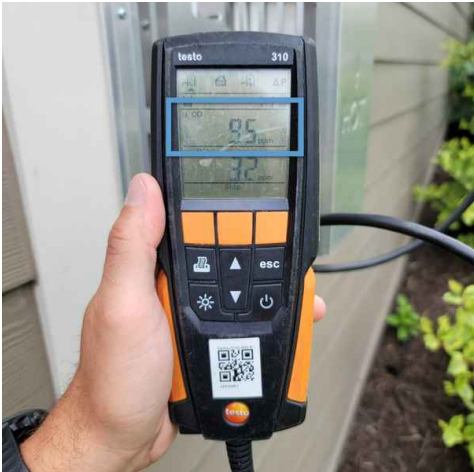
acceptable flue gas CO level

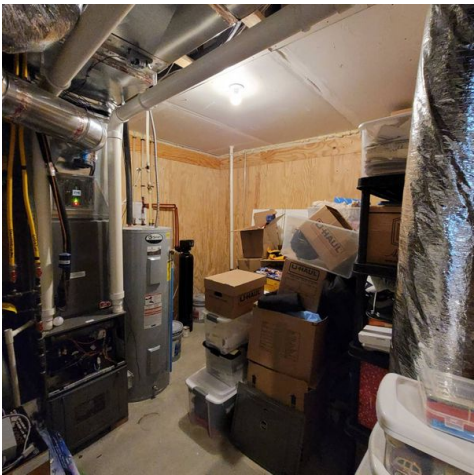
STORED ITEMS

Stored items prevented a complete inspection of the basement.

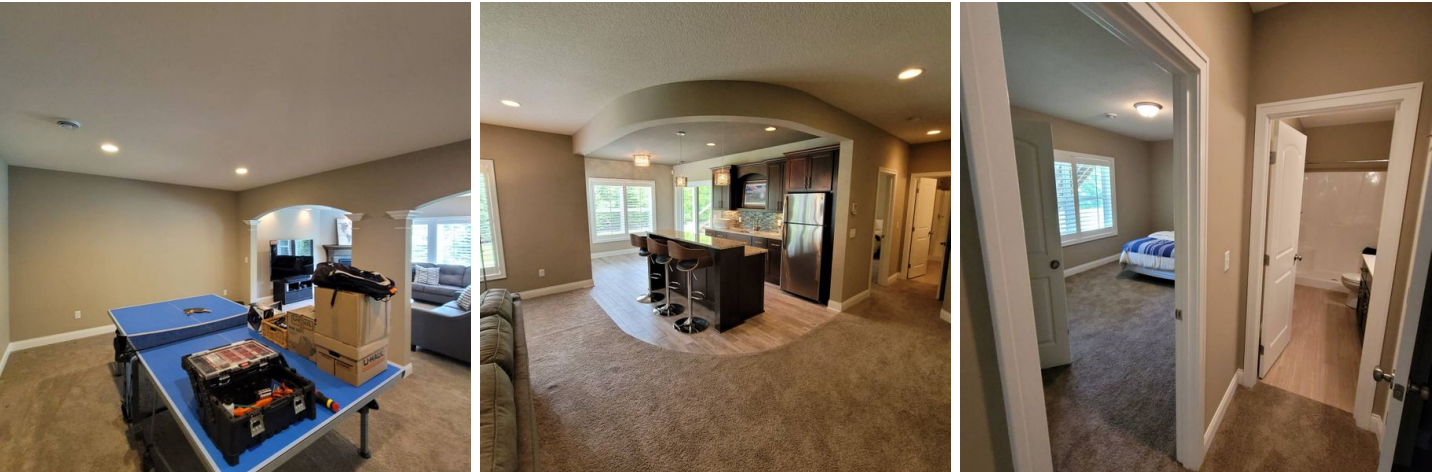
FINISHED AREAS

There were finished areas and/or insulated areas that could not be inspected (e.g. basement floor, foundation walls, insulation, wall structure, and/or floor structure).

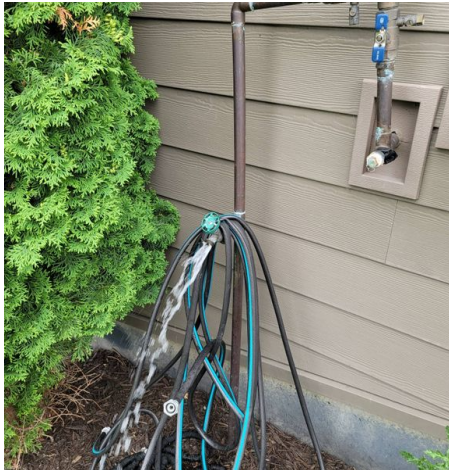
side of house

Exterior Faucets: Winterization reminder

Winterize all exterior faucets every fall to help prevent freeze damage. For instructions, click here: [How to prevent your outside faucets from freezing](#)

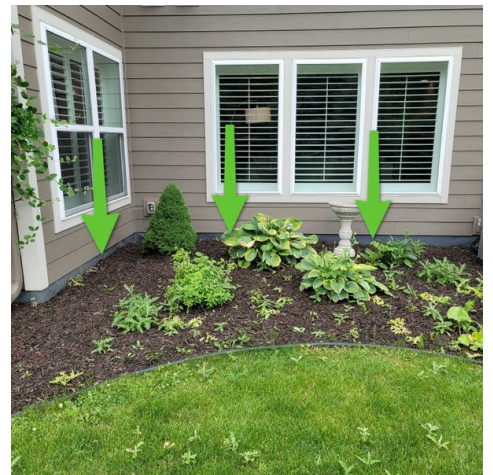
COVERED

The exterior of the foundation walls were covered by insulation, vegetation, grading, and/or other components. The concealed portions of the foundation were not inspected.

covered by protective membrane

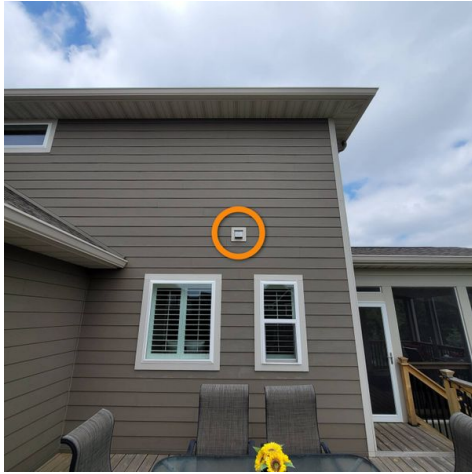
1st floor bathroom

There were nests at one or more bath fan exhausts, blocking the dampers. Remove the nests.

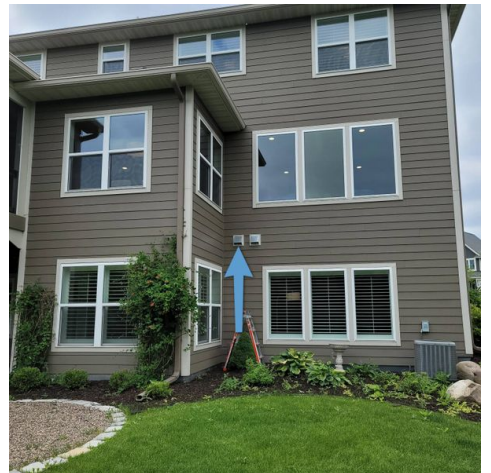
The combustion air intake should be checked regularly and cleared if necessary to ensure sufficient combustion air is brought into the house for fuel-burning appliances. The intake was clean at the time of inspection. For more information on this topic, click here:

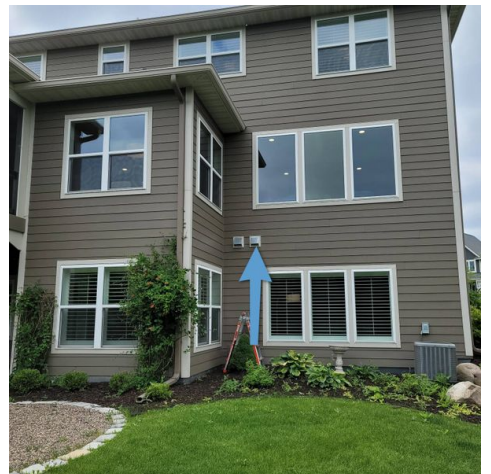
**AIR EXCHANGER INTAKE -
REMEMBER TO CLEAN**

Remember to clean the intake vent for the air exchanger. This will ensure proper airflow and operation of the air exchanger.

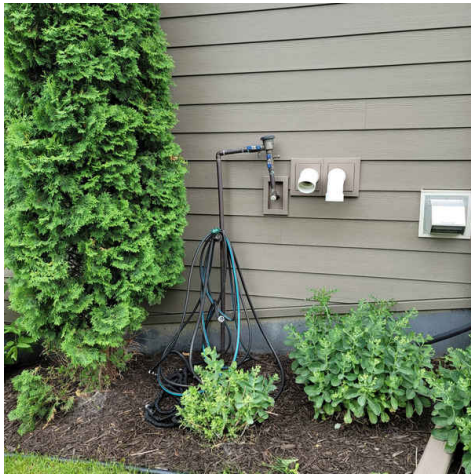
plumbing at exterior

The irrigation system must be winterized every fall to help prevent underground pipes from freezing. Ask the seller for information regarding the current service provider.

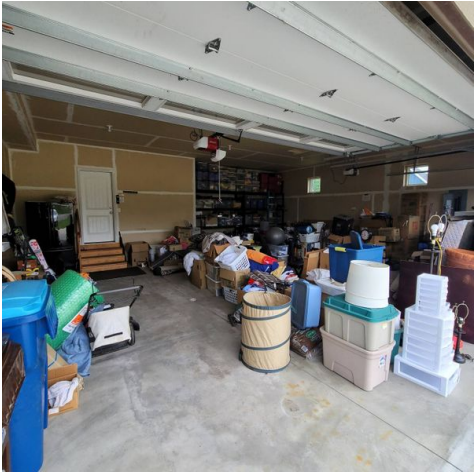
STORED ITEMS BLOCK OUTLETS

Stored items may have prevented viewing/testing one or more outlets in the garage.

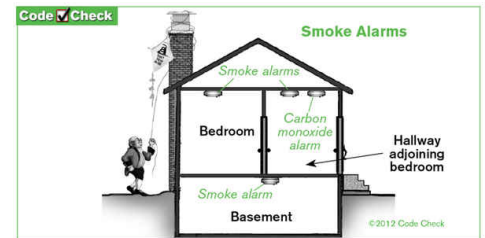
CO ALARMS - PRESENT

Carbon monoxide alarms were properly located and installed. CO alarms are required outside and within 10' of every sleeping room. Depending on the manufacturer/model specifications, carbon monoxide alarms have a lifespan of 5 to 10 years and should be replaced at that time.

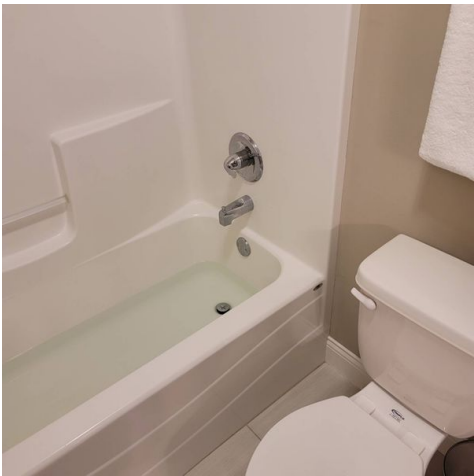
BATHTUB ACCESS

The bathtub access panels were blocked, nailed shut, painted shut, or no access was created. The concealed components were not inspected. Additionally, if the drains need to be accessed, openings will need to be created in walls or ceilings.

2nd floor bathroom - blocked by stored items in adjacent closet

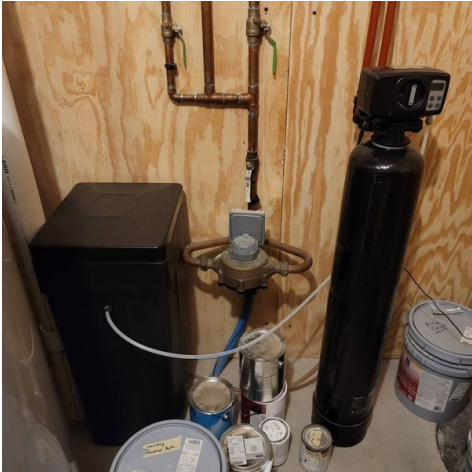
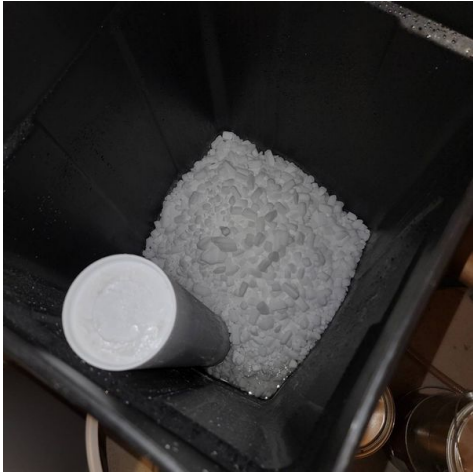
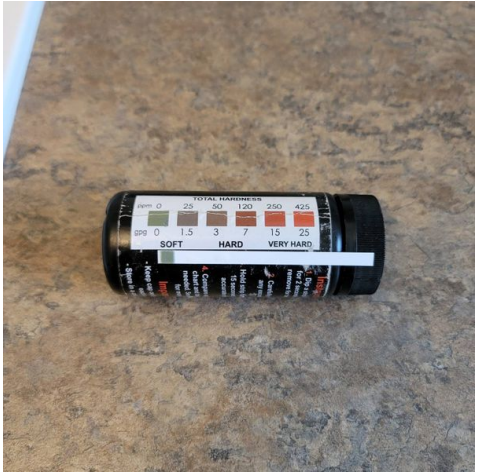
The photo below shows a hardness test strip, taken from a water supply with softened water. Consult with a water treatment specialist if the test strip results differ from your preference.

salt in storage tank

water tested soft

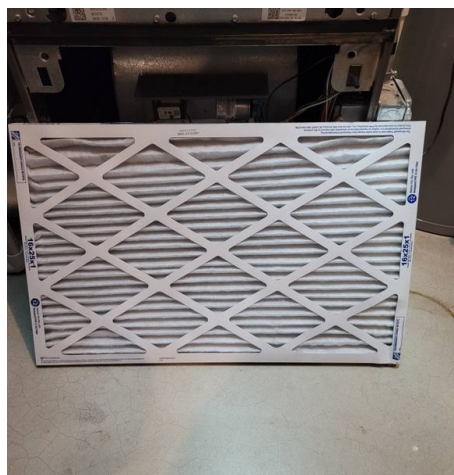
clean

Change the filter regularly to ensure the proper operation of the HVAC system. For more information on this topic, click here: [Don't Ruin Your Furnace. Change Your Filter Frequently.](#)

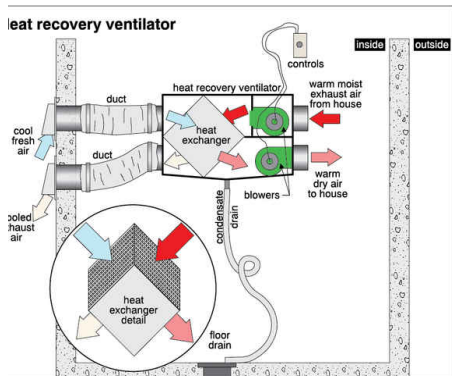
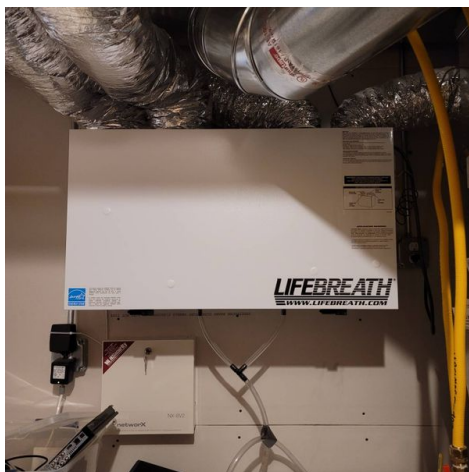
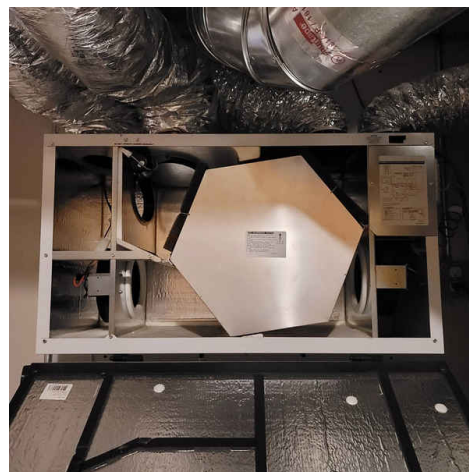
An HRV (heat recovery ventilator) was installed as the home's air exchange system. Follow the manufacturer's recommendations for operation and cleaning. For general operation and maintenance information, click here: [HRV, Part 2 of 3: Maintenance & Operation](#)

internal components

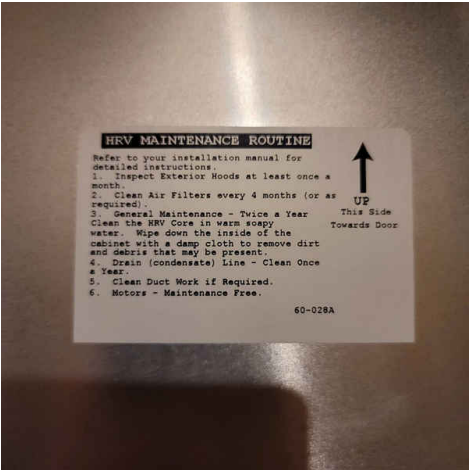
maintenance instructions on core

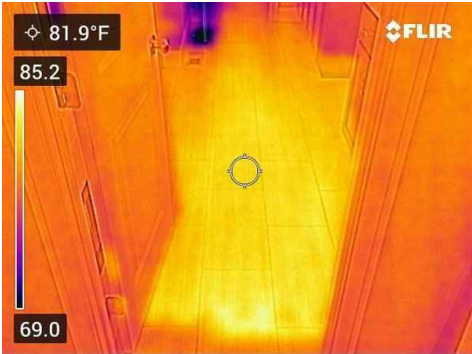
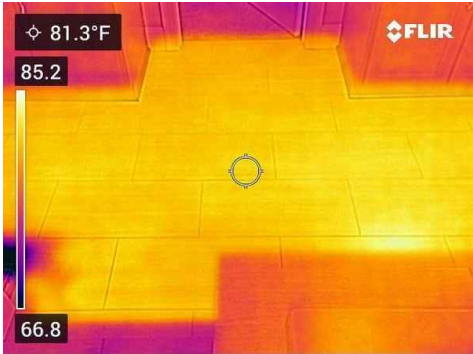
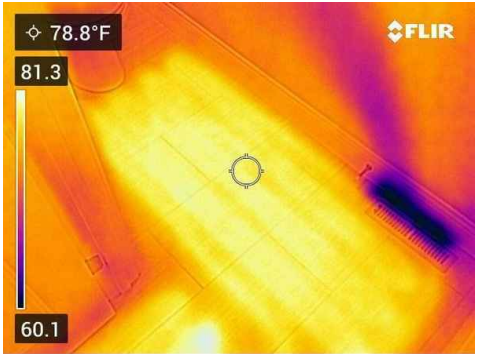
primary bathroom

IN-FLOOR HEAT FUNCTIONAL

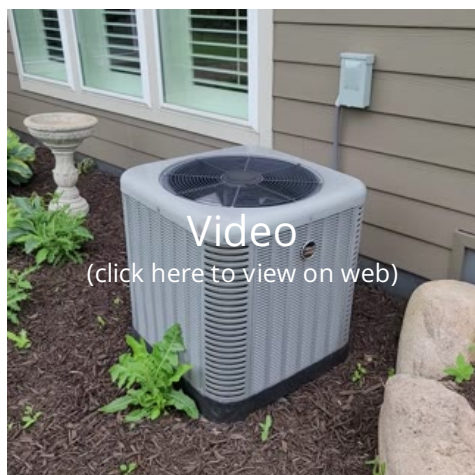
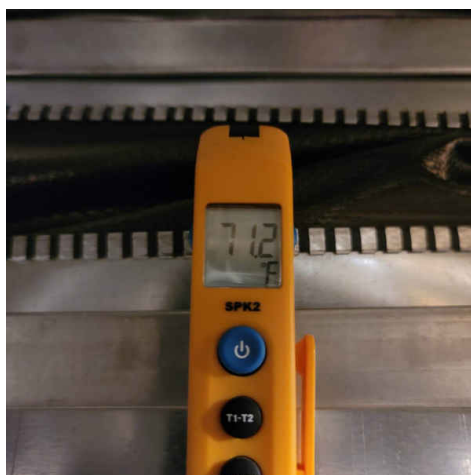
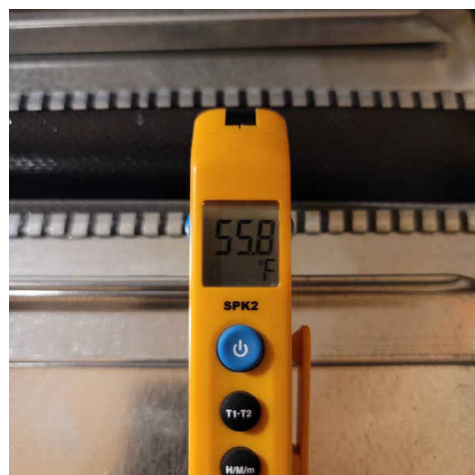
The air-conditioning responded to thermostatic controls and achieved an acceptable differential temperature split between the supply and return air (approximately 15-20 degrees).

supply temp - temp drop of approximately 16 degrees (acceptable)

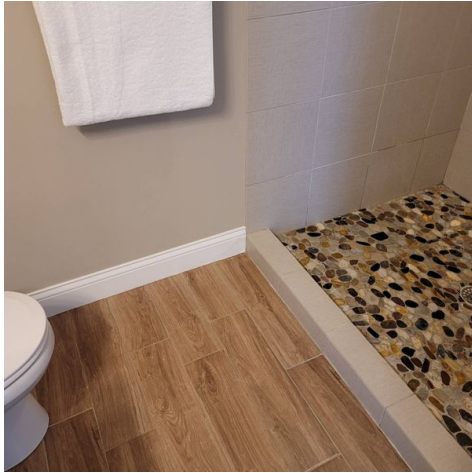
2nd floor bathroom

There was water damage at the drywall at the base of the shower wall. Consider adding splash guards to help prevent future water damage.

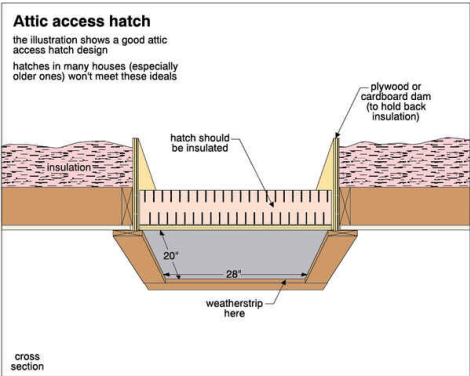
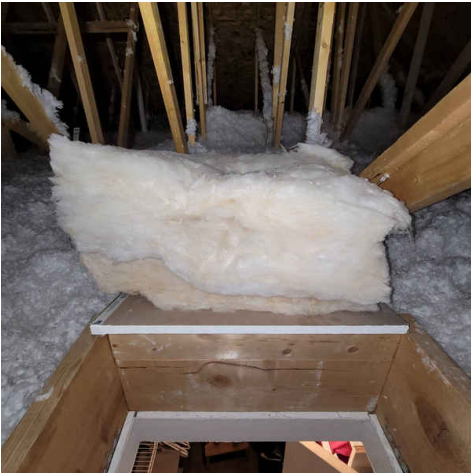
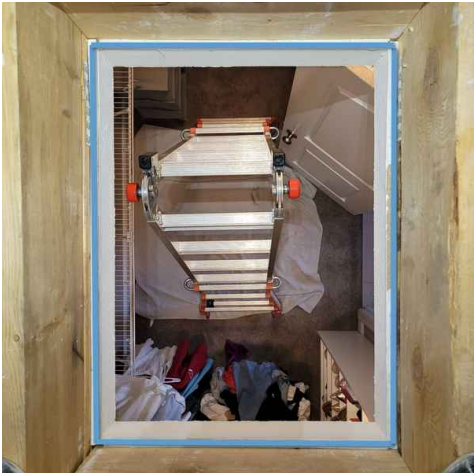
The attic access panel was covered with a piece of fiberglass insulation. It can be difficult to get the fiberglass to drop back down on top of the attic access panel if it is not properly attached. Insulate the top of the access panel with rigid foam. Additionally, the access panel did not make a tight seal at the ceiling. Have the access weather stripped to help prevent air leakage at this location. For more information on this topic, click here: [Poorly insulated attic access panels](#)

fiberglass batts at access panel

weather strip here

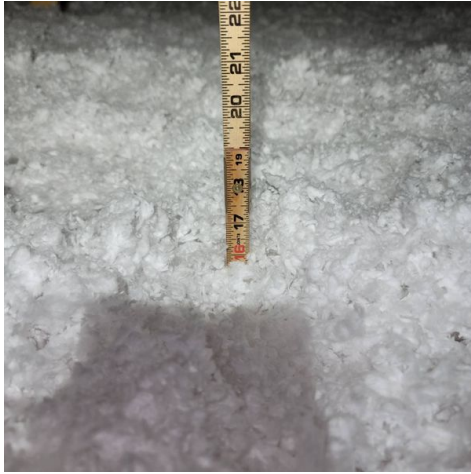
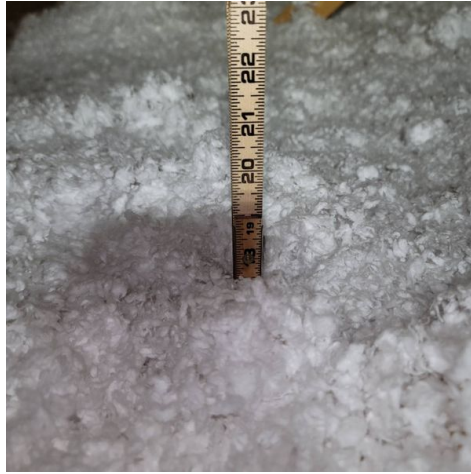
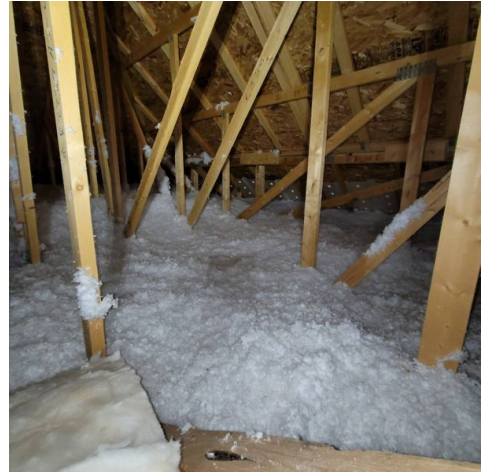
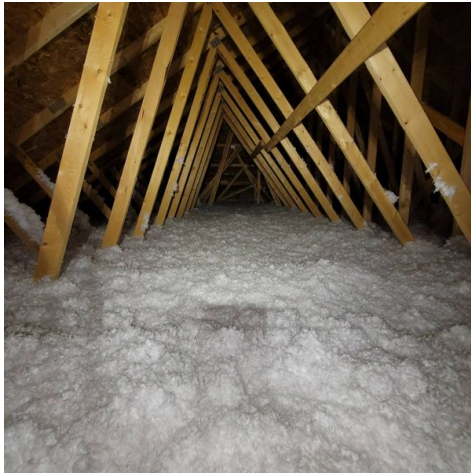
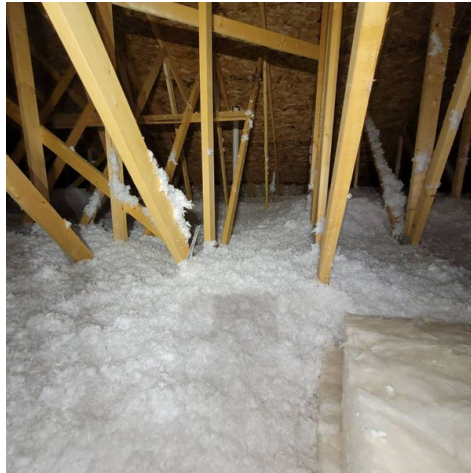
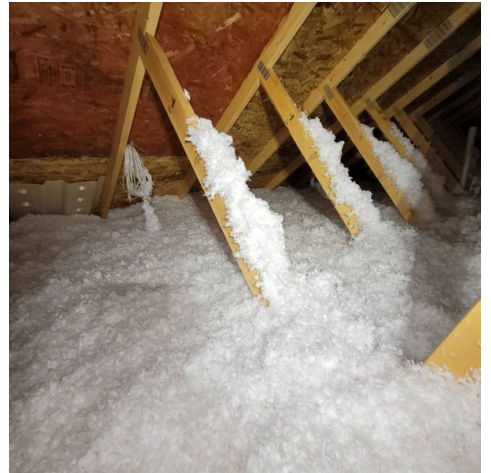
The attic insulation was acceptable.

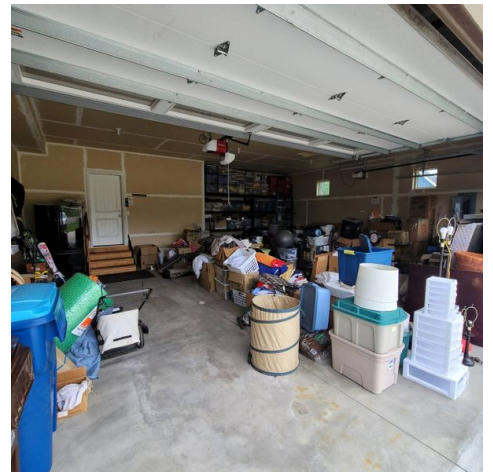
STORED ITEMS

There were stored items in the garage which prevented the garage floor, walls, and other components from being fully inspected.

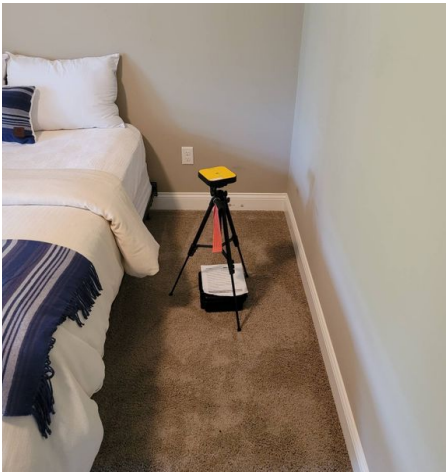
basement bedroom

A short-term (48 hour) radon test was performed on the home. The results of that test are sent in a separate report. For more information on radon and radon testing, click here: [Radon Testing - What the Results Mean](#)

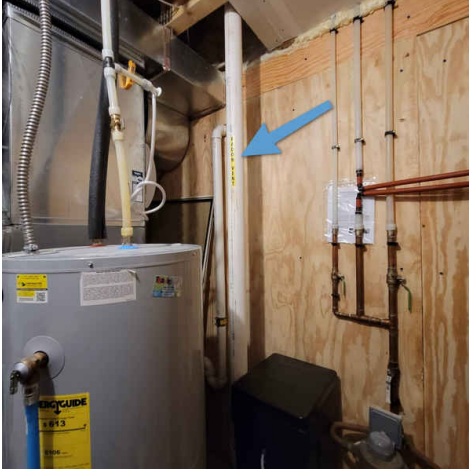
radon pipe in utility room

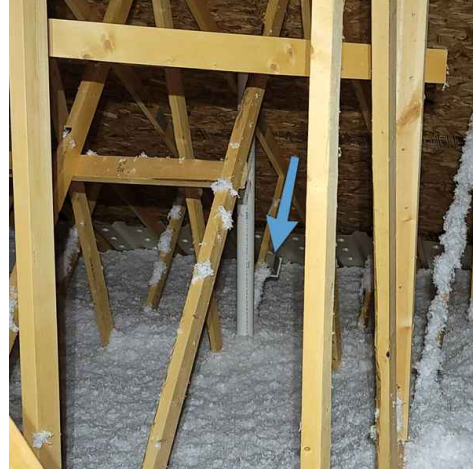
radon pipe and outlet in attic
