Inspection Report

Sample Report

Property Address:
1234 Anyplace Terrace
Yourtown MN

Structure Tech Home Inspections

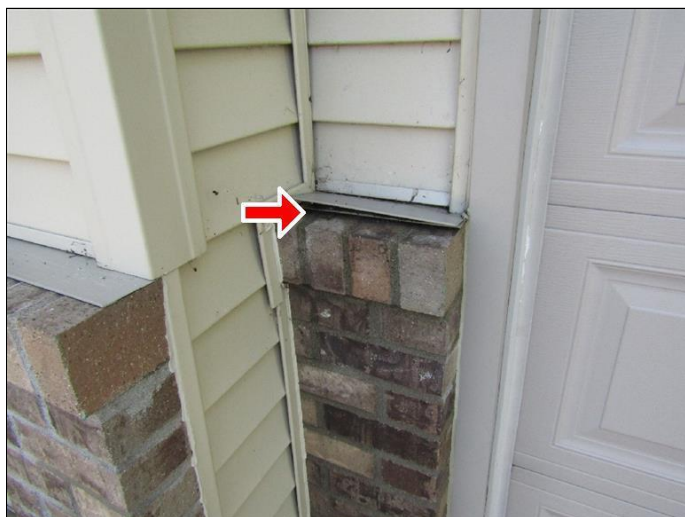
Example

🔍 Multiple sections of flashing over the brick veneer that were lifted throughout the community. Have the flashing secured and sealed to prevent water intrusion behind the brick veneer.

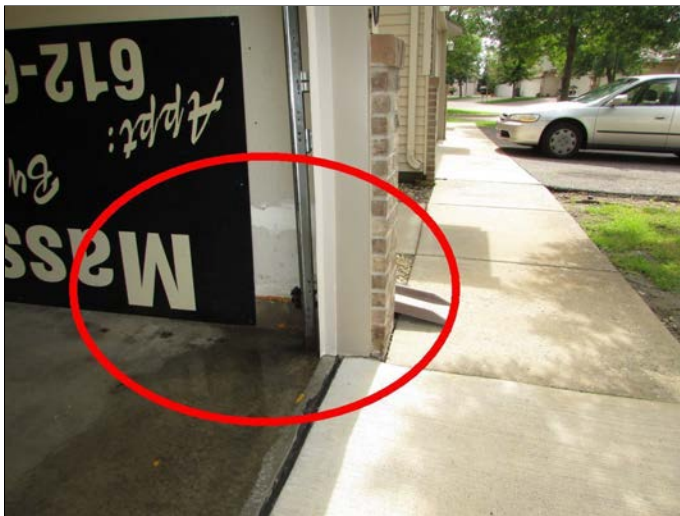
(1) A majority of the garage downspouts lacked proper extensions to carry the water away from the foundation. Downspouts dumping water against the building will concentrate water and greatly increase the potential for water problems and foundation problems. Add solid aluminum downspout extensions to carry the water at least 6 feet away from the house and beyond any landscape edging. Unit 4340 had an extension directed back toward the front entry.

Moisture noted at inside of garage at unit 9163

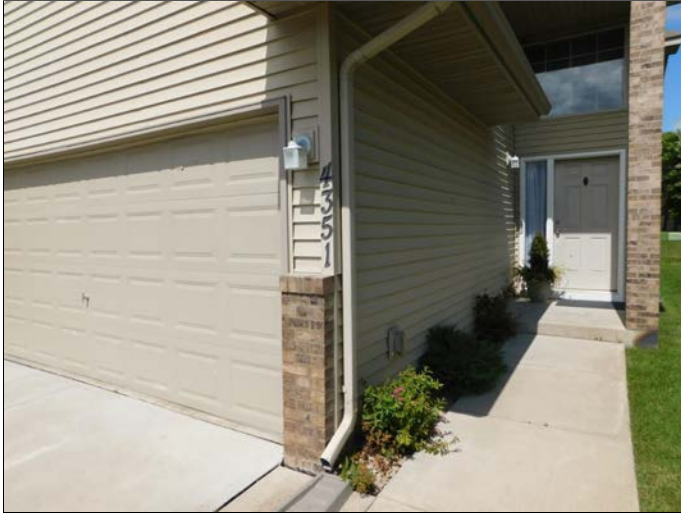
- (2) The downspouts at the front of the buildings drained onto the sidewalks and may cause ice buildup in the winter. Monitor for icing and re-direct these downspouts as necessary during the winter to help prevent a fall hazard.

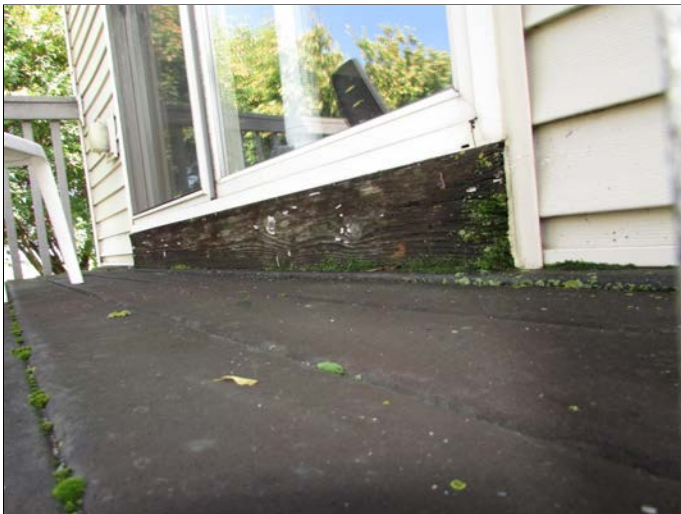
- (3) Gutters were only partially installed at various areas throughout the community. A complete gutter system is recommended for moisture control at the foundation and to help prevent damage to the house at areas such as decks where splashing water can accelerate deterioration and contribute to water intrusion. Consider having a full system of gutters and downspouts installed.

Typical type of deterioration where water splashes off decks without gutter protection

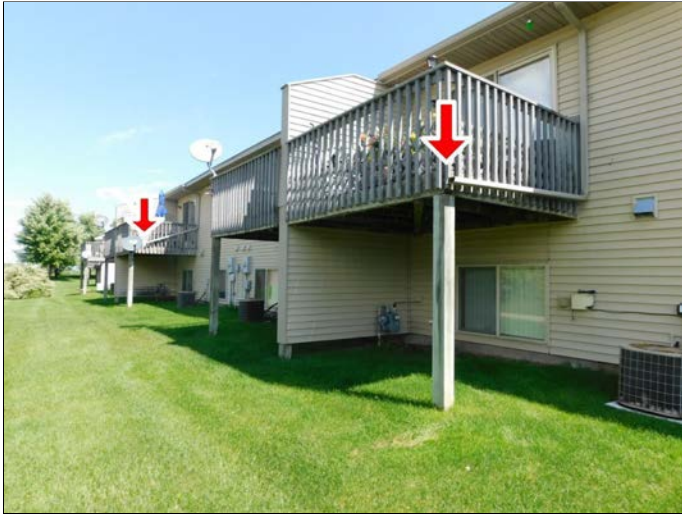
- (4) On units with a partial gutter installed at the deck, some downspouts noted lacked proper extensions to carry the water away from the deck footings. Downspouts dumping water near the footings will concentrate water against them and greatly increase the potential for problems with settled footings or frost heaves. Add solid aluminum downspout extensions to carry the water at least 6 feet away from the footings.

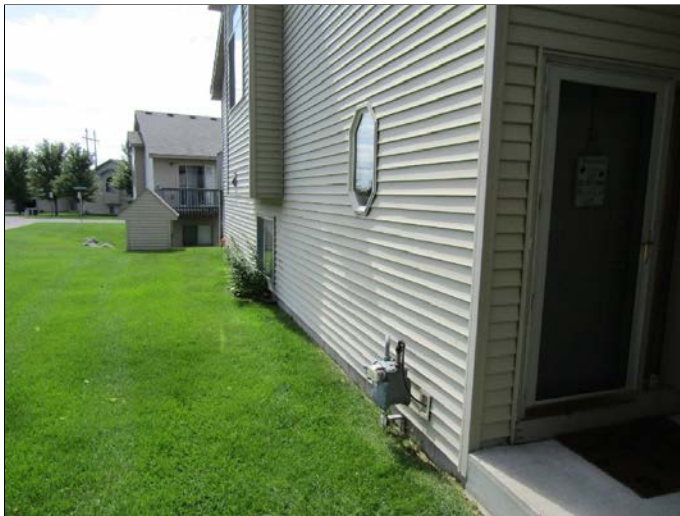
(5) The ground sloped toward the buildings or was flat in areas next to the buildings, which could lead to water entering the basements and/or cause excessive soil pressures against the foundations. The soil or the hard surfaces should slope away from the buildings for at least ten feet if possible, to help prevent basement water intrusion and foundation problems. Re-grade where possible to provide positive slope away from the buildings.

Unit 9161 - flat grading

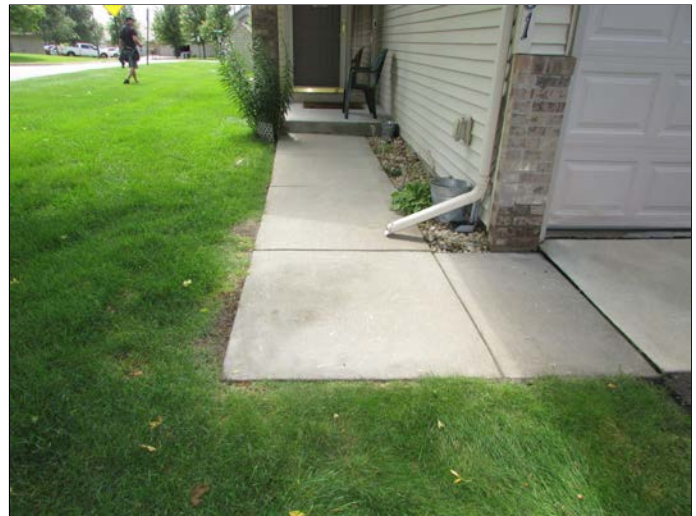
Negative slope sidewalk unit 9161

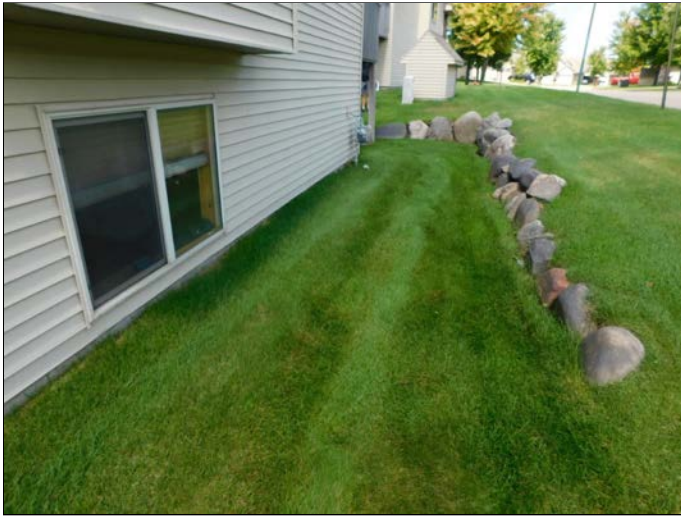
Unit 4373 - flat grading

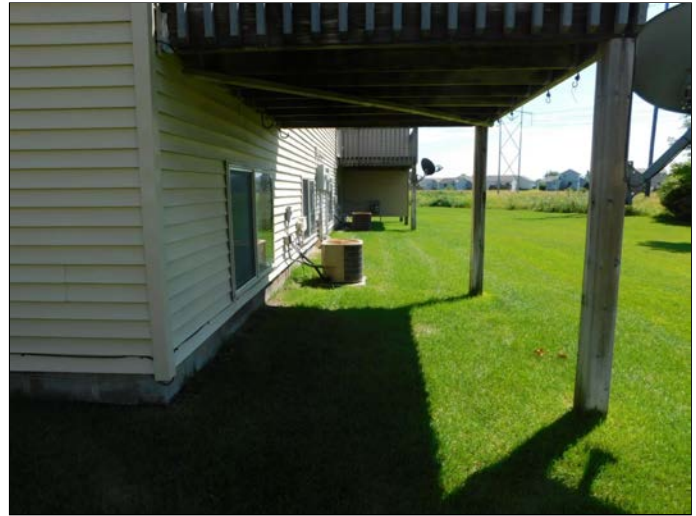
Generally flat behind building 10

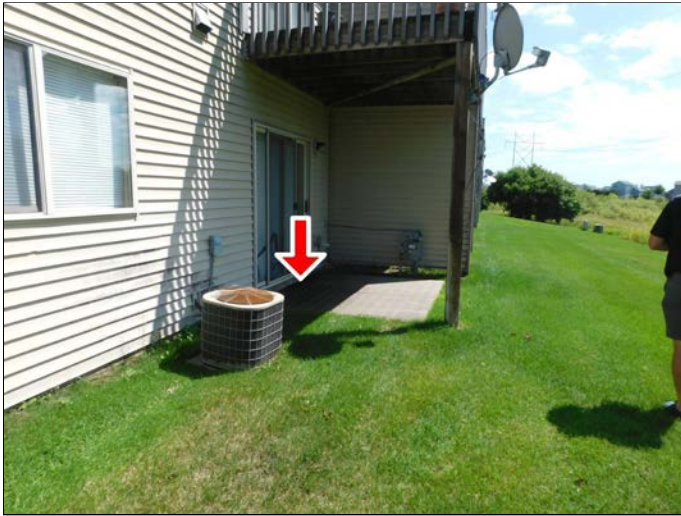
Example

(1) The patios at numerous units sloped toward the structure, which can lead to water intrusion and damage to the foundation wall. Have the slope corrected at the patios. Two common methods of leveling concrete are sandjacking and mudjacking. Units noted: 9166, 9162, 4318, 4320, 4322, 4328, 4330, 4332, 4340, 4344, 4348, 4352, 9162, 9156, 9152, 9184, 9188, 9192, 9221, 9223, 9225, 9227, 9201, 9195, and 9193.

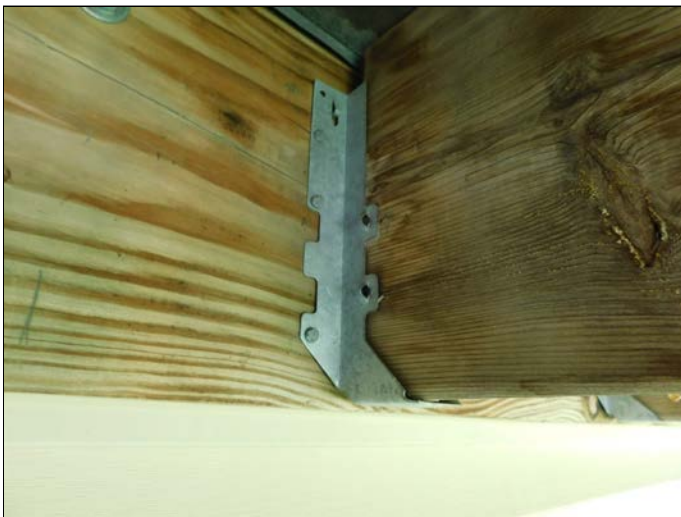
(2) Improper nails were used at the joist hangers at all the buildings. The joist hangers support the deck and now have the potential to fail. There were also missing nails at many of the hangers. Additionally, some joists were noted to be pulling away from the ledger board at numerous units. Have this corrected. For information on this correction, click here: [How to Correct Improper Joist Hanger Nails](#)

missing nails

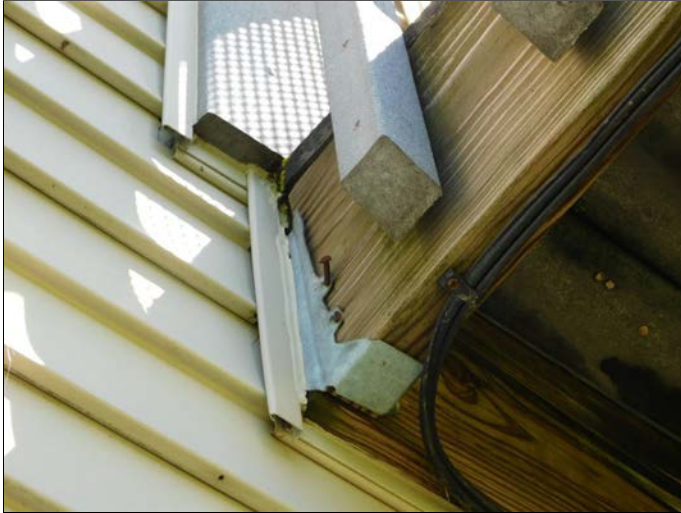
(3) There were improper joist hangers used at the ends of the ledger boards. These end joists have hangers specifically designed for these locations. Have this corrected.

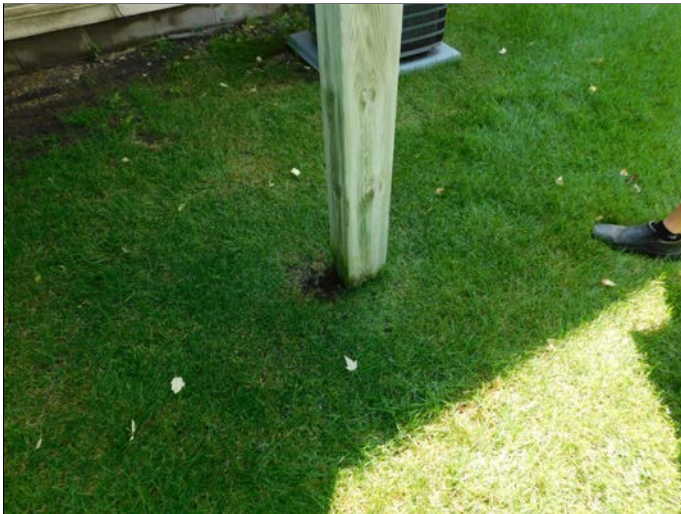
(4) Almost all of the deck footings were not visible at the surface of the grade or landscaping and the posts were in contact with the soil. Monitor the deck posts for rotted wood.

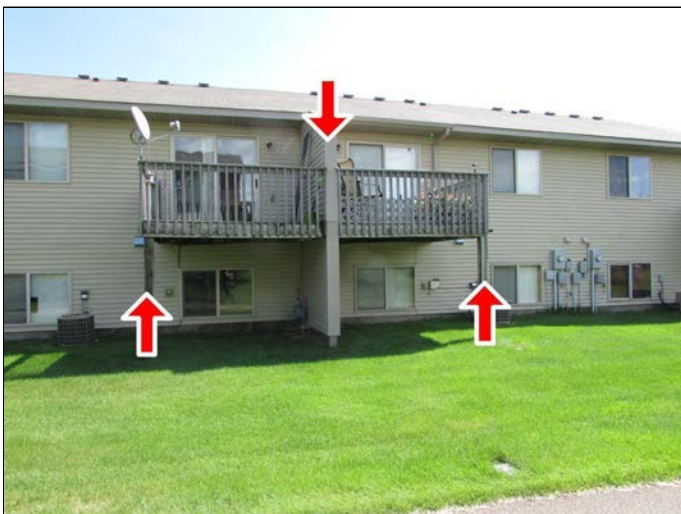
(5) There were multiple decks throughout the community that likely have heaved. This may be due, in part, to the poor locations of the sump discharge and downspout piping.

Example of frost heave

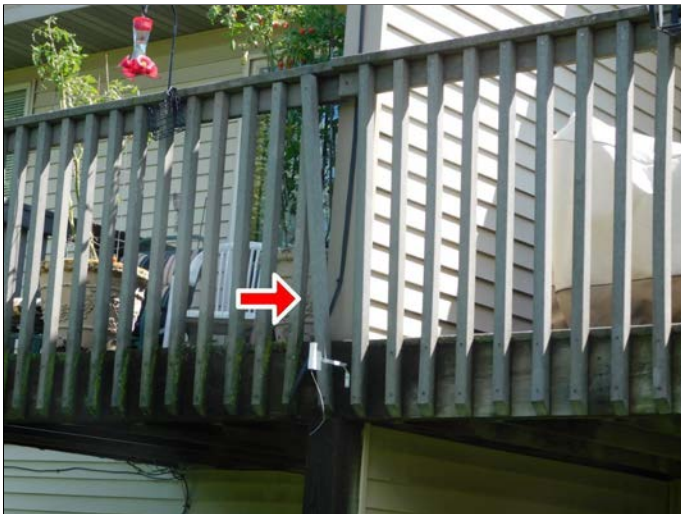
- (7) There were loose balusters noted at decks throughout the community. Have all balusters secured to help prevent injuries from falling.

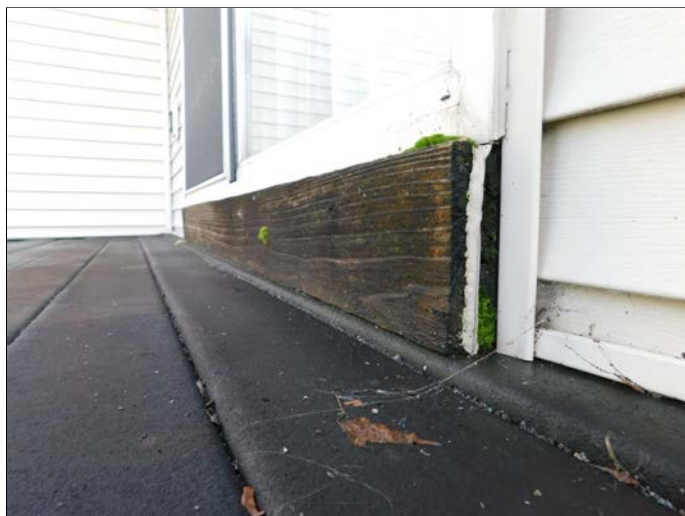
(8) There was rot noted at the kick plate at multiple units. Have the affected plates replaced to help prevent water intrusion.

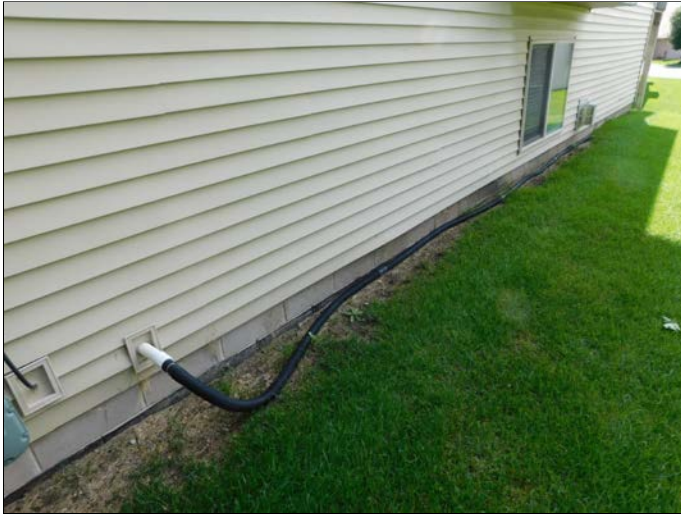
Building 4

- (3) There were some sump pump discharge tubes that were directed into a corrugated tube that runs across the lawns. This has the potential to fill with ice and prevent the pumps from functioning properly during the winter. Remember to disconnect the corrugated extension tubing in the fall. For more information on this topic, click here: [Potential for Freezing at the Exterior](#)

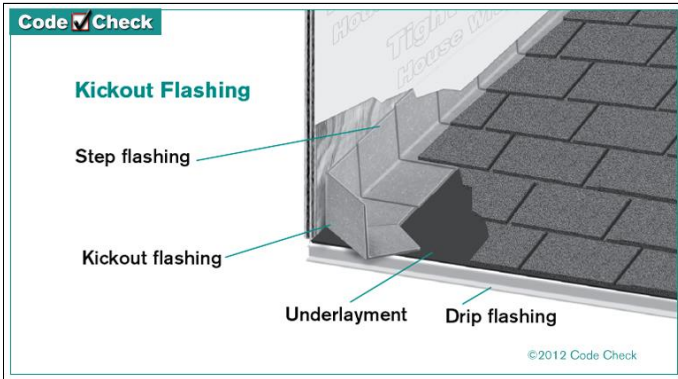
Example

Kickout flashing was not installed at most of the roof/wall intersections, which is recommended to help prevent moisture intrusion at roof/wall intersections. Consider having kickout flashing installed at these locations to help prevent water intrusion. For more information on this topic, click here: [Kickout Flashing](#)

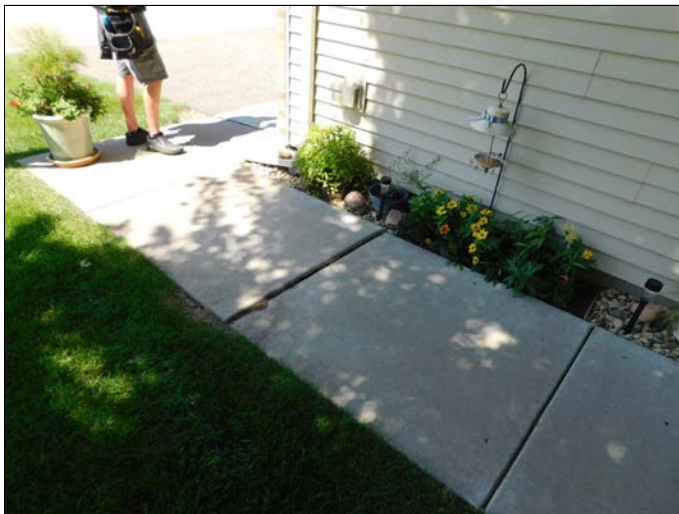
Unit 9152

👉 (1) Several walkways have settled, cracked and/or are uneven. This can be a trip hazard and prevent proper drainage of water away from the buildings. Have this corrected. Consider mudjacking or sandjacking for correction.

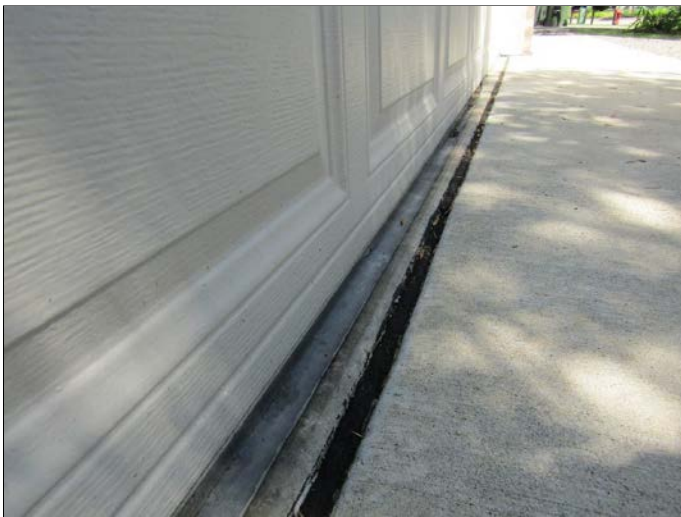
Example

(2) Any gaps between the garage floors and the driveways should be sealed to help prevent water intrusion and soil erosion beneath the floor, which can lead to foundation damage.

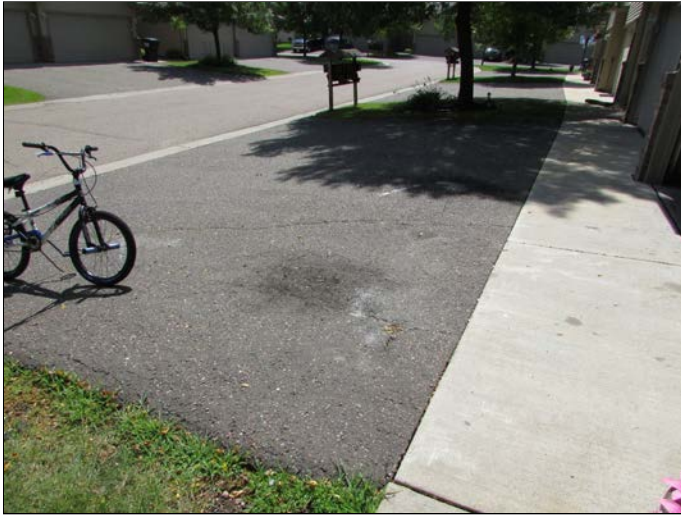
i There were exposed stone faces at the asphalt driveways and common parking areas throughout the community, indicating it's time to apply a sealcoat. This is a regular maintenance item which will help to preserve the life of the driveways.

Example - all driveways were similar

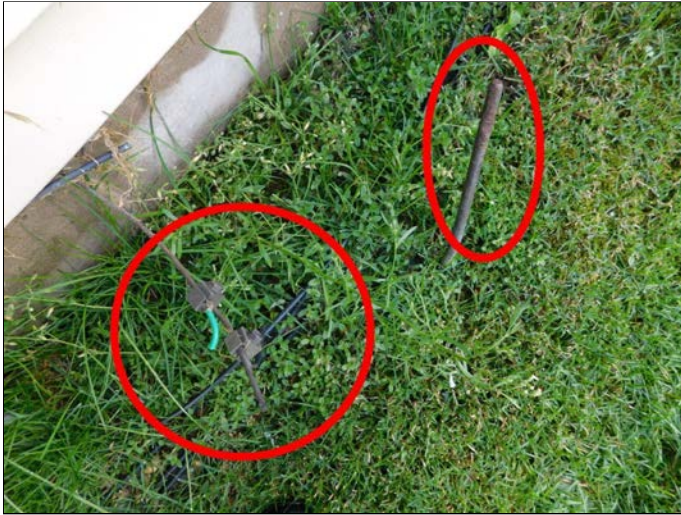
(2) There was a cut ground wire at one of the units at building 1. This should be corrected by a licensed electrician. Additionally, several ground rods were sticking out of the ground, likely because the ground has settled over time. All are potential trip hazards. Have this corrected for safety.

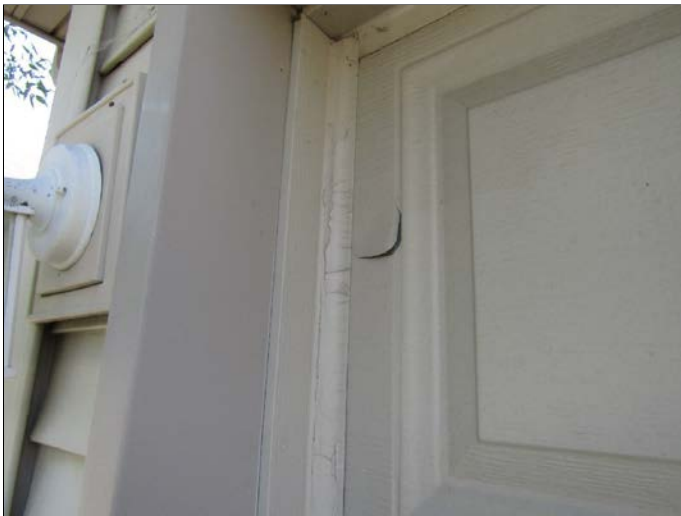
(3) There was peeling paint noted at the overhead garage door of unit 9229. Have the door serviced.

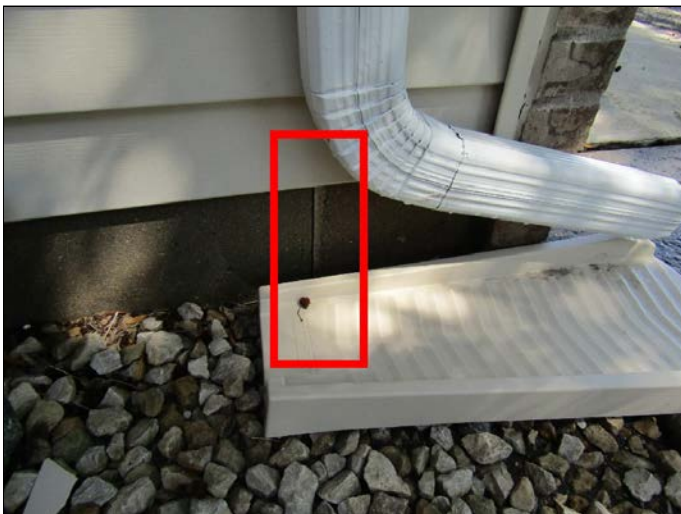
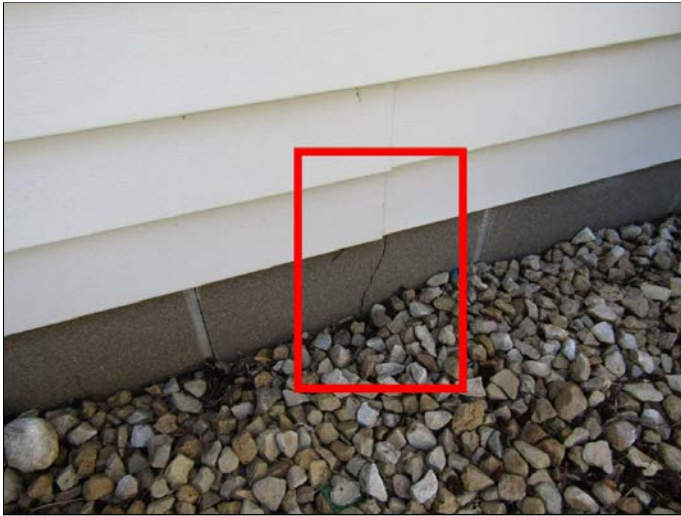
(4) There were some small cracks and gaps at a few foundation walls. Seal the cracks with mortar and monitor for any future movement.

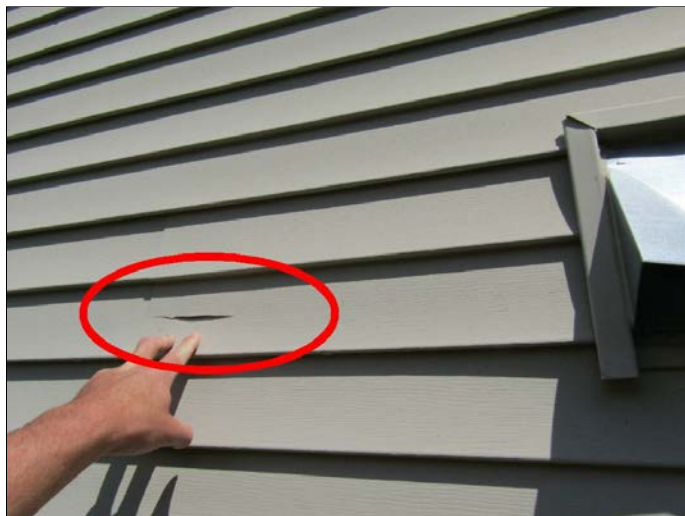
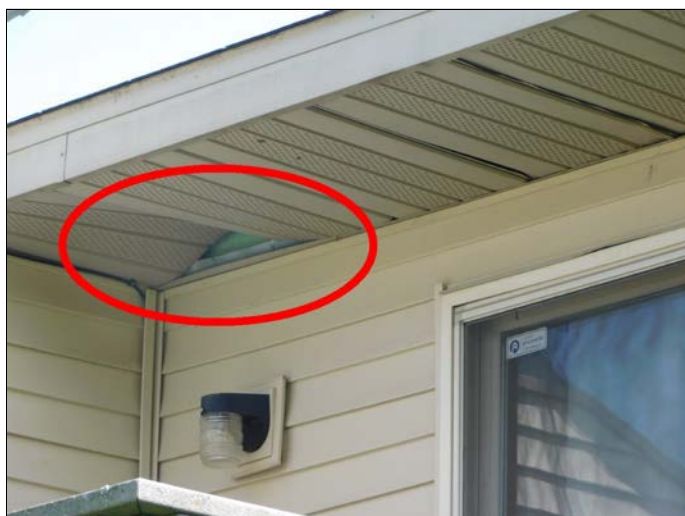
There was some loose and damaged sections of soffit at building 1. This could allow for pest intrusion and should be serviced.

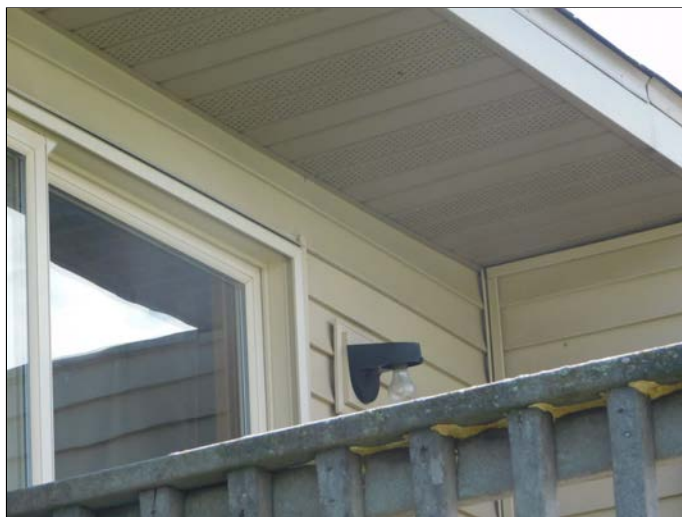
(2) There were missing globes at the back of the units at building 2. Have the globes replaced.

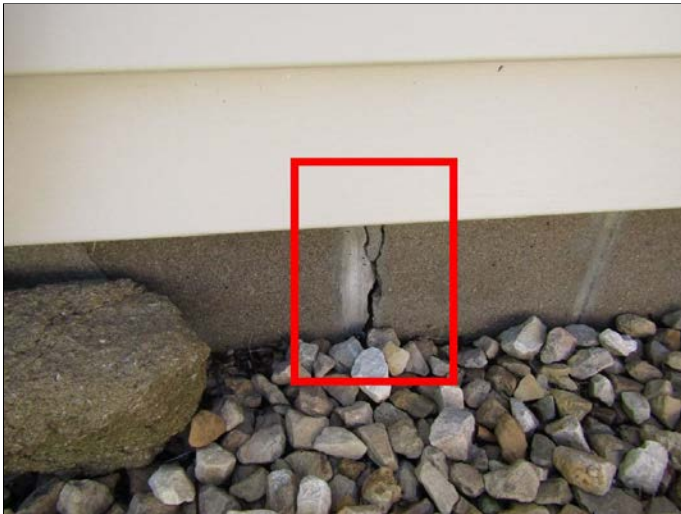
- (4) There was a small crack at the garage foundation wall. Seal the crack with mortar and monitor for any future movement.

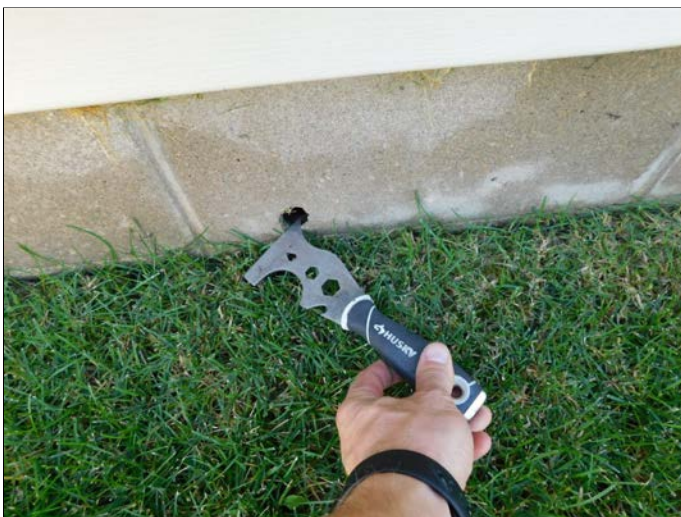
- (5) There was a small hole in the foundation at unit 9209. Have the hole filled with mortar to help prevent pest intrusion.

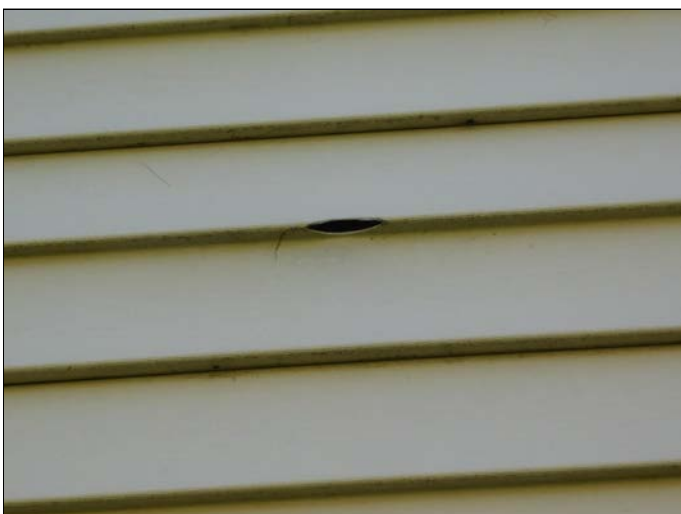
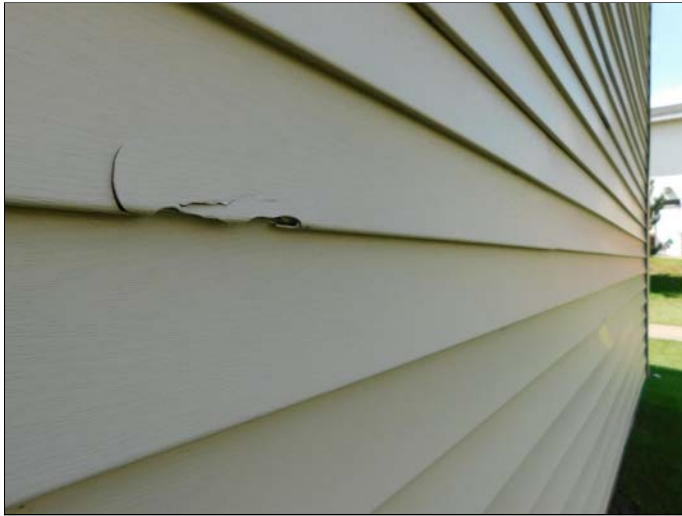
North wall of building 2

- (6) There were loose, damaged or missing pieces of vinyl siding at the building. Have the loose pieces of siding secured to lower the potential for water intrusion or wind damage.

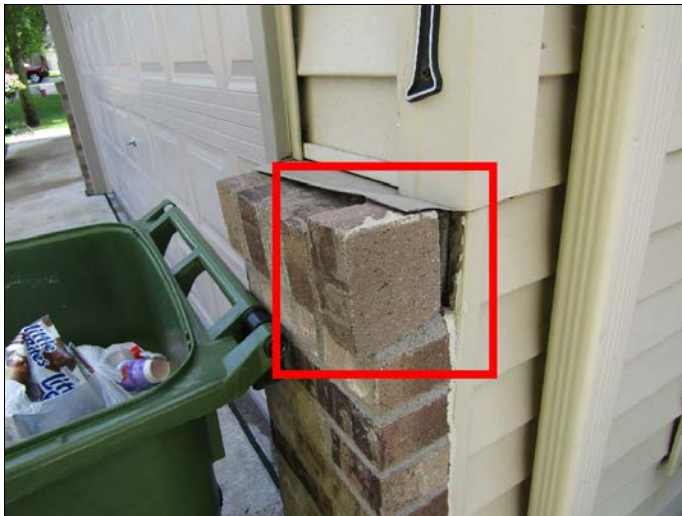
There was a loose brick at the wall of unit 9171. Have the brick repaired.

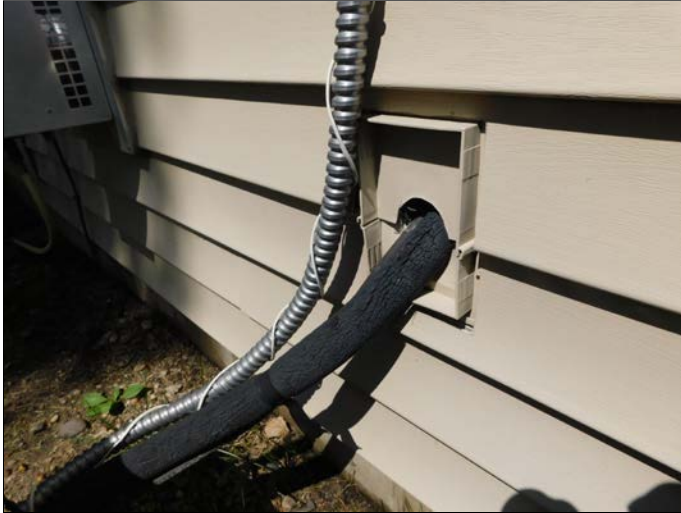
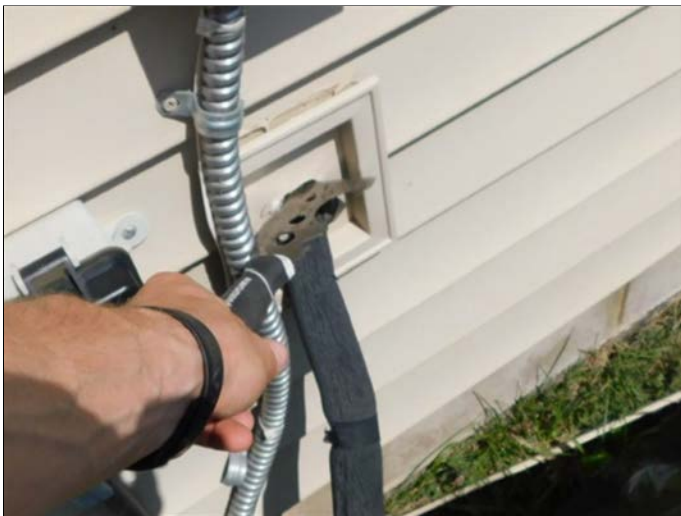
- (1) Caulk around the AC refrigerant lines where they enter the building. This will help prevent water intrusion, pest intrusion, and air leakage.

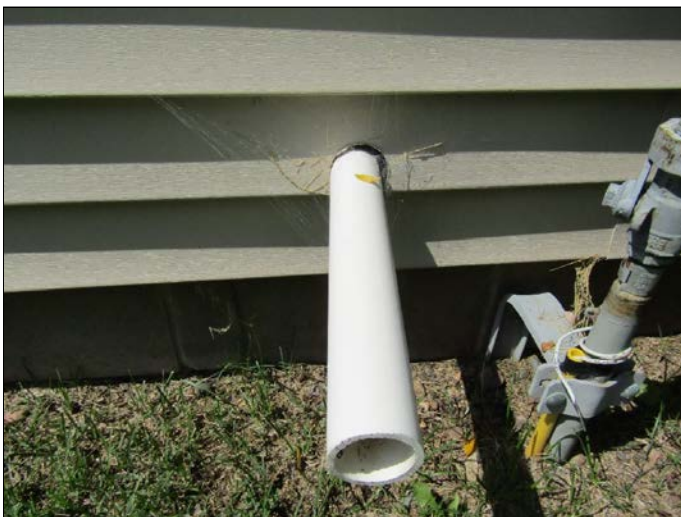
- (2) Caulk around the sump pump pipes where they enter the building. This will help prevent water intrusion, pest intrusion, and air leakage.

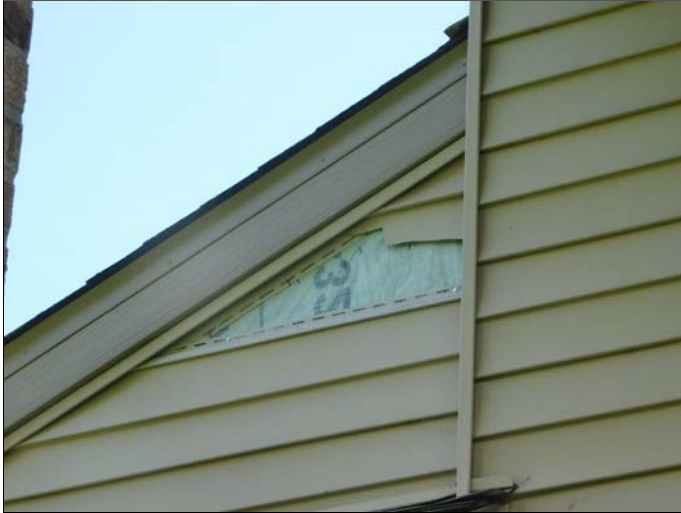
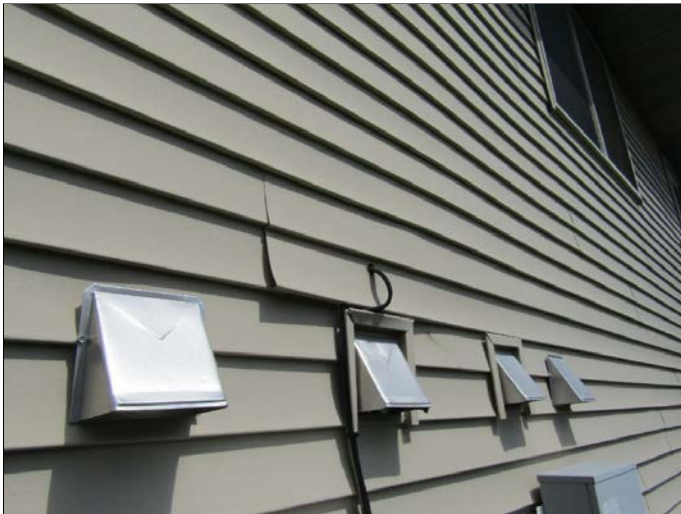
📍 (2) There were loose, damaged or missing pieces of vinyl siding at the building. Have the loose pieces of siding secured to lower the potential for water intrusion or wind damage.

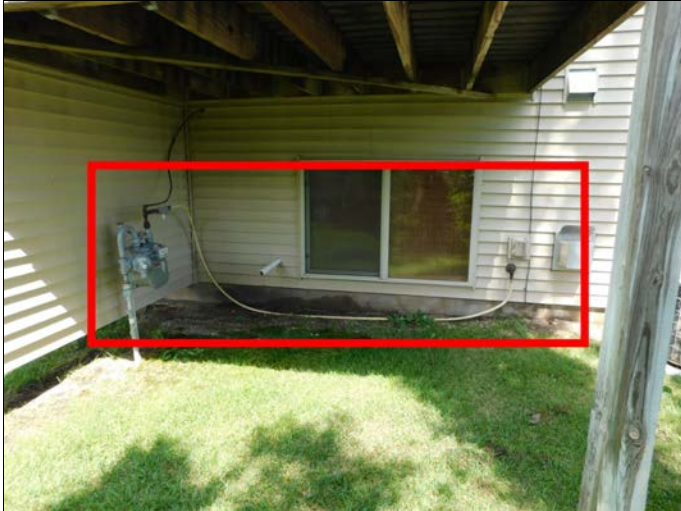
- (3) The CSST gas tubing for the gas fireplace at the back of the building (possibly unit 9173 or 9177) was improperly installed. The tubing runs along the surface of the ground at the side of the building, where it could be damaged. Have the tubing secured and protected at the side of the building.

Also, the gas piping was not properly bonded, which is a requirement when CSST (Corrugated Stainless Steel Tubing) is used for gas piping. Bonding the gas piping to the electrical system is required to reduce the risk of damage and fire from a lightning strike. Have this corrected. For more information about bonding CSST, click here: [CSST Bonding](#)

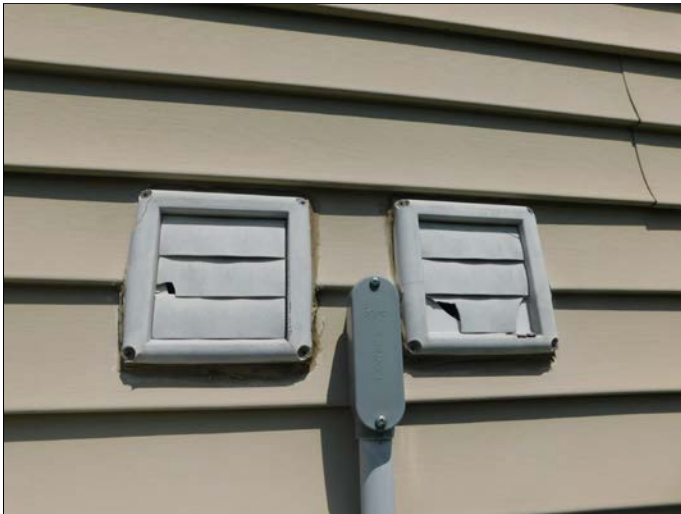
- (4) There were damaged louvers at the vent at unit 9173. Have this replaced to help prevent pest and exterior air intrusion.

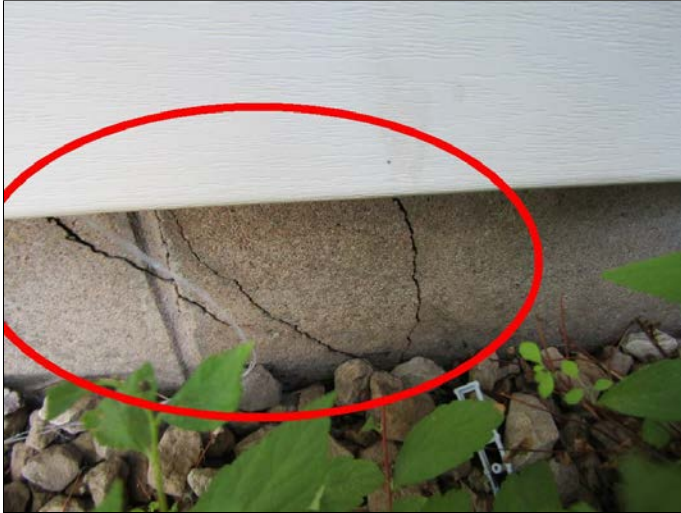
- (5) There was a small crack at the garage foundation wall. Seal the crack with mortar and monitor for any future movement.

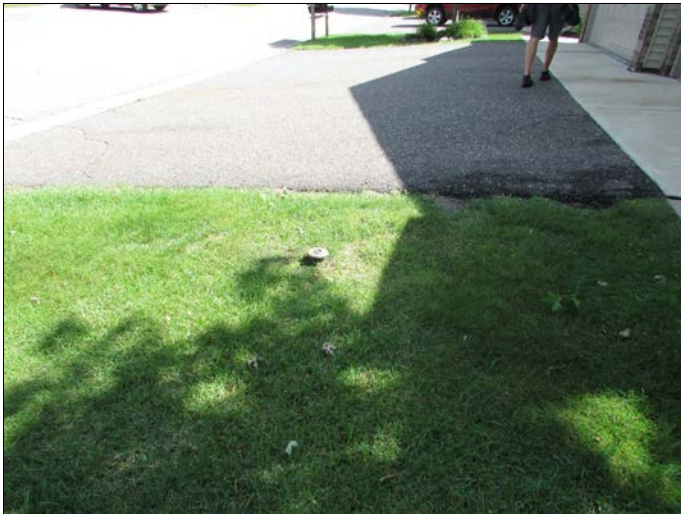
- The municipal water shutoff was protruding from the ground at unit 9167, which is a potential trip hazard. Consider correcting if possible.

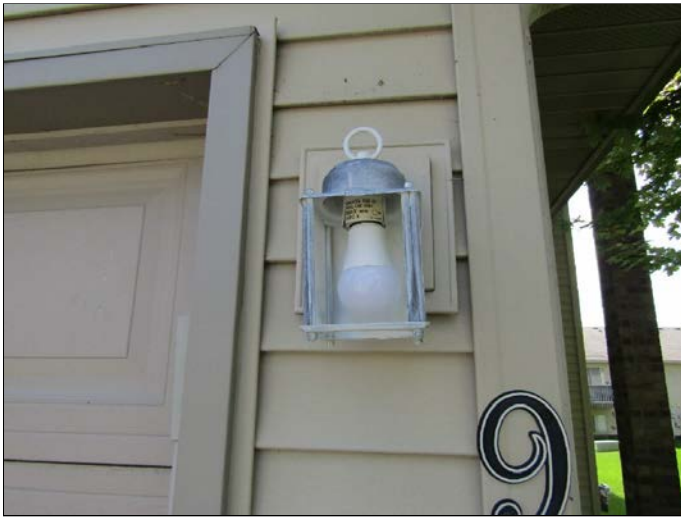
🔧 A light fixture at unit 9167 had broken or missing glass. Have the fixture repaired or replaced.

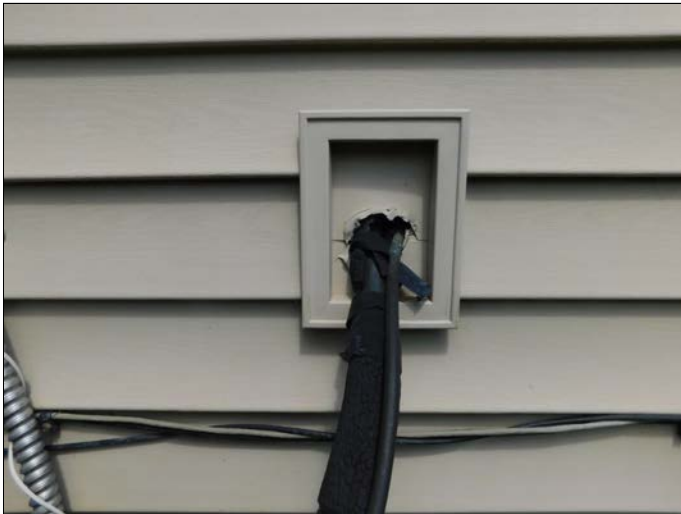
🔧 (1) Caulk around the AC refrigerant lines where they enter the building. This will help prevent water intrusion, pest intrusion, and air leakage.

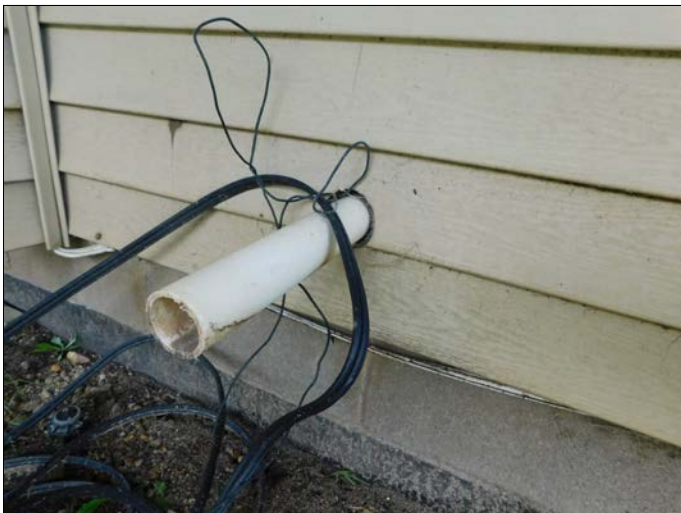
🔧 (2) Caulk around the sump pump pipes where they enter the building. This will help prevent water intrusion, pest intrusion, and air leakage.

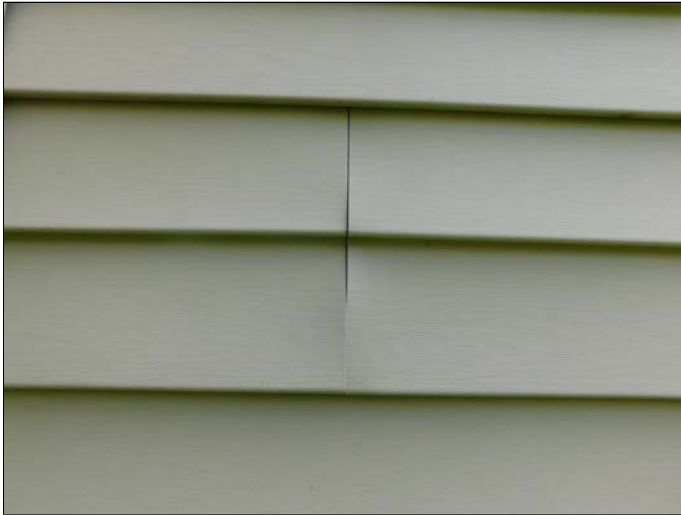
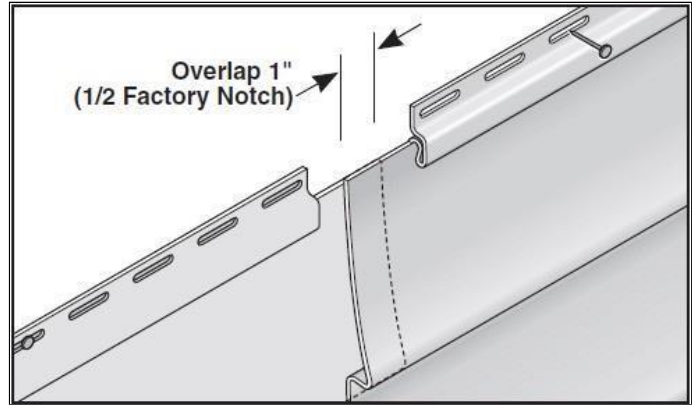
- (1) There was a piece of siding that appeared to be cut too short or have moved from expansion/contraction, leaving gaps in the siding. This could allow unnecessary water intrusion behind the siding. Have this corrected to allow for a proper 1" overlap.

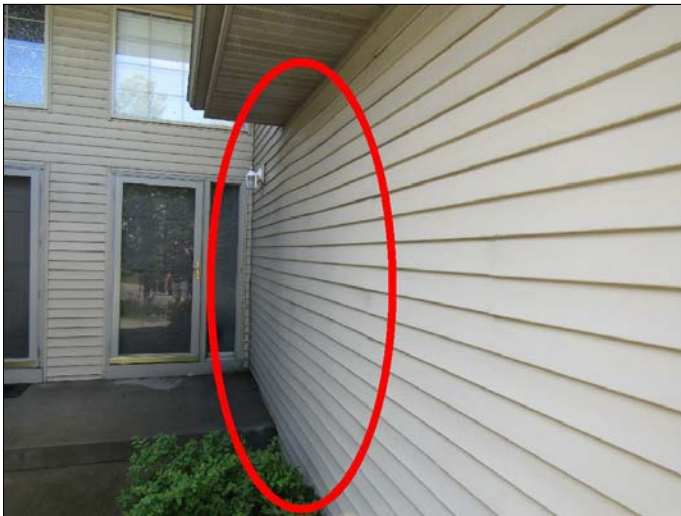
- (2) There were damaged garage door panels noted at unit 9161 and 9165. Repair or replace the damaged panels or whole door if necessary.
- (3) There was a noted bow in the wall at unit 9165. Monitor for further movement. Any chances should be evaluated further.

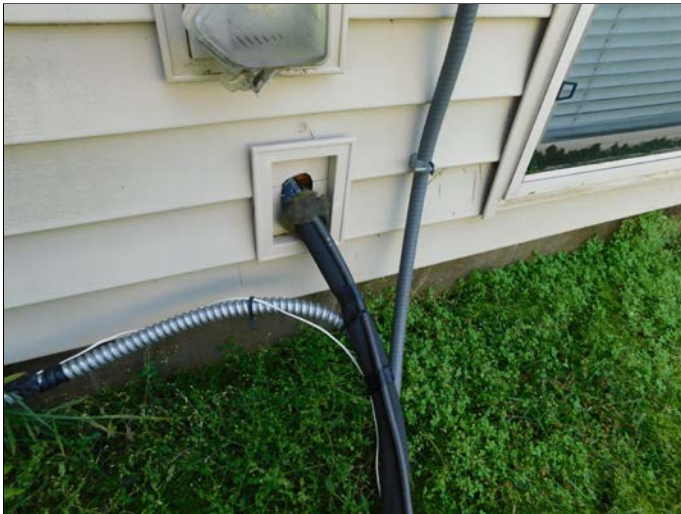
- (1) Caulk around the AC refrigerant lines where they enter the building. This will help prevent water intrusion, pest intrusion, and air leakage.

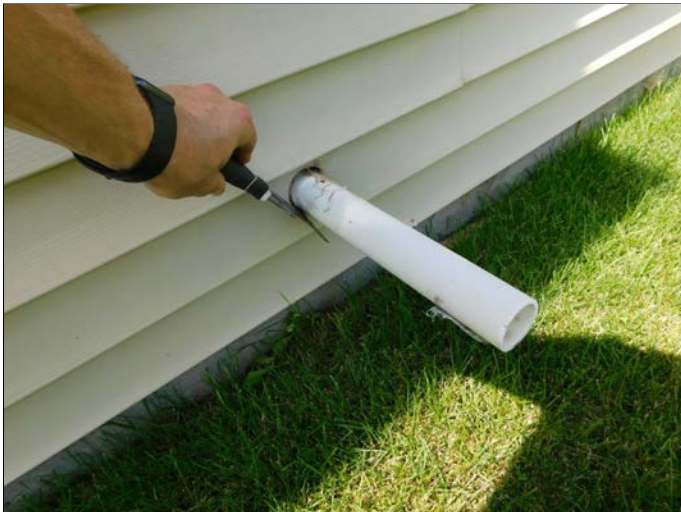
- (2) Caulk around the sump pump pipes where they enter the building. This will help prevent water intrusion, pest intrusion, and air leakage.

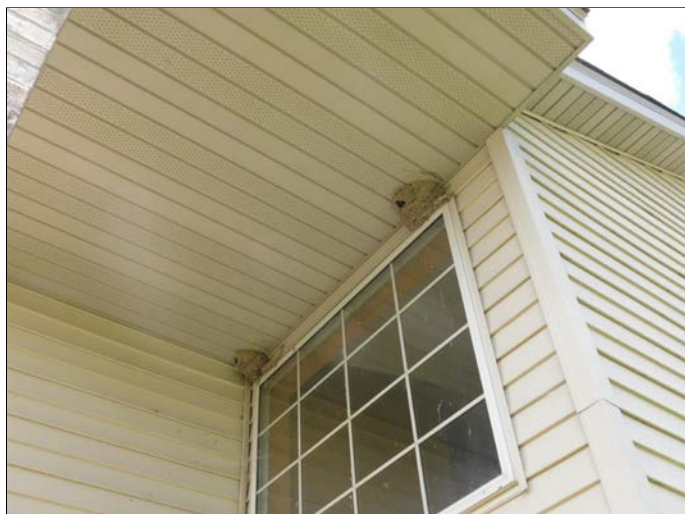
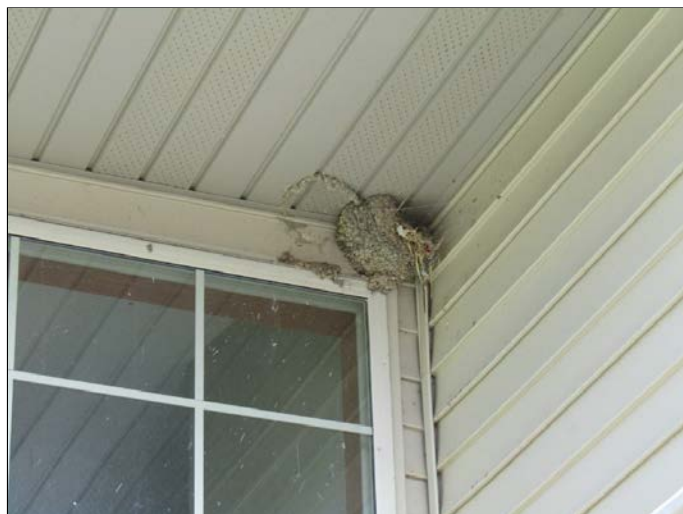
- (1) There was bird nesting material located at unit 4373 and 4361. Have the nests removed to help eliminate bird activity.

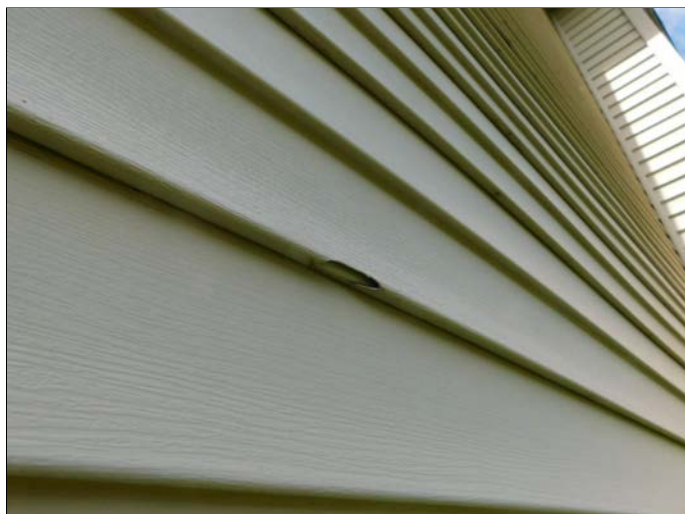
- (2) There was a loose, damaged or missing piece of vinyl siding at the building. Have the loose piece of siding secured to lower the potential for water intrusion or wind damage.

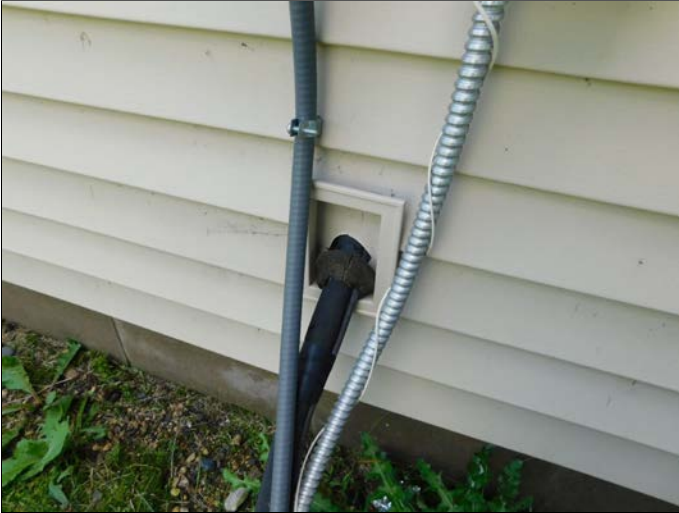
(1) Caulk around the AC refrigerant lines where they enter the building. This will help prevent water intrusion, pest intrusion, and air leakage.

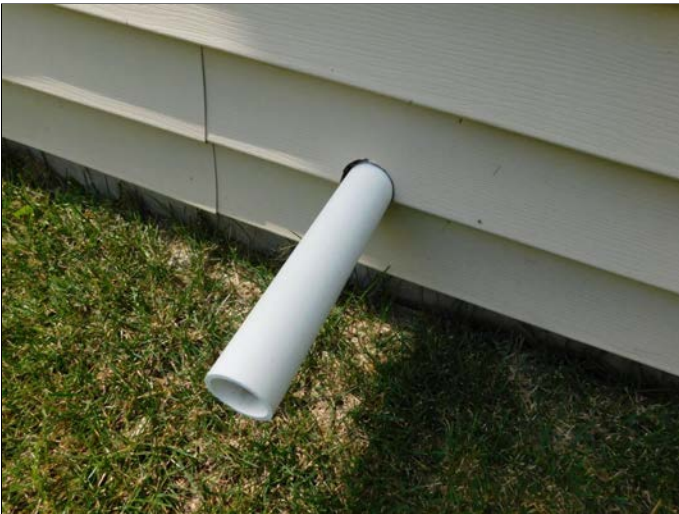
(2) Caulk around the sump pump pipes where they enter the building. This will help prevent water intrusion, pest intrusion, and air leakage.

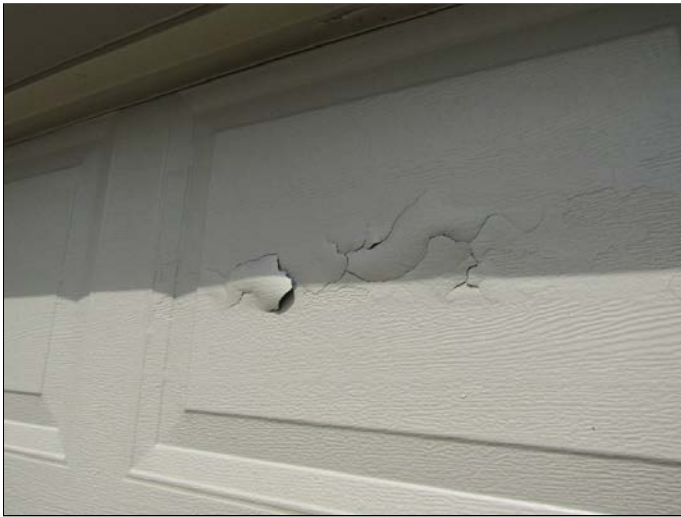
- (2) There was peeling paint noted at the overhead garage door of unit 4351. Have the door serviced.

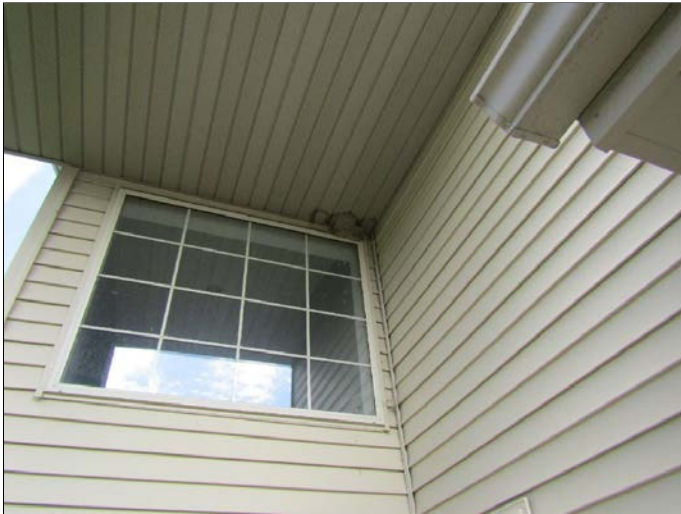
- (3) There was bird nesting material located at unit 4341. Have the nests removed to help eliminate bird activity.
