Inspection Report

Sample Report

Property Address:
1234 Anyplace Terrace
Yourtown MN

Structure Tech Home Inspections

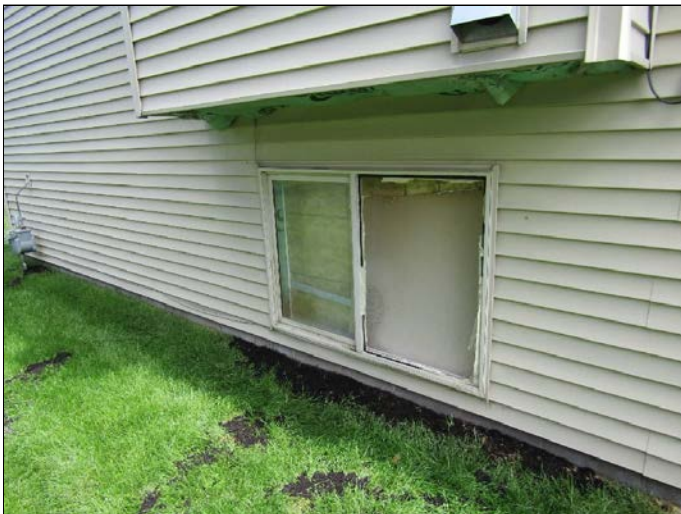
- (4) A window was broken out and boarded up at unit 4341. Have the window replaced.

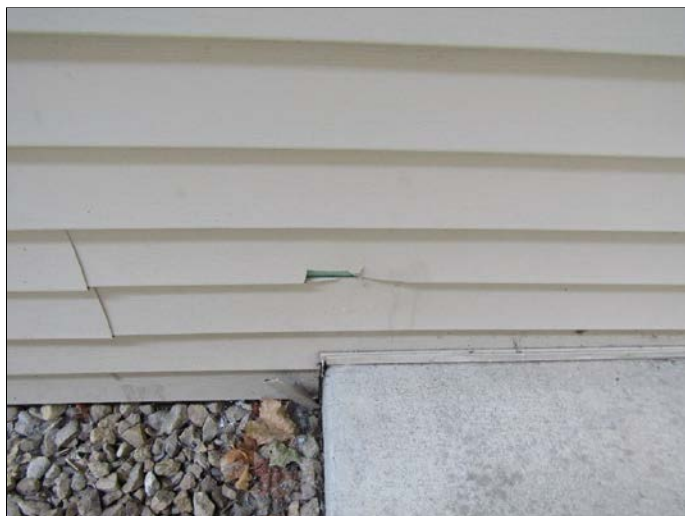
(5) There was a loose, damaged or missing piece of vinyl siding at the building. Have the loose piece of siding secured to lower the potential for water intrusion or wind damage.

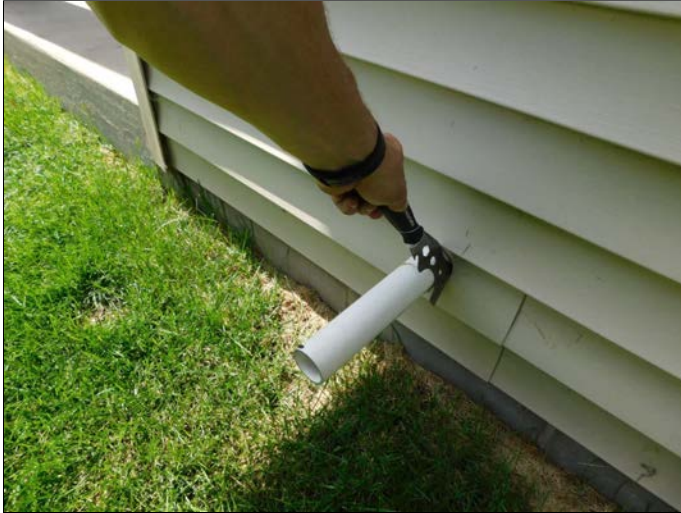
- (1) Caulk around the sump pump pipes where they enter the building. This will help prevent water intrusion, pest intrusion, and air leakage.

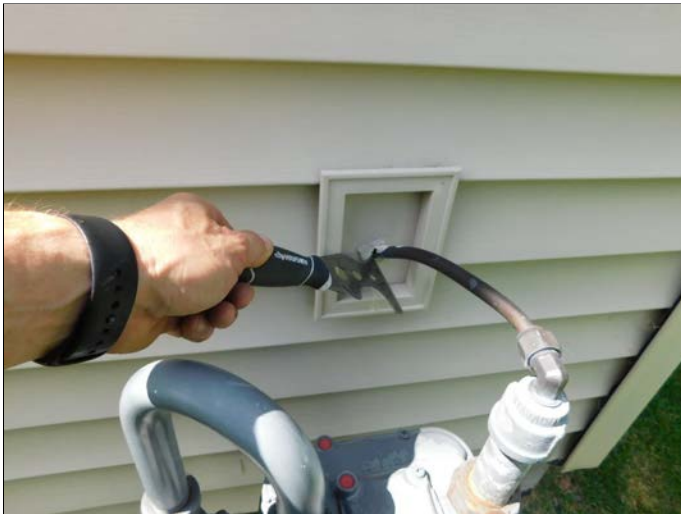
- (2) Caulk around the gas line where it enters the building. This will help prevent water intrusion, pest intrusion, and air leakage.

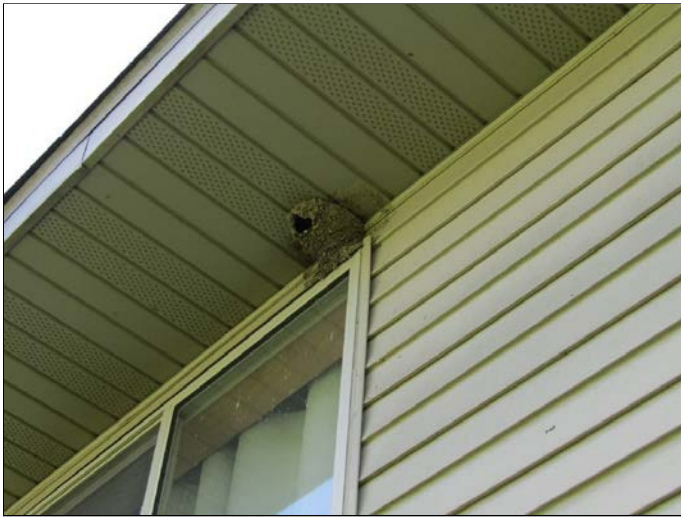
(2) There was a bird nest located at unit 4319. Have the nests removed to help eliminate bird activity.

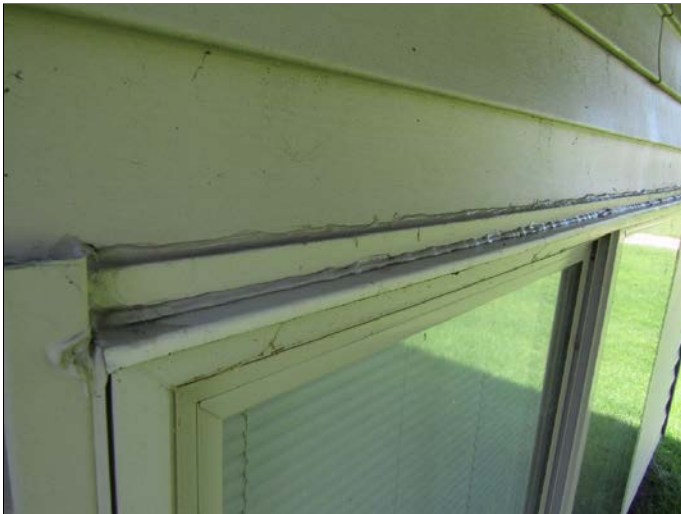
(3) The head flashing above a window was caulked at unit 4319. This flashing provides a drainage plane for water, and the caulking could hold water inside the wall at this location, increasing the potential for water damage at the walls. For more information on this topic, click here: [Don't Caulk Head Flashing](#)

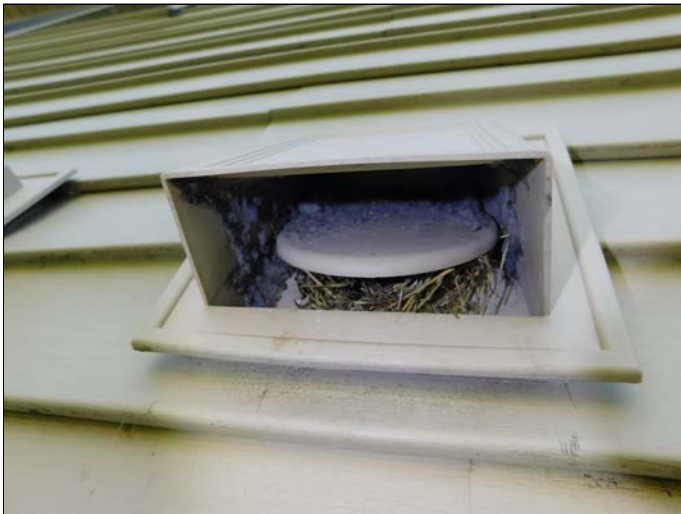
(4) There was bird nesting materials in multiple dryer vents at building 7. Have the materials cleared out for proper operation of the dryer, to reduce the potential for fire, and reduce the potential for carbon monoxide buildup in the homes.

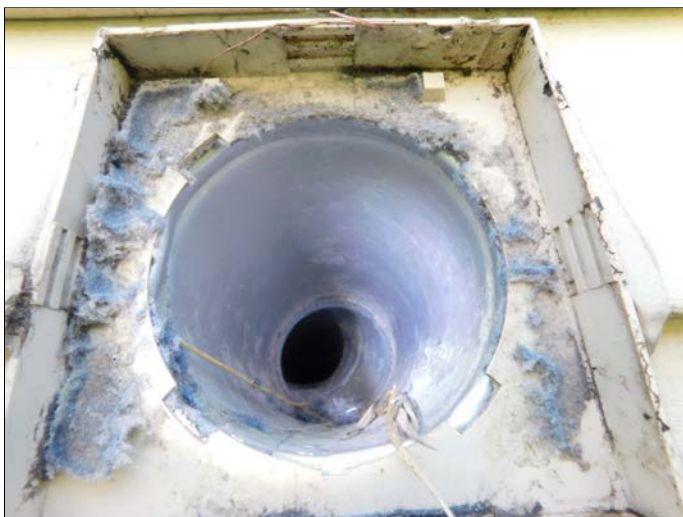
- (5) There was a missing vent terminal at the back of building 7.

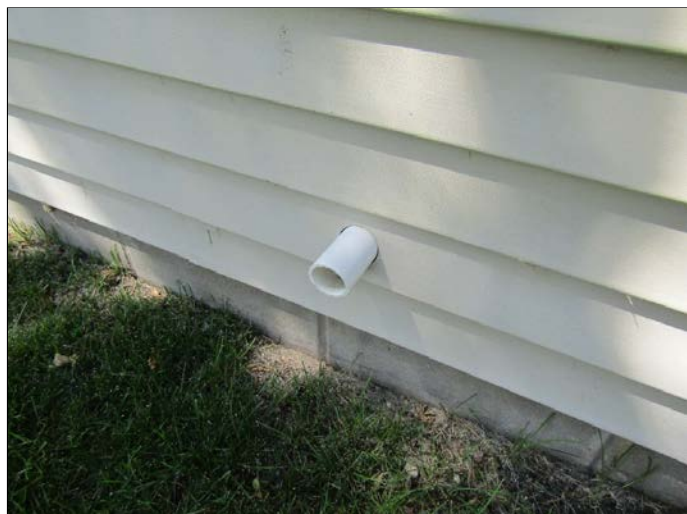
- 🔍 Caulk around the sump pump pipes where they enter the building. This will help prevent water intrusion, pest intrusion, and air leakage.

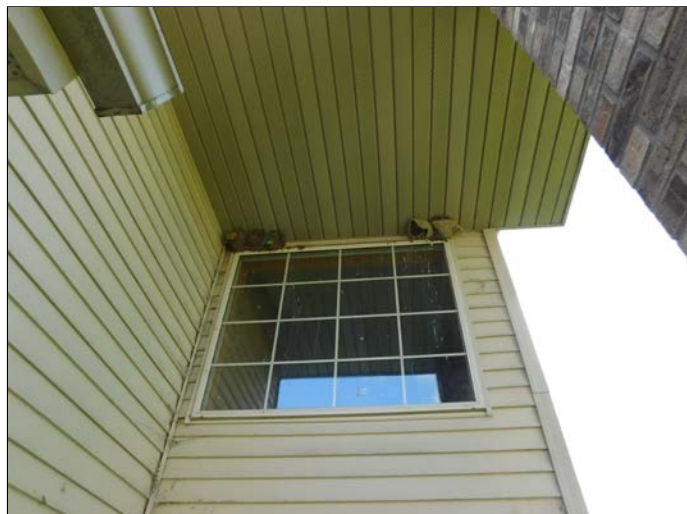
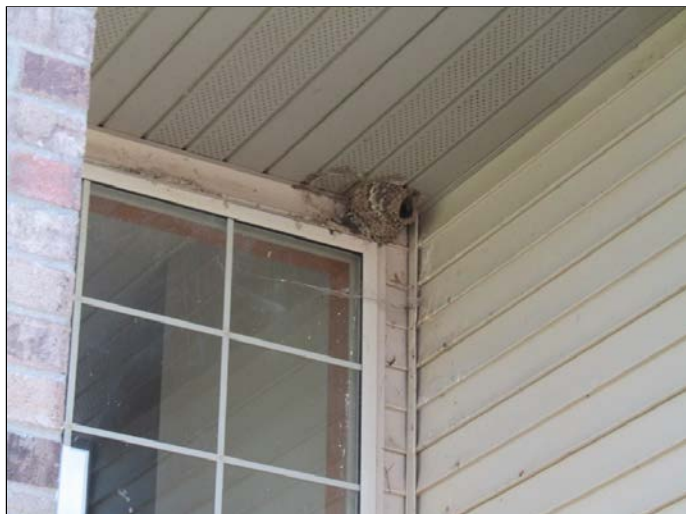
- 🔍 (1) There was bird nesting material located at unit 4320 and 4332. Have the nests removed to help eliminate bird activity.

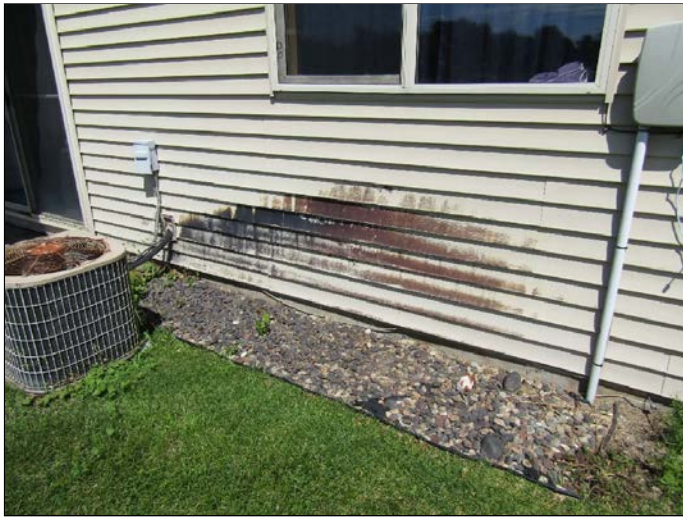
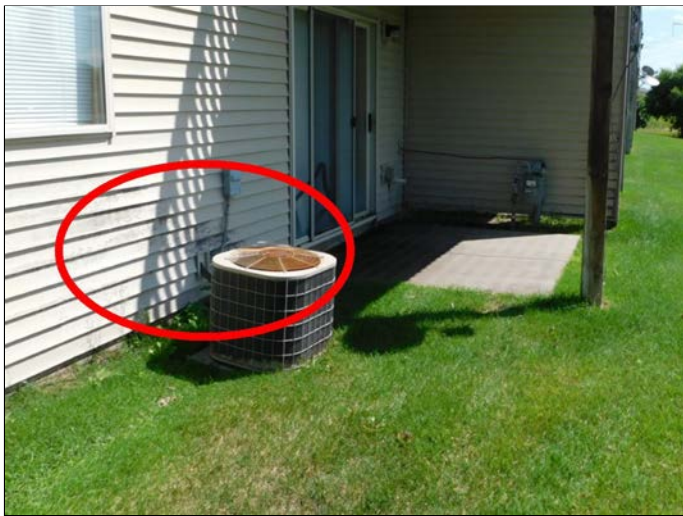
(2) Staining was noted at several walls. This is a cosmetic concern.

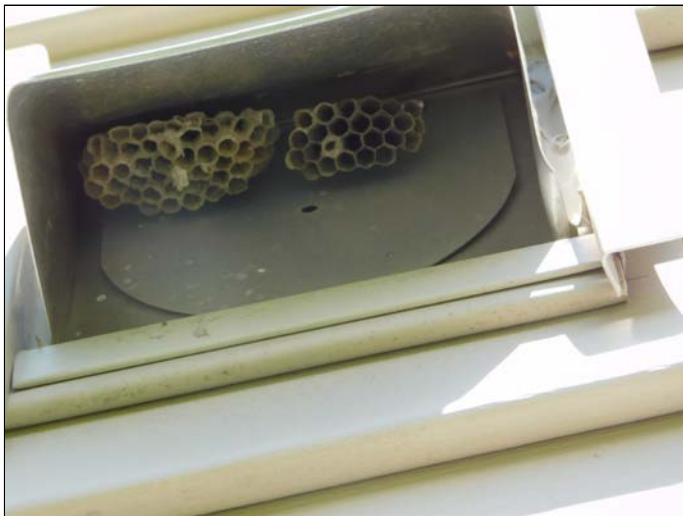
(3) There were bee's / wasp's nests at the dryer vent. Have them removed allow proper air flow.

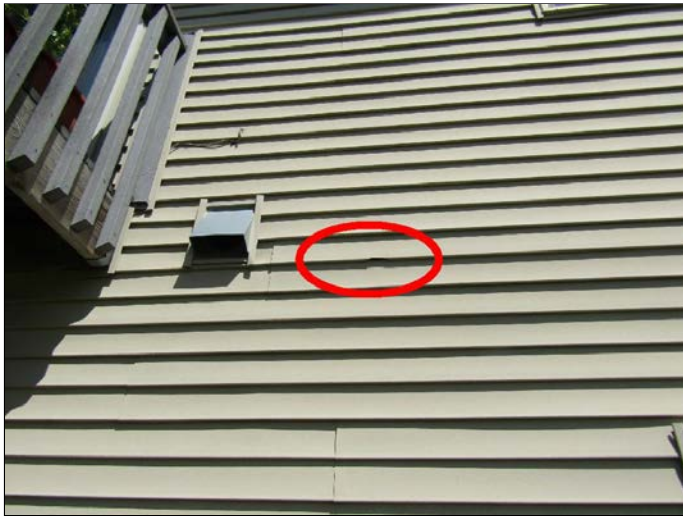
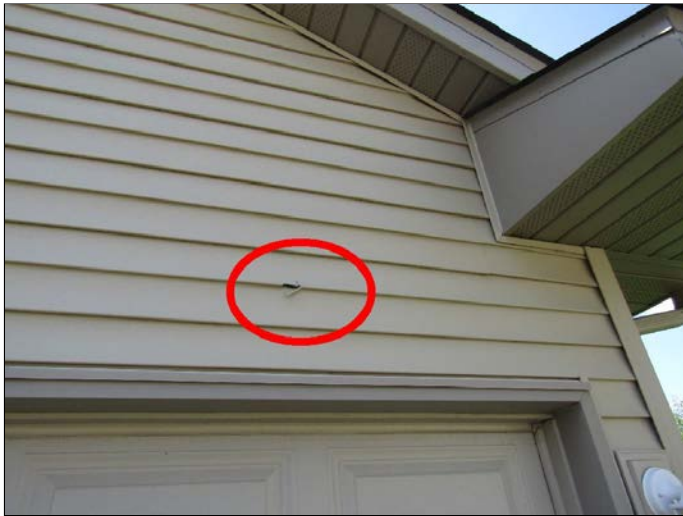
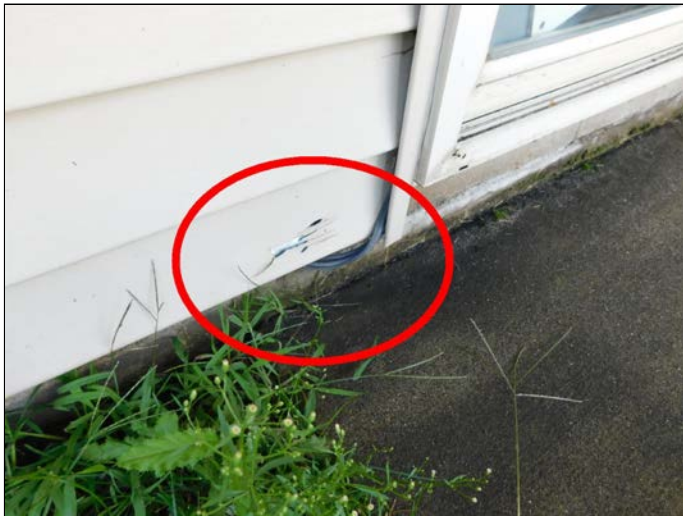
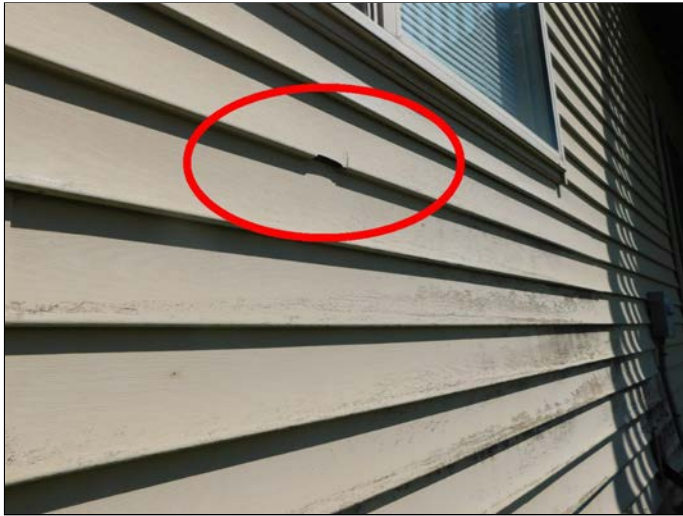
- (4) There were loose, damaged or missing pieces of vinyl siding at the building. Have the loose pieces of siding secured to lower the potential for water intrusion or wind damage.

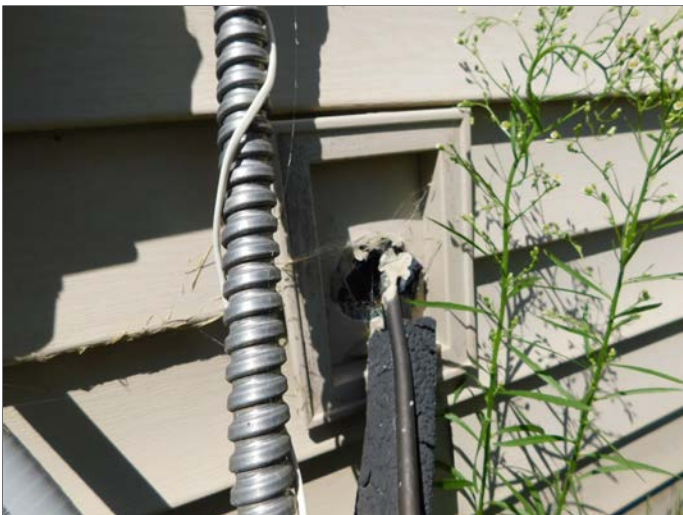
(1) Caulk around the AC refrigerant lines where they enter the building. This will help prevent water intrusion, pest intrusion, and air leakage.

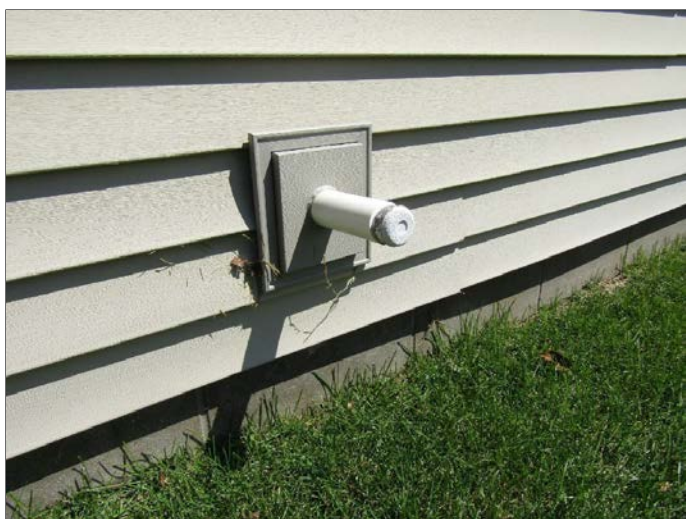
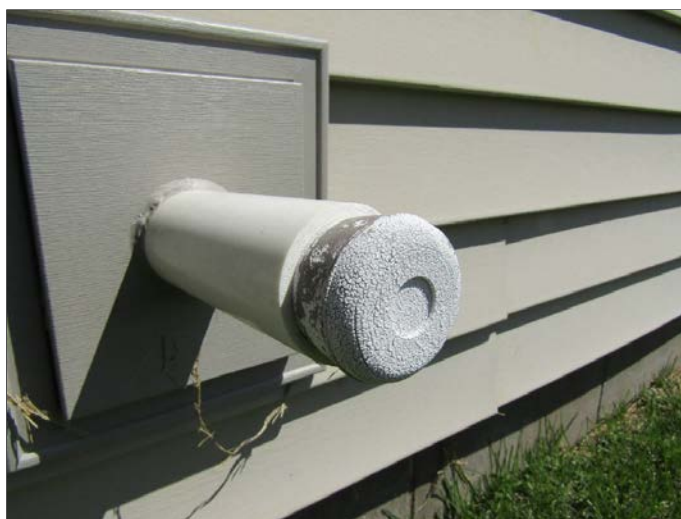
(3) The sump discharge pipe was plugged at unit 4340. Have this corrected to allow the sump to drain properly.

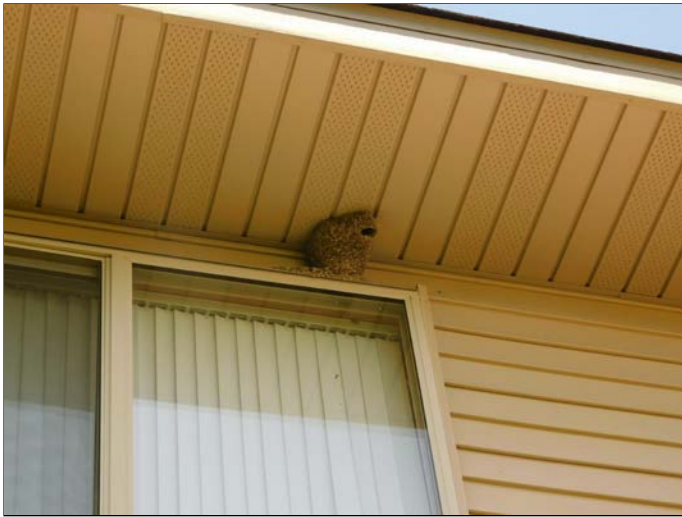
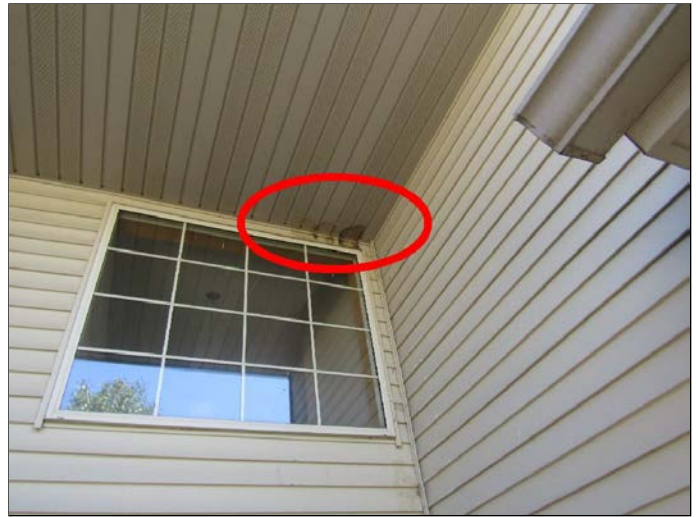
- (1) There was bird nesting material located at unit 4352. Have the nests removed to help eliminate bird activity.

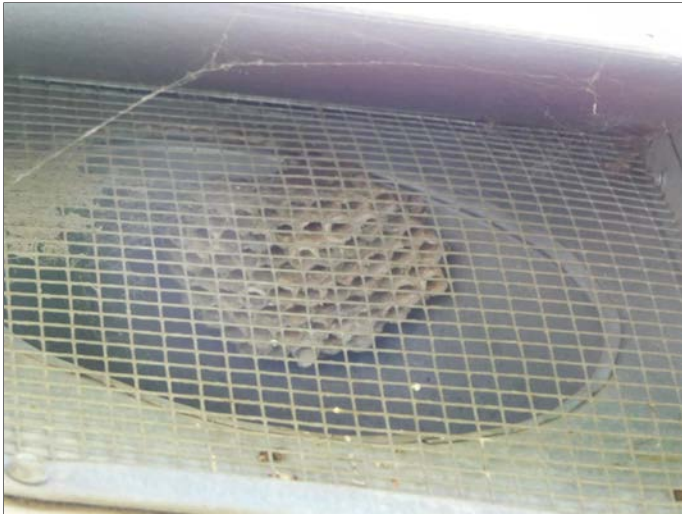
- (2) There were bee's / wasp's nests at the combustion air intake vent at building 9. Have them removed.

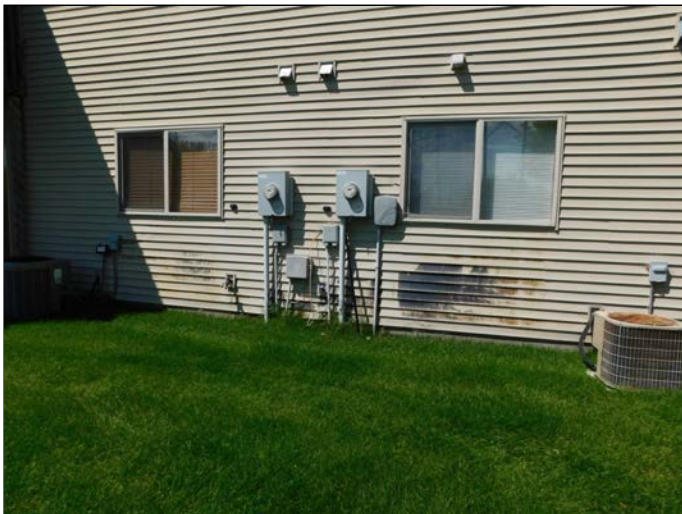
- (3) Staining was noted at a couple walls. This is a cosmetic concern.

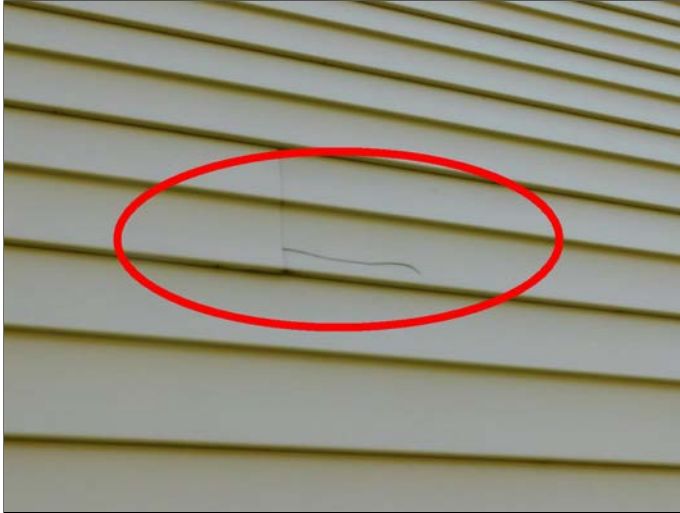
- (4) There were loose, damaged or missing pieces of vinyl siding at the building. Have the loose pieces of siding secured to lower the potential for water intrusion or wind damage.

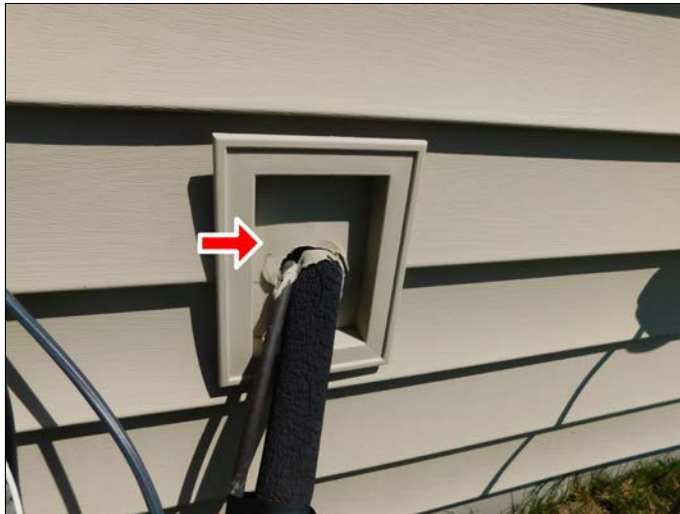
- (1) Caulk around the AC refrigerant lines where they enter the building. This will help prevent water intrusion, pest intrusion, and air leakage.

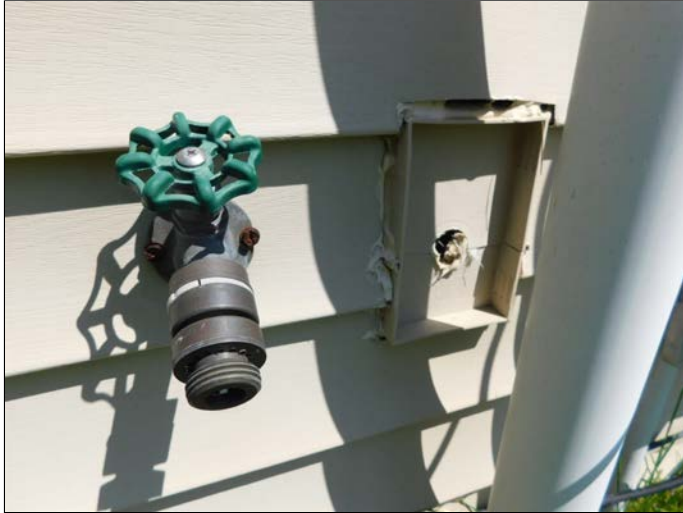
- (2) Caulk around the abandoned gas line where it entered the building. This will help prevent water intrusion, pest intrusion, and air leakage.

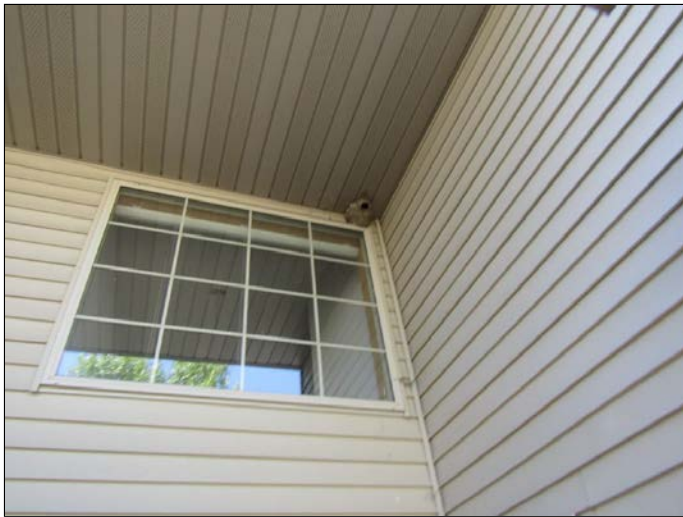
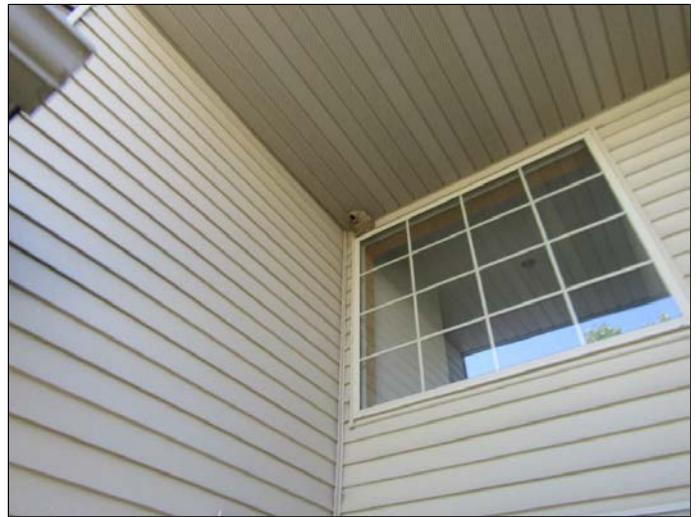
- (1) There was bird nesting material located at unit 9083 and 9095. Have the nests removed to help eliminate bird activity.

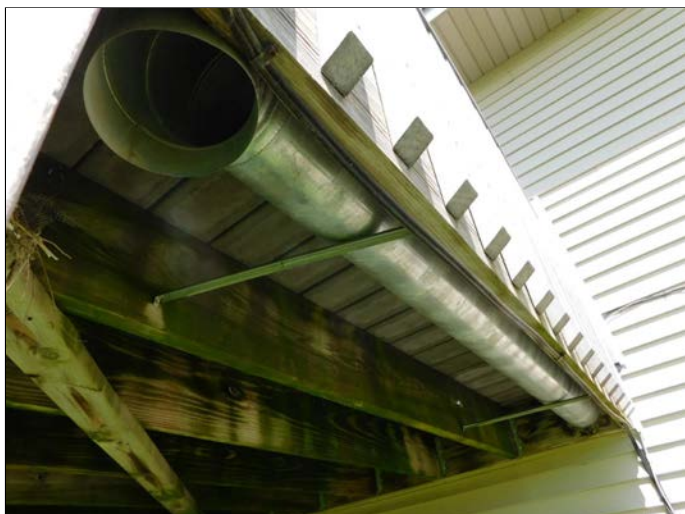
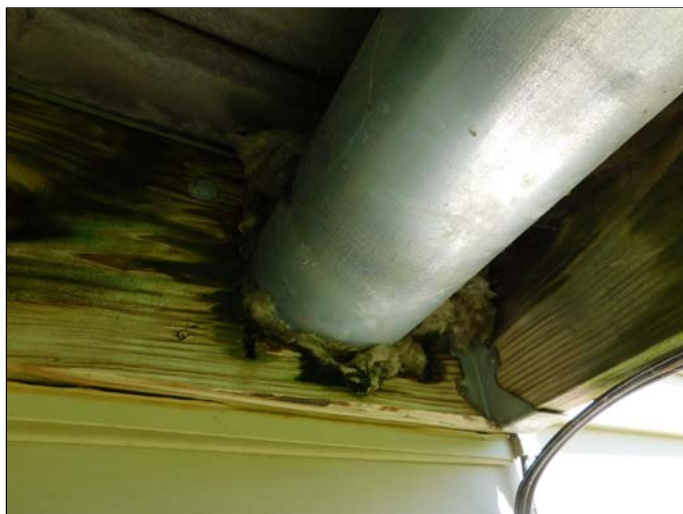
- (2) There was a duct of an unknown purpose that passed through the ledger board at building 10 (possibly unit 9087). Have the gaps around the pipe filled to help prevent water and pest intrusion.

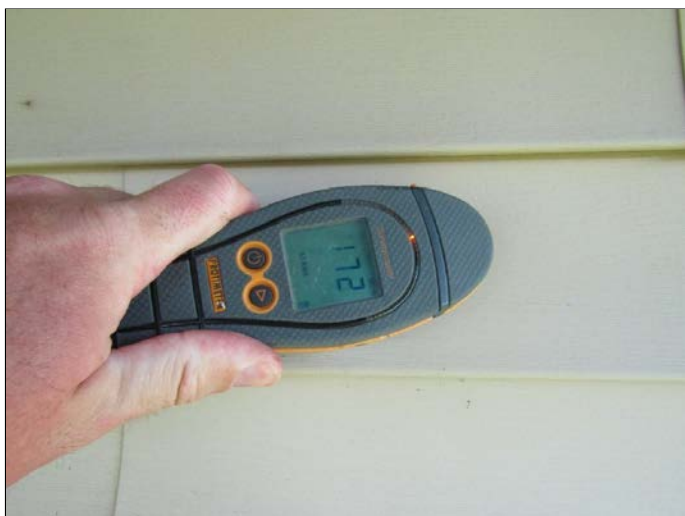
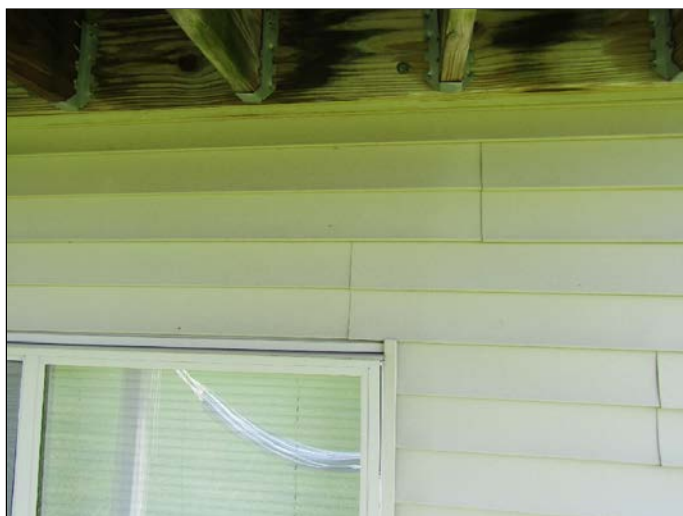
- (3) Moisture was noted at the back side wall of unit 9079 below the deck. Areas below the deck leger board were randomly scanned with a non-invasive moisture meter due to the lack of gutters. These areas can be vulnerable to water intrusion because of splashing water. Consider removing/un-snapping a piece of siding at this area to determine if there is any concealed damage. Gutters are recommended to help prevent accelerated deterioration at doors/decks.

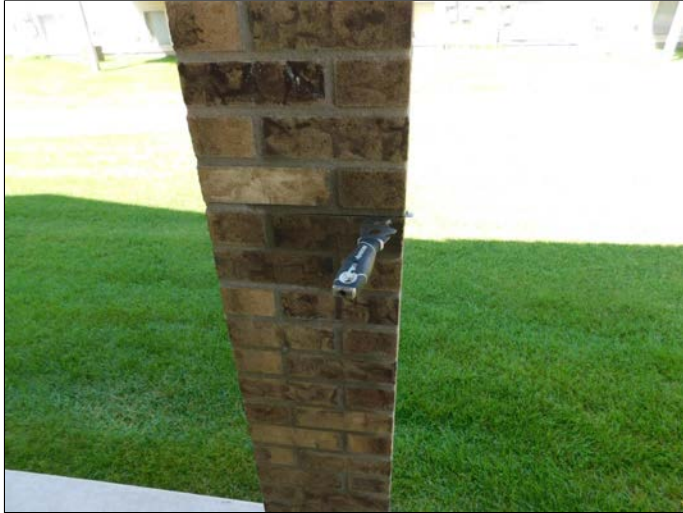
- (4) There were gaps at the mortar at the brick veneer around the column at unit 9097. Have the gaps filled with mortar to help prevent water intrusion and further damage.

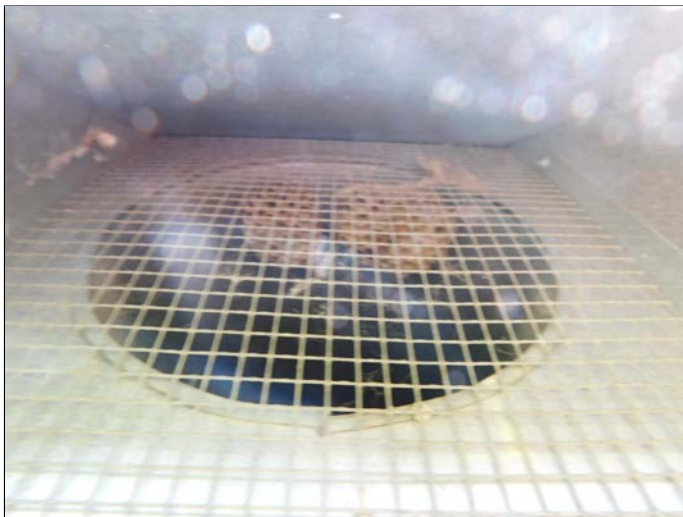
- (5) There were bee's / wasp's nests at the combustion air intake vents. Have them removed.

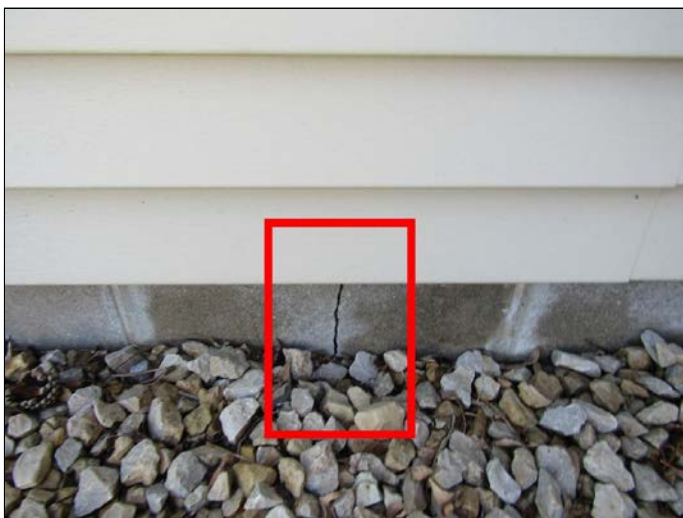
- (6) There were some small cracks and gaps at many of the garage foundation walls. Seal the cracks with mortar and monitor for any future movement.

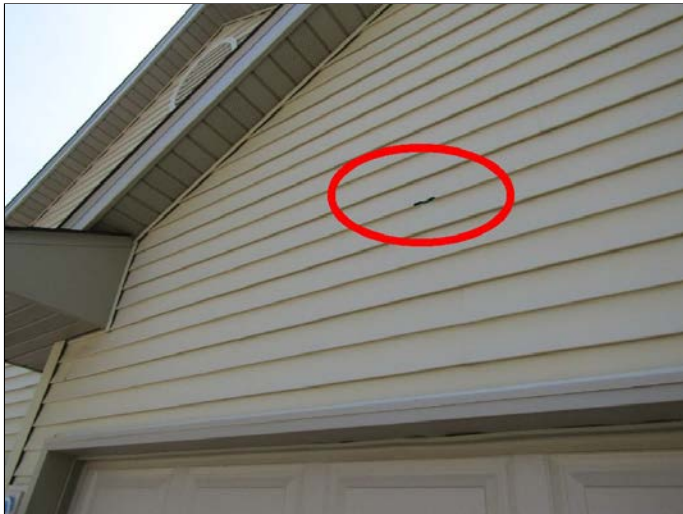
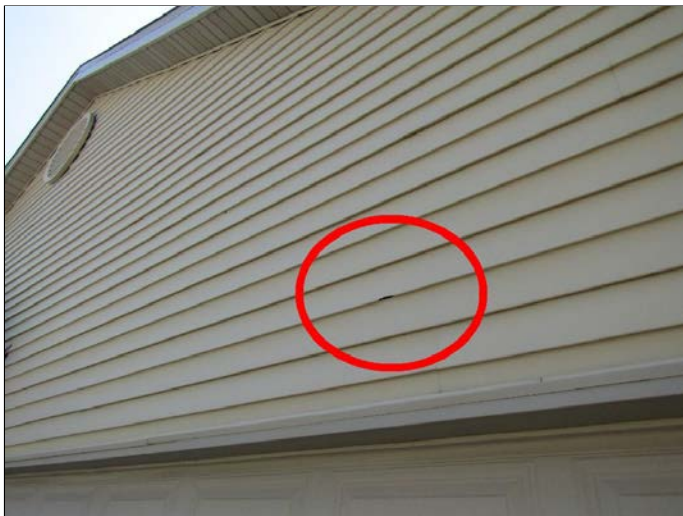
- (7) There were loose, damaged or missing pieces of vinyl siding at the building. Have the loose pieces of siding secured to lower the potential for water intrusion or wind damage.

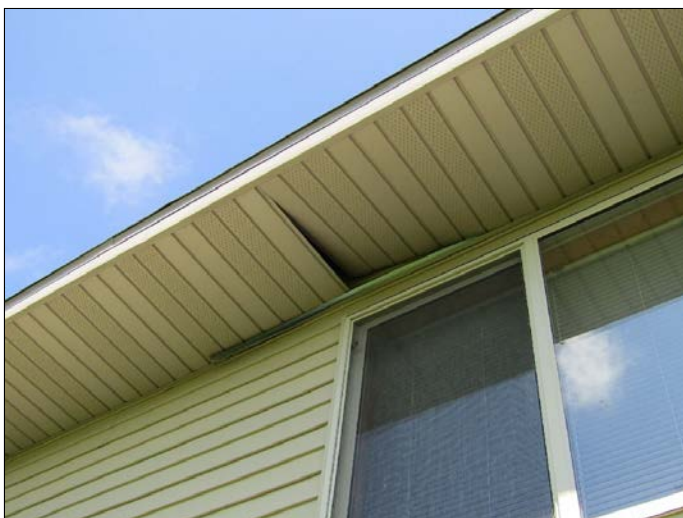
Near 9083

- There was some loose and damaged sections of soffit at building 10. This could allow for pest intrusion and should be serviced.

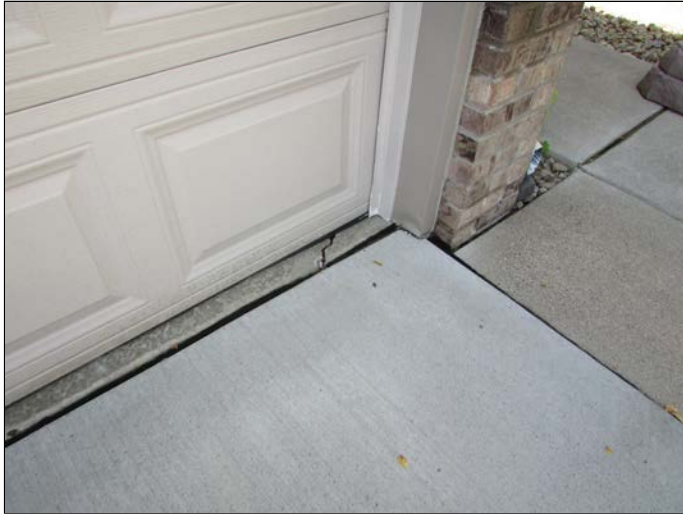
🔍 There was a crack noted at the garage floor or unit 9087. Repair the damage.

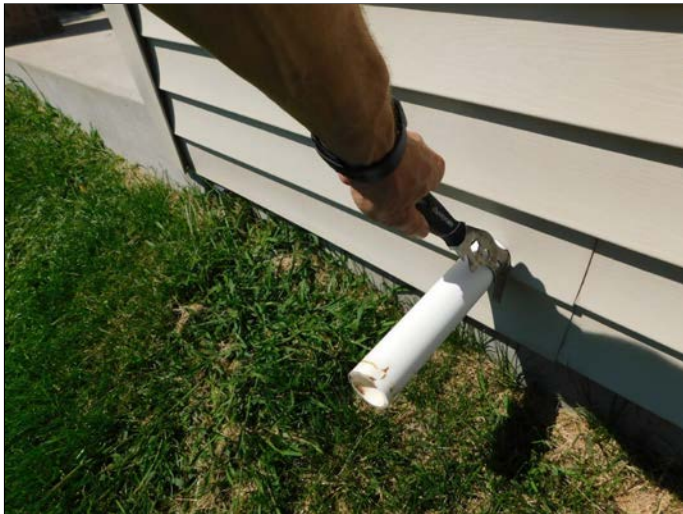
🔍 Caulk around the sump pump pipes where they enter the building. This will help prevent water intrusion, pest intrusion, and air leakage.

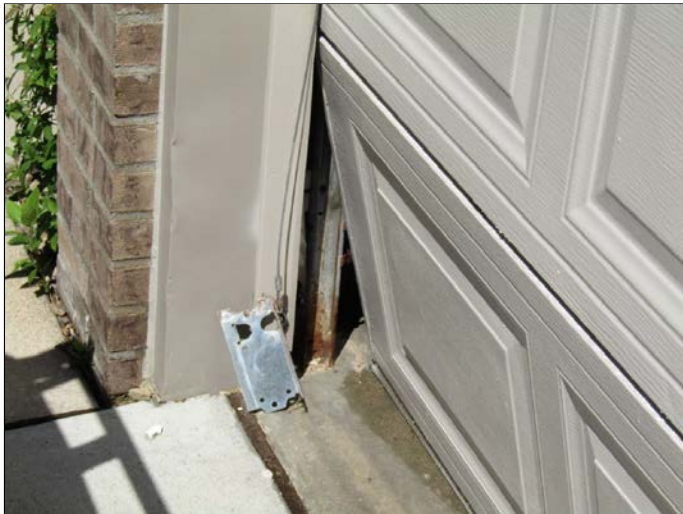
- (1) Unit 9106's door was off the track and appeared damaged. Have the overhead door repaired to allow proper functionality.

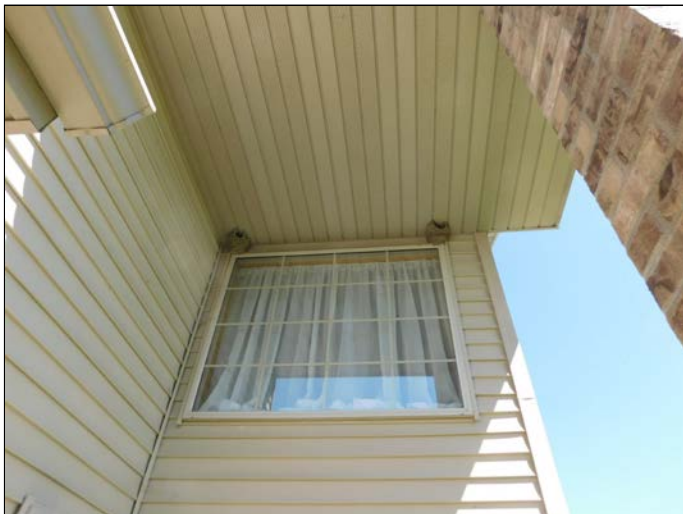
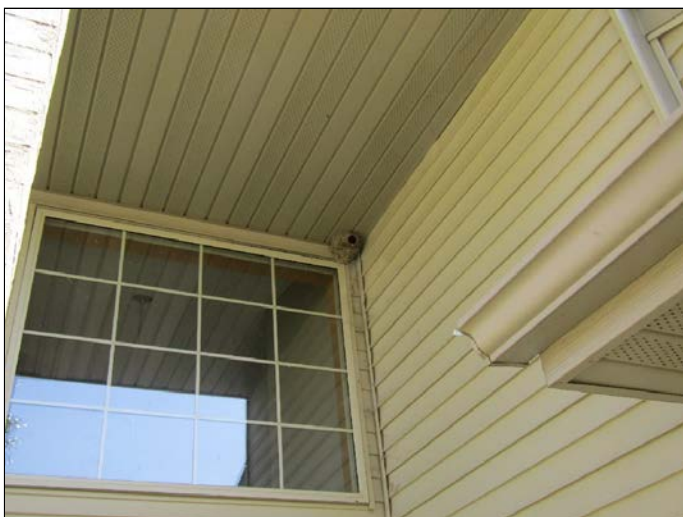
- (3) There was bird nesting material located at unit 9114. Have the nests removed to help eliminate bird activity.

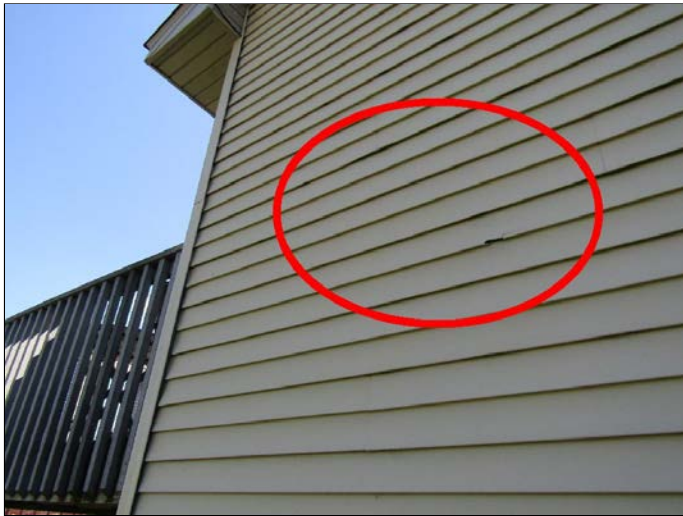
- (4) There were loose, damaged or missing pieces of vinyl siding at the building. Have the loose pieces of siding secured to lower the potential for water intrusion or wind damage.

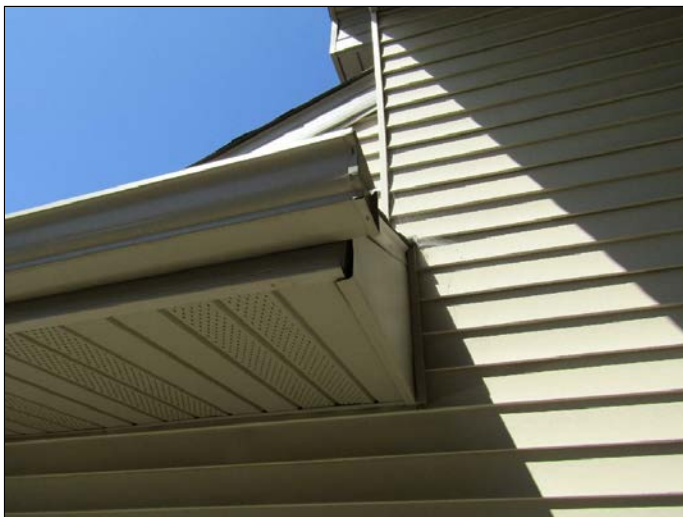
- There was a loose piece of aluminum wrap present at unit 9108. Repair as needed by re-fastening the aluminum wrap to the wood fascia.

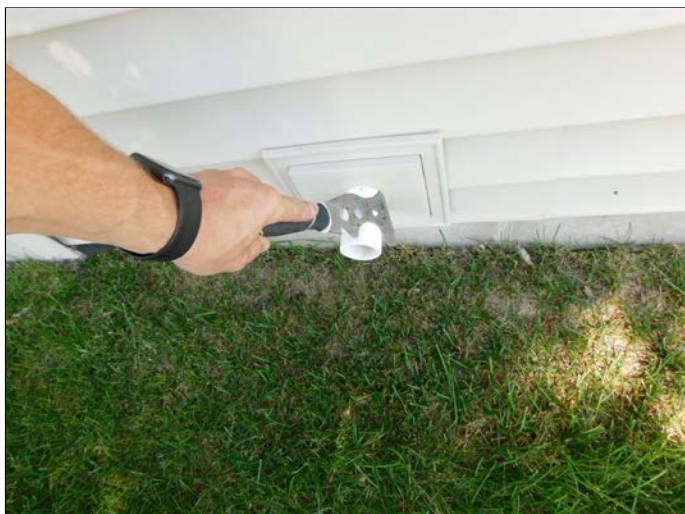
- 🔍 Caulk around the sump pump pipes where they enter the building. This will help prevent water intrusion, pest intrusion, and air leakage.

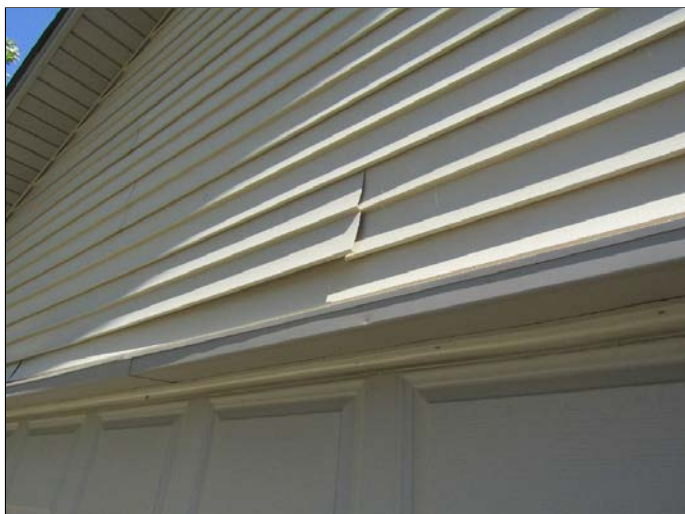
- (2) There were loose, damaged or missing pieces of vinyl siding at the building. Have the loose pieces of siding secured to lower the potential for water intrusion or wind damage.

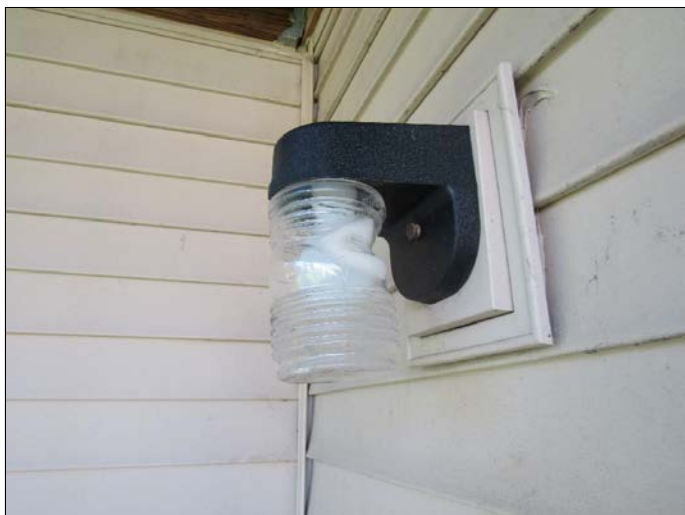
- (1) There were loose outlets that should be secured to help prevent loosening of the wires which could lead to sparking or arcing at unit 9184. Have this corrected.
- (2) There was a melted globe at unit 9188. Have the globe replaced and have the light evaluated and repaired if needed by a licensed electrician.

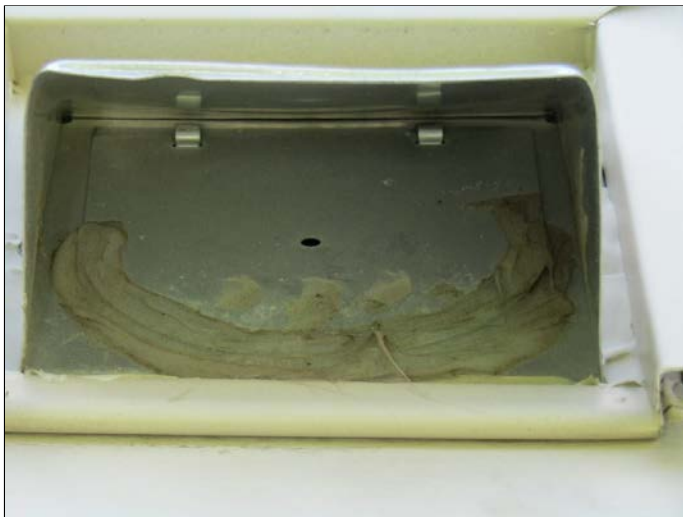
- (1) There was a damper caulked shut at 9188. This will prevent proper ventilation. Have this corrected.

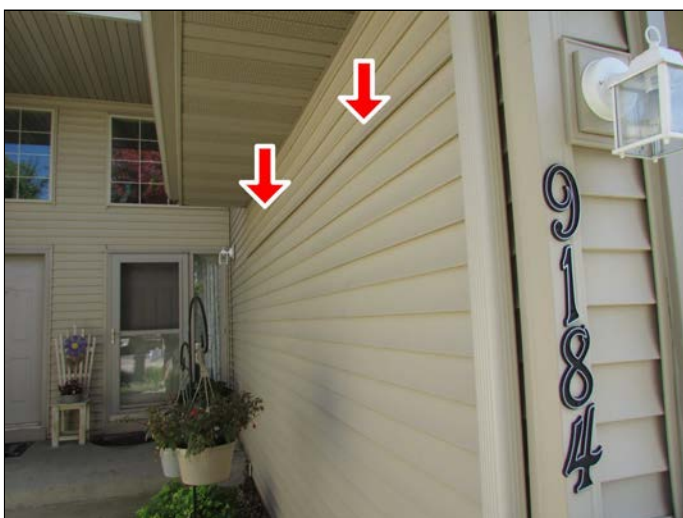
- (2) There were loose, damaged or missing pieces of vinyl siding at the building. Have the loose pieces of siding secured to lower the potential for water intrusion or wind damage.

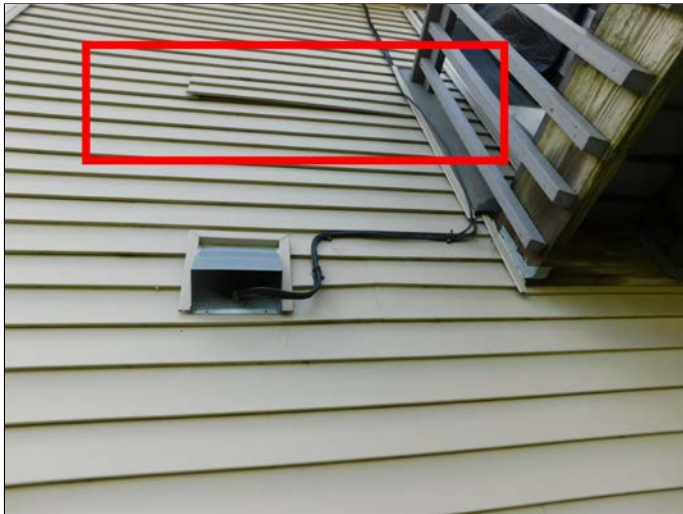
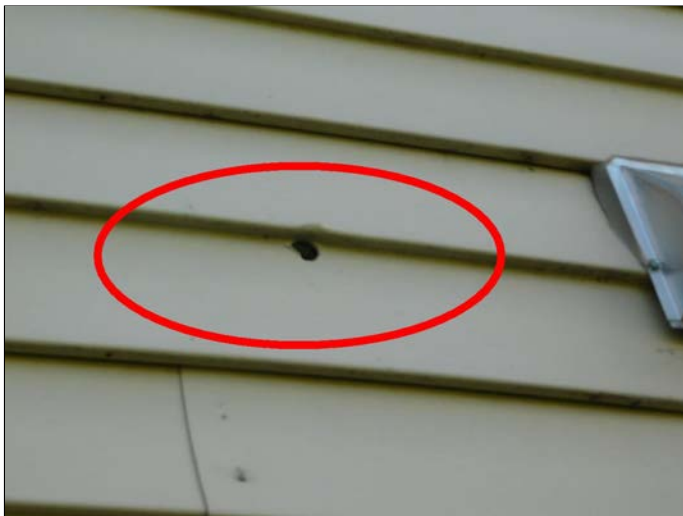
(3) There were loose, damaged or missing pieces of vinyl siding at the building. Have the loose pieces of siding secured to lower the potential for water intrusion or wind damage.

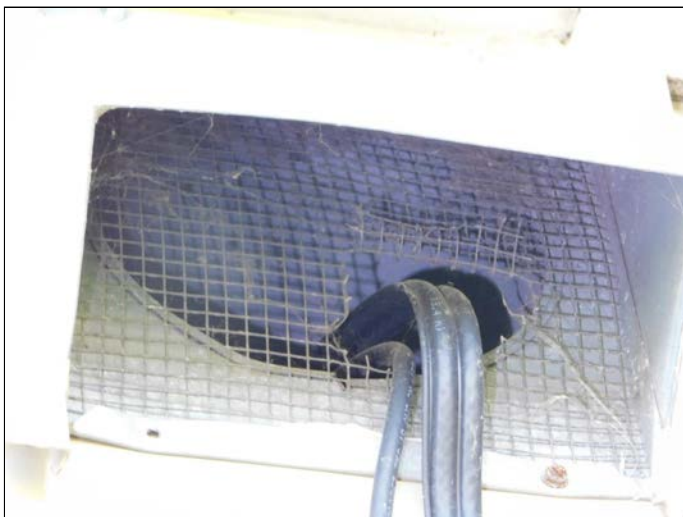
(4) There was a damaged combustion air intake from the communication wire installation. Have this corrected to help prevent pest intrusion.

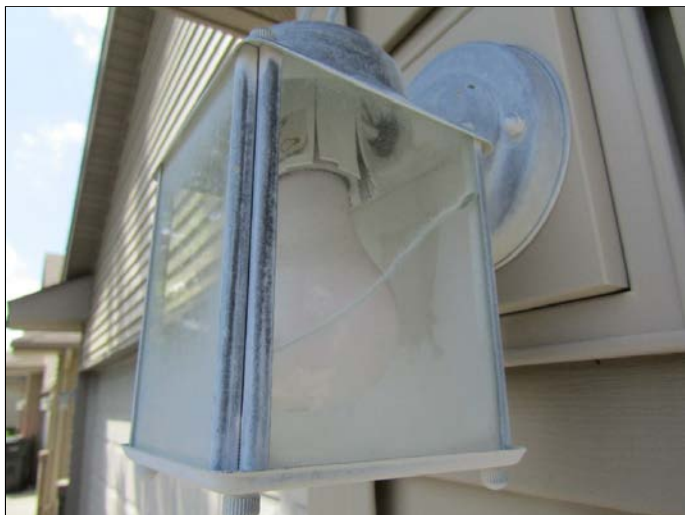
(2) A light fixture at unit 9227 had broken or missing glass. Have the fixture repaired or replaced.

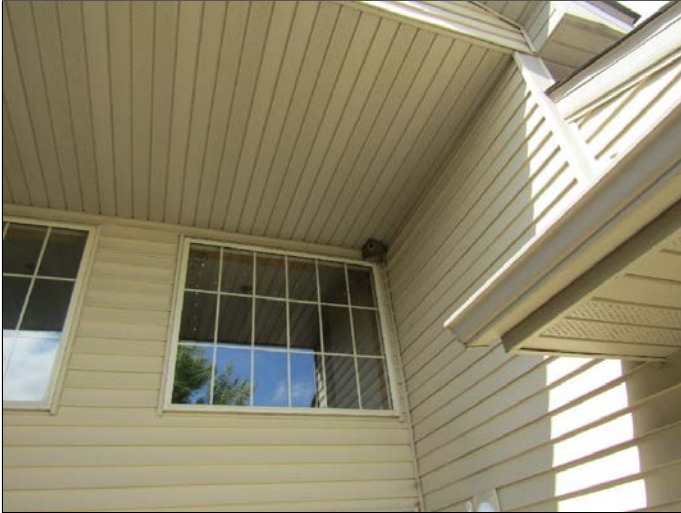
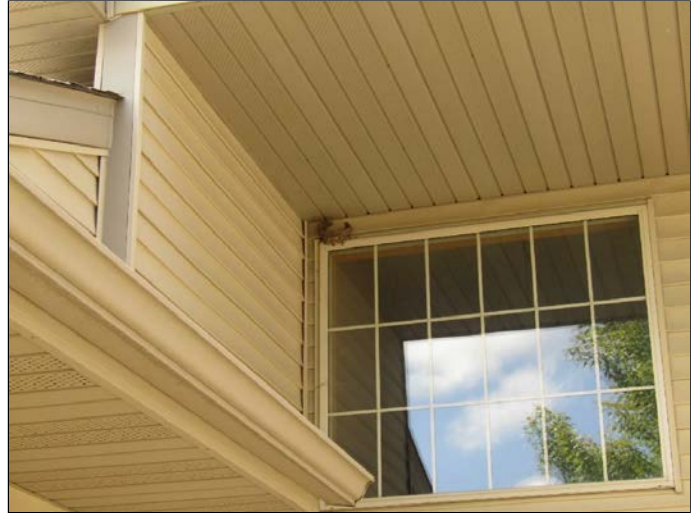
(1) There was bird nesting material located at unit 9219 and 9221. Have the nests removed to help eliminate bird activity.

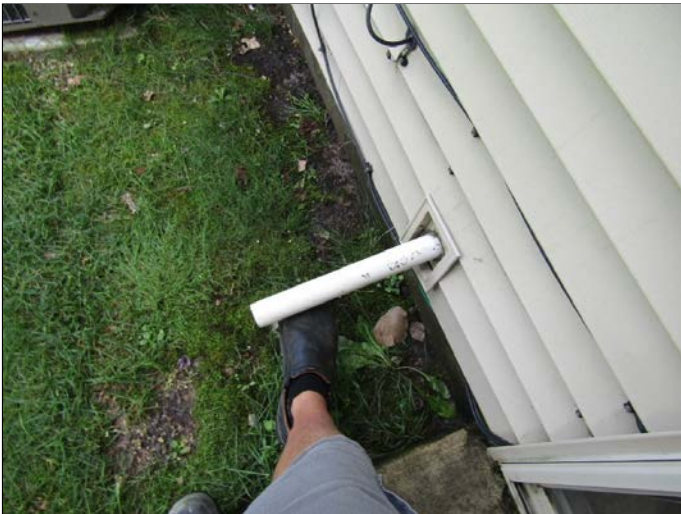
(2) There was loose and possibly disconnected sump discharge pipe at unit 9221. Have this further investigated for correction to help prevent water damages inside the unit.

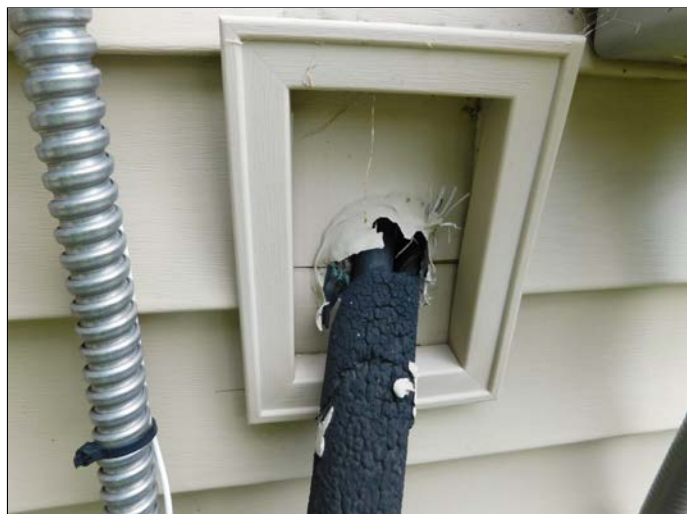
- ☑️ Caulk around the AC refrigerant lines where they enter the building. This will help prevent water intrusion, pest intrusion, and air leakage.
