Inspection Report

Sample Report

Property Address:
1234 Anyplace Terrace
Yourtown MN

Structure Tech Home Inspections

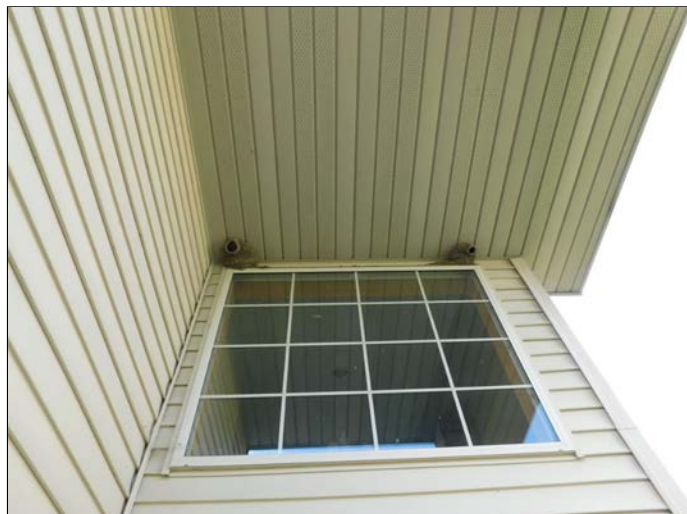
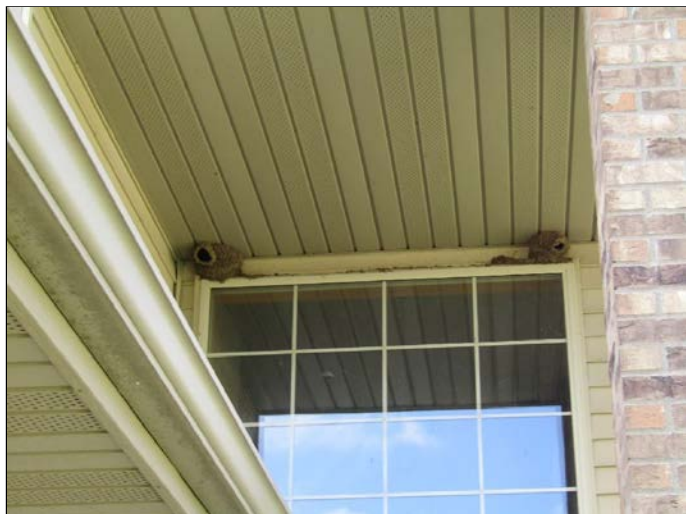
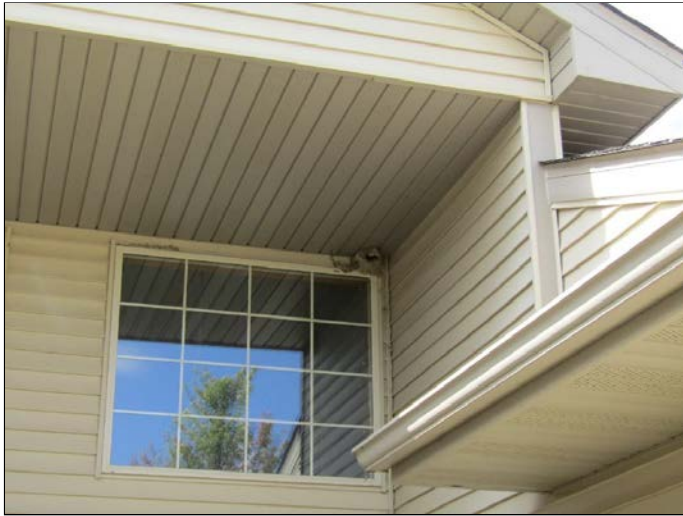
- ☑️ (1) There was bird nesting material located at unit 9205 and 9201 Orchard Circle. Have the nests removed to help eliminate bird activity.

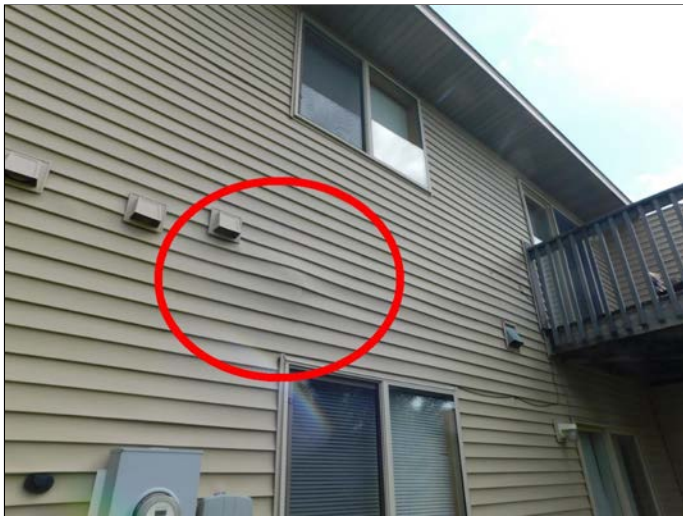
- (2) There was a bulge in the siding at building 16. Have this investigated further to determine a cause and correct as needed.

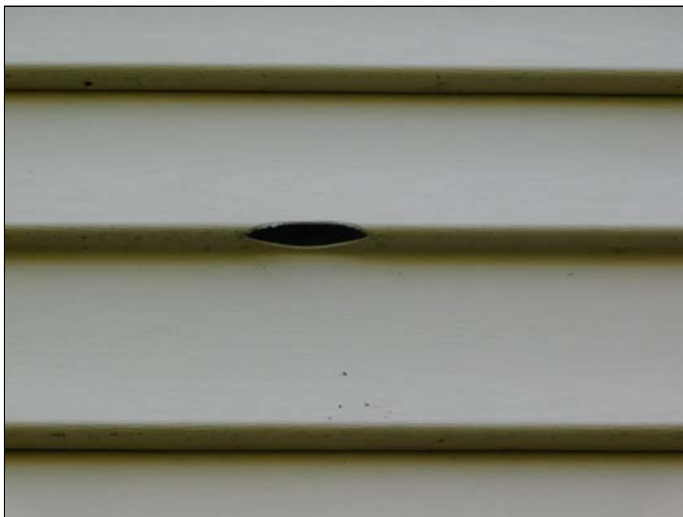
- (3) There was a loose, damaged or missing piece of vinyl siding at the building. Have the loose piece of siding secured to lower the potential for water intrusion or wind damage.

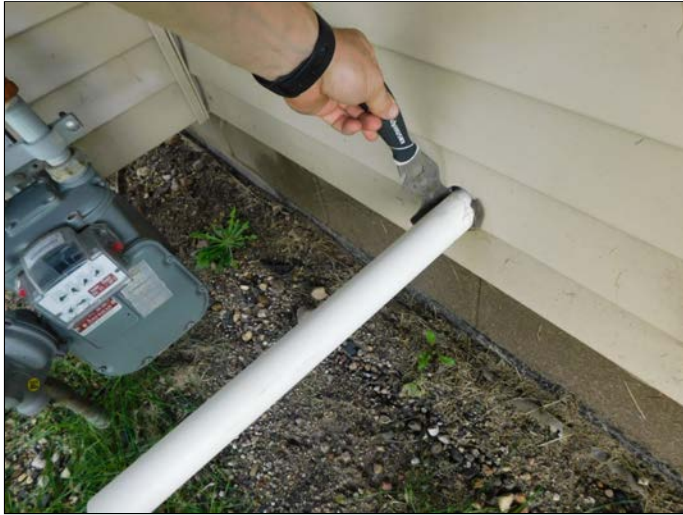
Caulk around the sump pump pipes where they enter the building. This will help prevent water intrusion, pest intrusion, and air leakage.

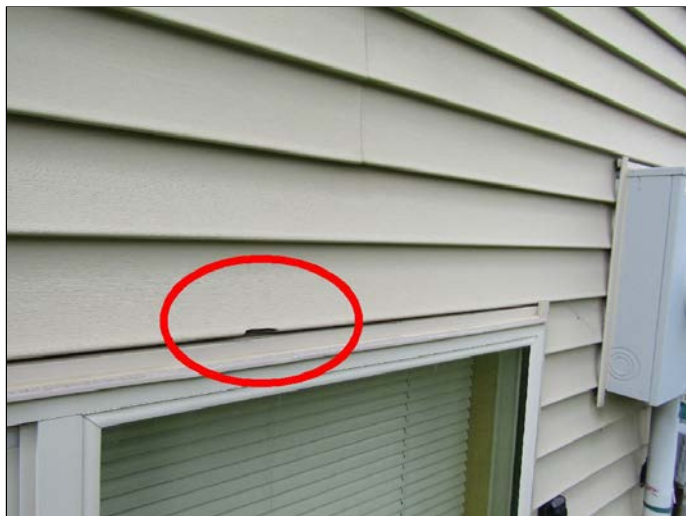
(1) There were loose, damaged or missing pieces of vinyl siding at the building. Have the loose pieces of siding secured to lower the potential for water intrusion or wind damage.

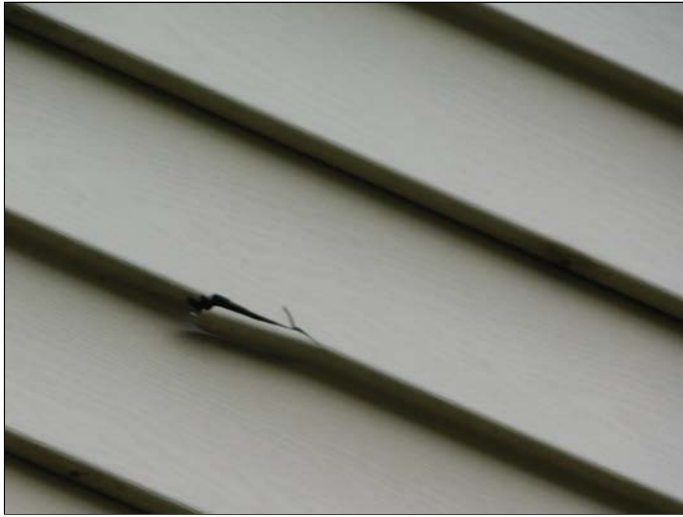
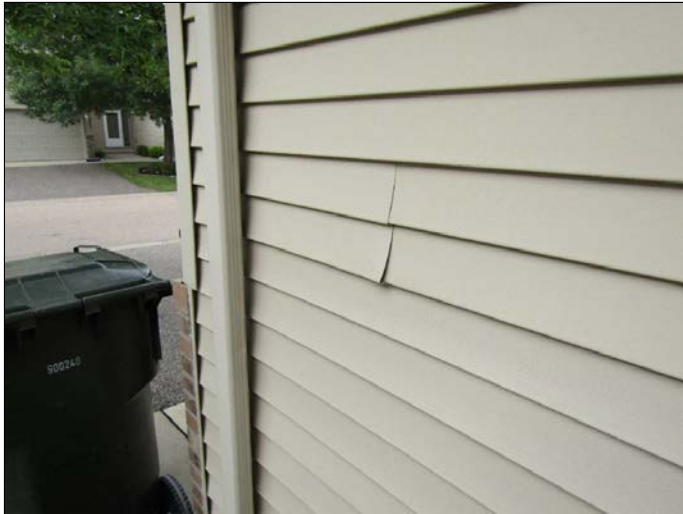
(2) There were loose, damaged or missing pieces of vinyl siding at the building. Have the loose pieces of siding secured to lower the potential for water intrusion or wind damage.
